## Corporate Bridge Register (CBR) Structure Inventory Data Form "BRIDGES"

| *Forest Service Road: CANTELON CRK | Kilometres: 8.2 |

**Routine Condition Bridge Inspection Form**  
(except for log stringer or timber stringer bridges)

| GENERAL INFORMATION | | | |
|---|---|---|---|
| 2010-09-02 | Onsite Engineering Ltd | Ali Sadeghi | |

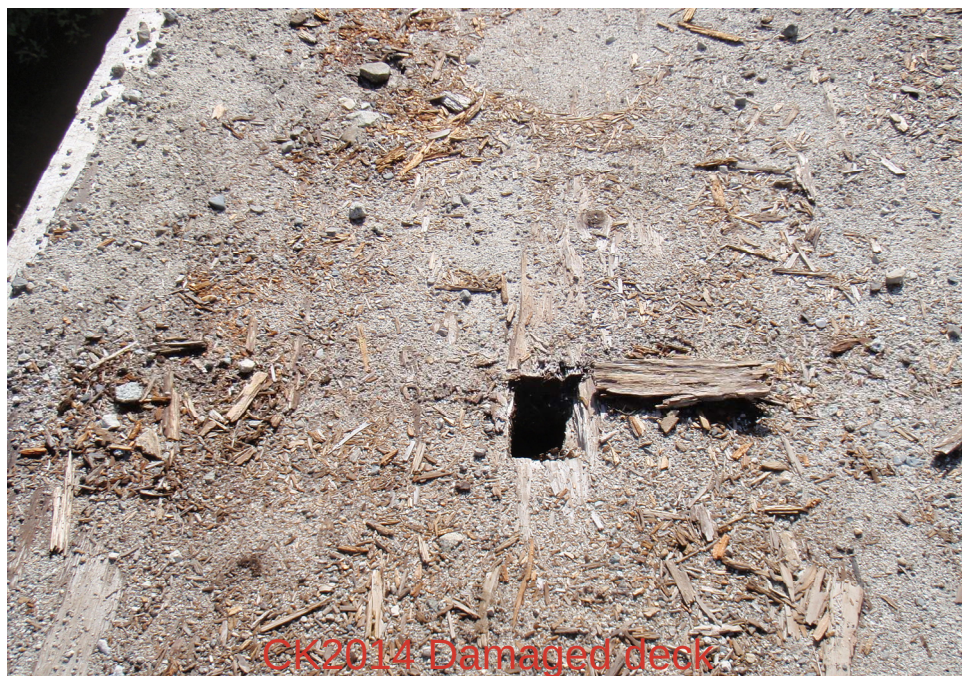
| GENERAL INFORMATION | | | | (enter either long/lat or UTM below - not both) | | | |
|---|---|---|---|---|--|--|--|
| Running Planks | E G F <u>(P)</u> N/A UR | ROTTEN DECK. 4" x 12" | | | | | |
| Ties | E G F <u>(P)</u> N/A UR | ROTTEN. TIMBER - 200 x 250 mm | | | | | |

CK2014 Damaged deck

| GENERAL INFORMATION | | | |
|---|---|---|---|
| 1 | <b>H</b> M L | | REPLACE RUNNING SURFACE |

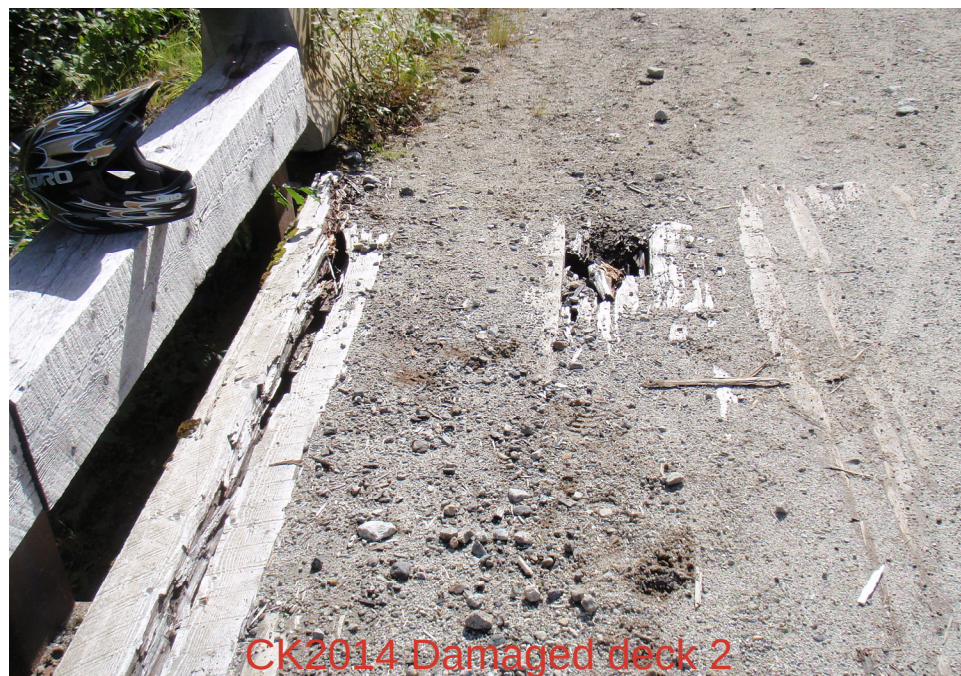
CK2014 Damaged deck 2

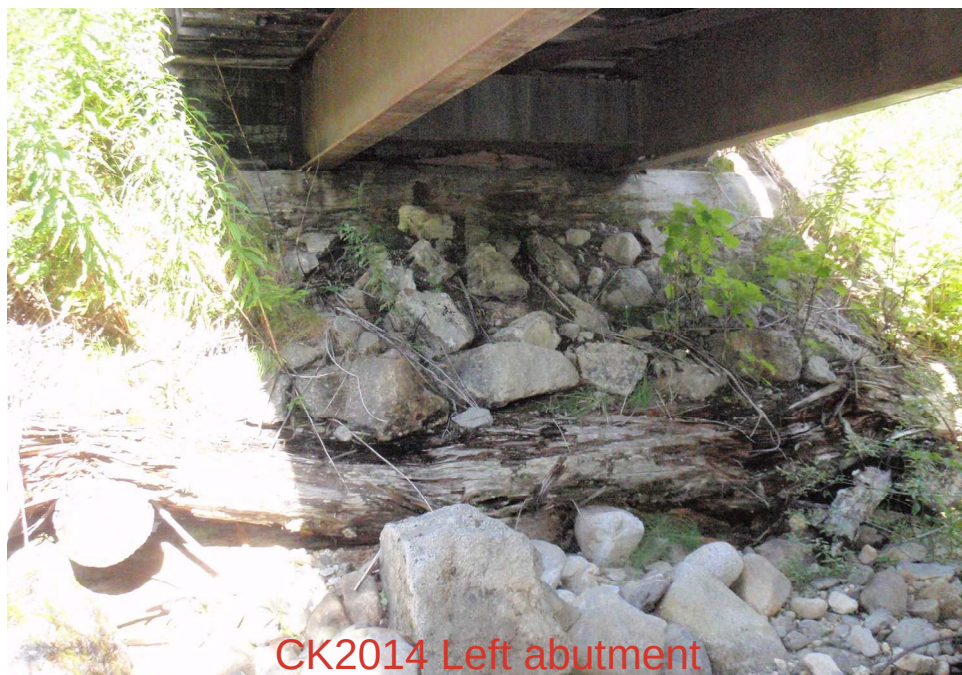
CK2014 Left abutment

| GENERAL INFORMATION | | | | (enter either long/lat or UTM below - not both) | | | |
|---|---|---|---|---|--|--|--|
| Log/Timber Crib | E G <u>(F)</u> P N/A UR | OLD CRIB IN FRONT OF SILL RETAINING | | | | | |
| Fill | E G F <u>(P)</u> N/A UR | FILL IN LEFT ABUT HAS BEEN EXCAVATED? | | | | | |

FILL THE LEFT ABUT FILL IS VERY ROTTEN AND COULD POTENTIALLY FAIL COMPROMISING NEW SILL FOOTING

| GENERAL INFORMATION | | | |
|---|---|---|---|
| Close bridge - please remove or replace bridge or barricade. | | | |
