**Routine Condition Bridge Inspection Form**  
(except for log stringer or timber stringer bridges)**GENERAL INFORMATION**

| *Site #: <u>CK-2016</u> | *Crossing Name: | *Type/Class: <input type="checkbox"/> Temporary bridge<br><input checked="" type="checkbox"/> Permanent bridge | *Project File ID# <u>B124</u> |
| *FSR Name: <u>CANTELON CRK.</u> | *Forest District: <u>Chilliwack</u> | *Kilometres: <u>9.1</u> | User km: |

| GENERAL INFORMATION | | | |
|---|---|---|---|
| *Date of Inspection (yyyy/mm/dd)<br>2010-09-02 | *Inspection Company Name<br>Onsite Engineering Ltd | *Inspector's Name (print)<br>Ali Sadeghi | Inspector's Signature<br> |

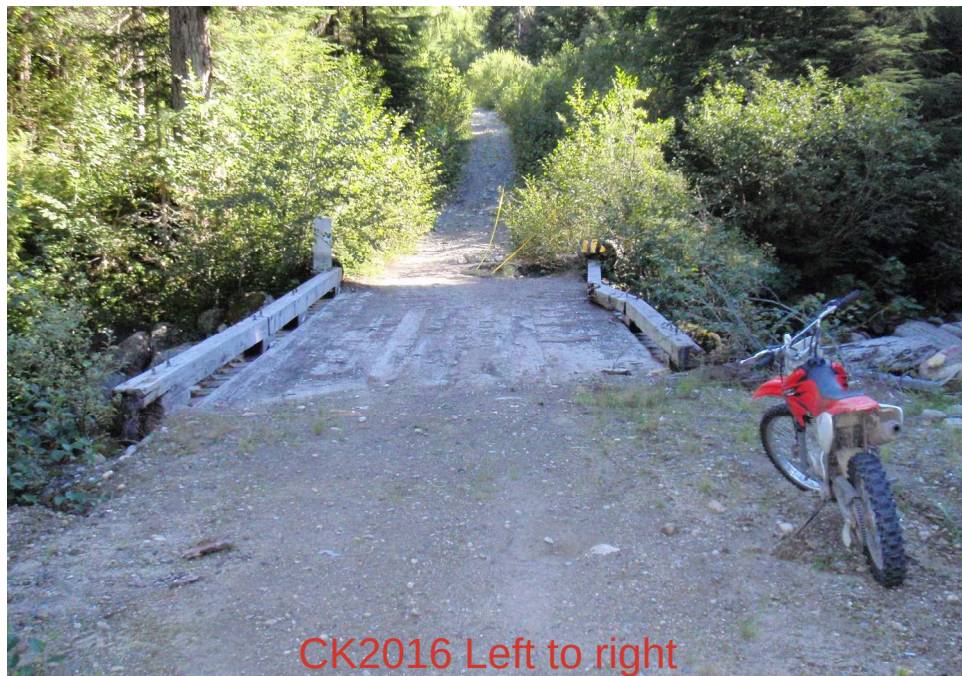
CK2016 Left to right

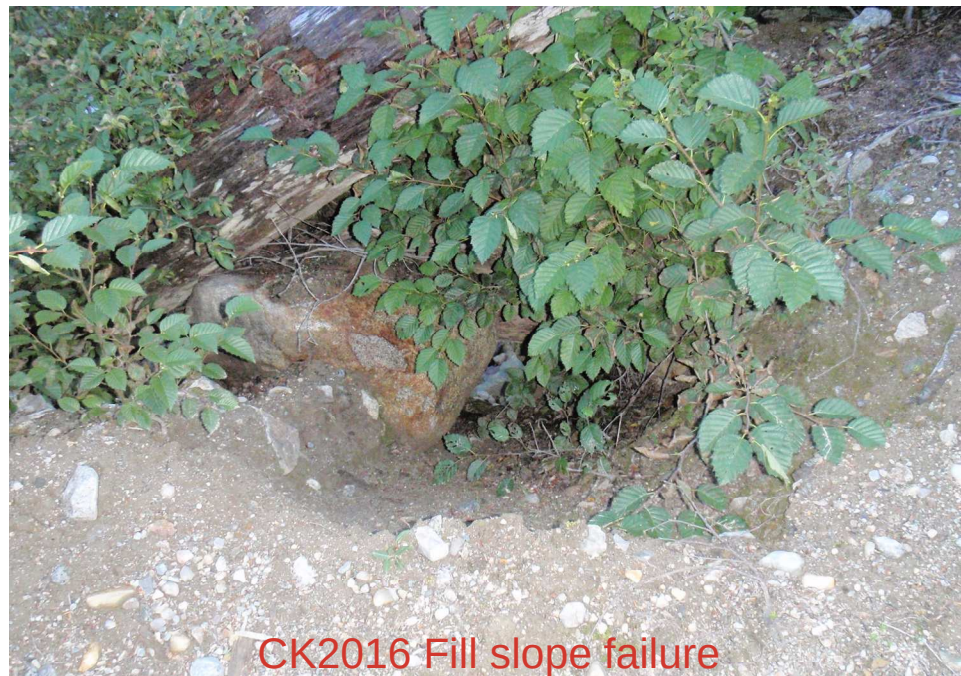
| Item | Present Condition (circle) | Comments (a comment is mandatory if condition "Poor" is selected) |
|---|---|---|
| Log/Timber Cribs | E G <u>(F)</u> <u>(P)</u> N/A UR | 2x CRIB SEVERLY SLOURED + UNDERMINED. |
| Fill | E G F <u>(P)</u> N/A UR | SEVER SLOUR + FILL FAILURE BEHIND CRIBS. |

CK2016 Fill slope failure

| GENERAL INFORMATION | | | |
|---|---|---|---|
| 1 | <b>(H)</b> M L | | REPLACE STRUCTURE. |

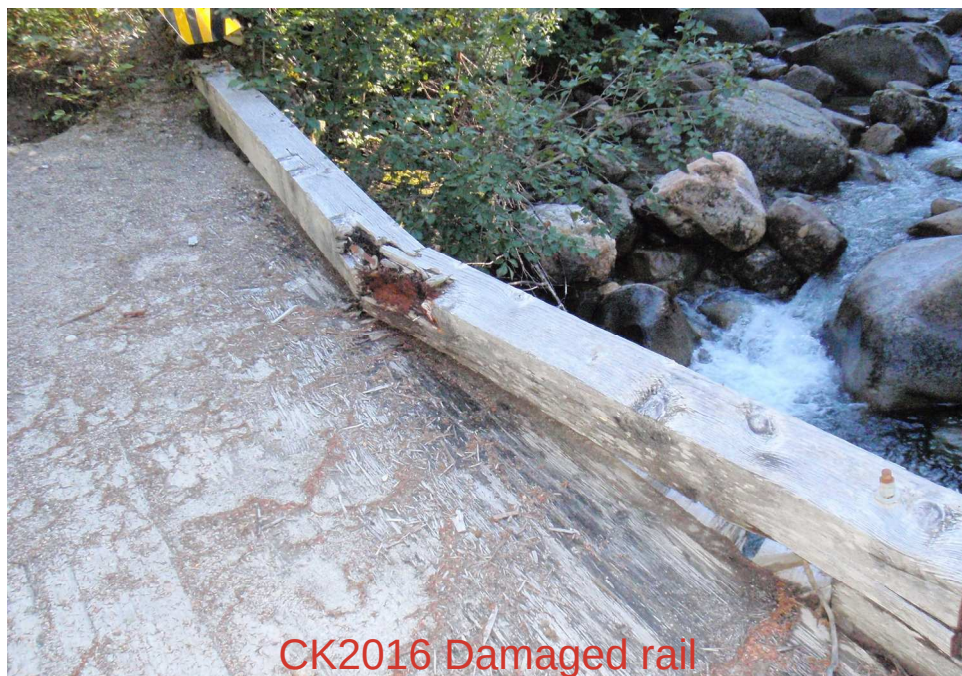
| Item | Present Condition (circle) | Comments (a comment is mandatory if condition "Poor" is selected) |
|---|---|---|
| Curb Rail/Blocks/Posts | E G F <u>(P)</u> UR | UPSTREAM DAMAGED + ROTTEN |

CK2016 Damaged rail

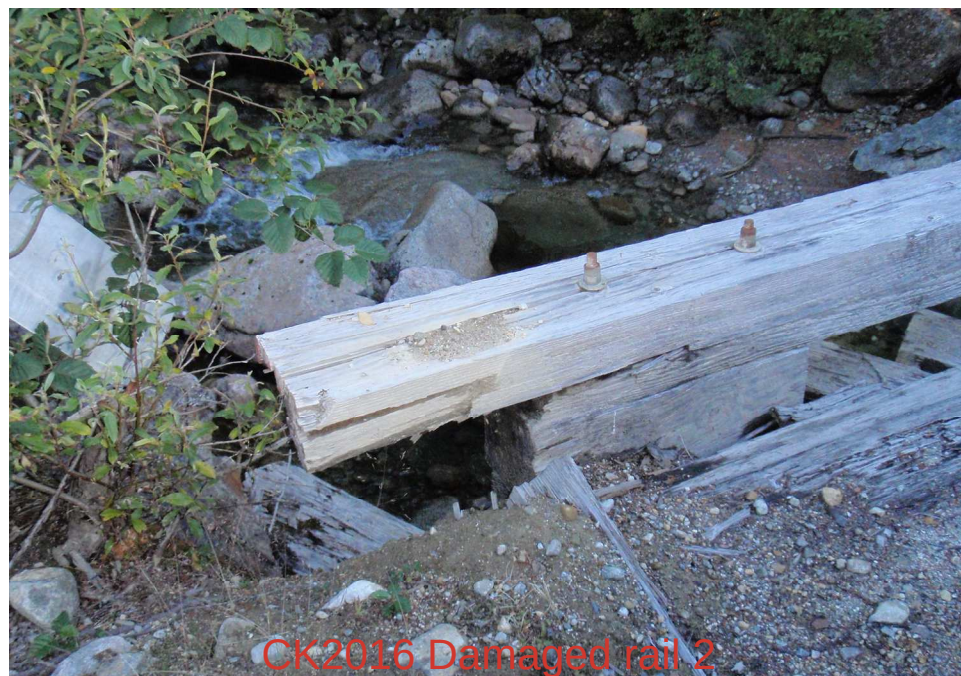
CK2016 Damaged rail 2

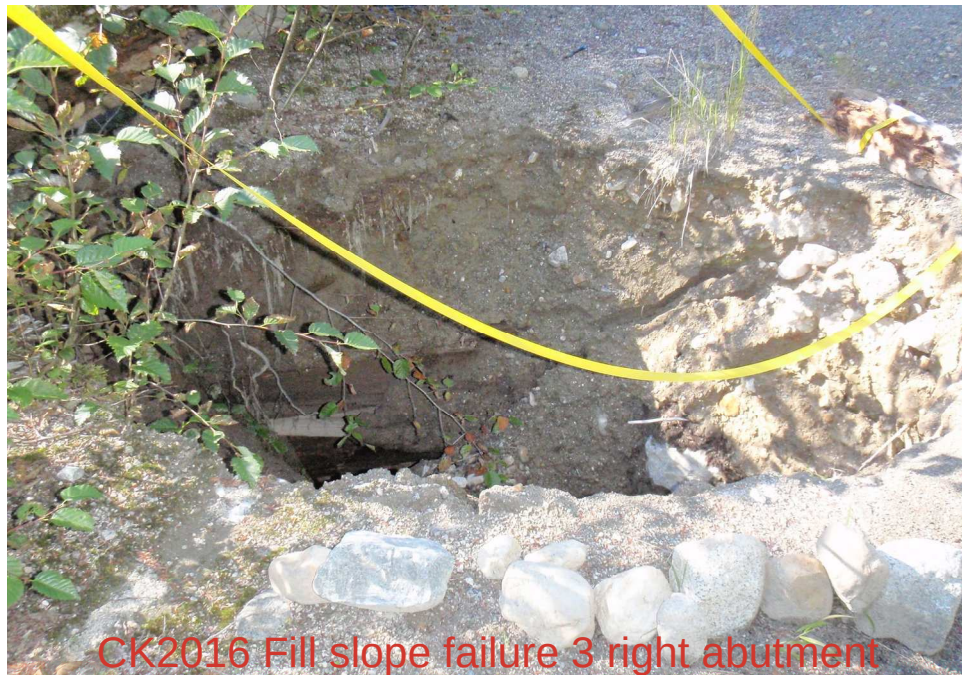
CK2016 Fill slope failure 3 right abutment

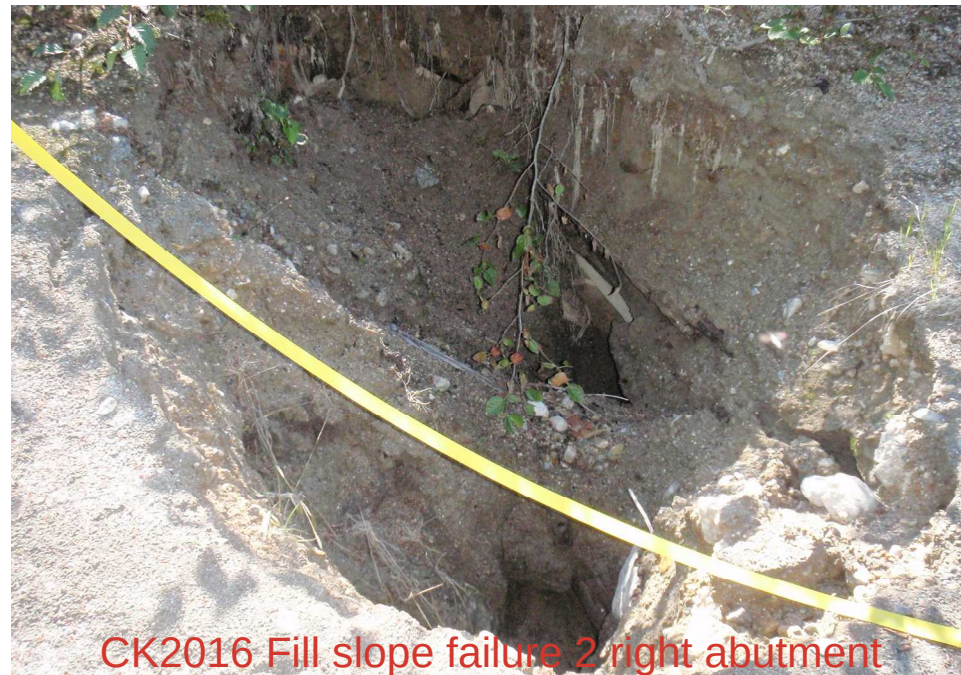
CK2016 Fill slope failure 2 right abutment

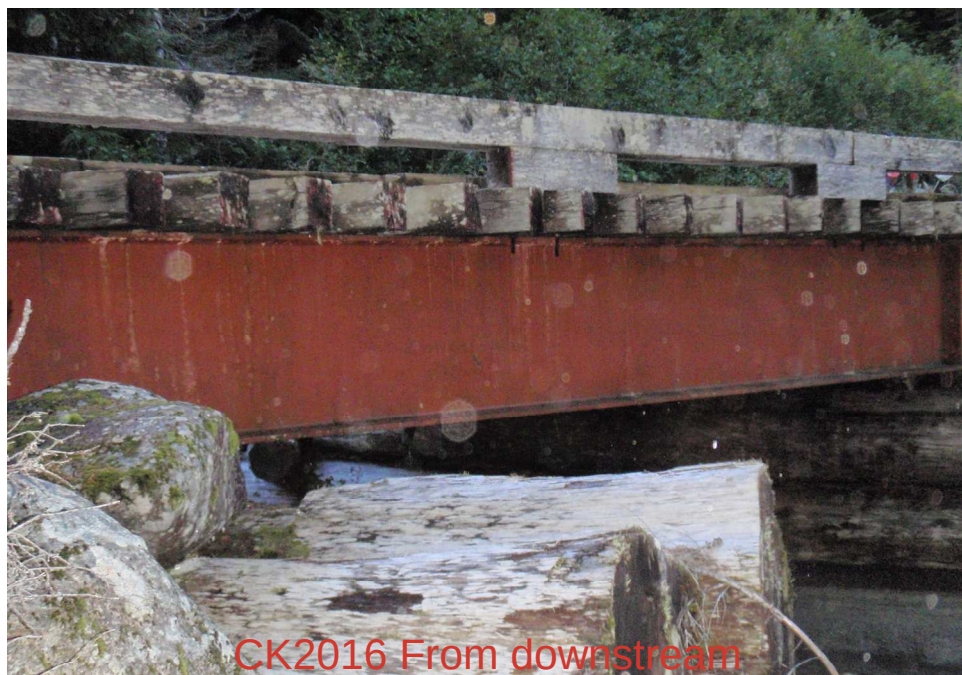
CK2016 From downstream

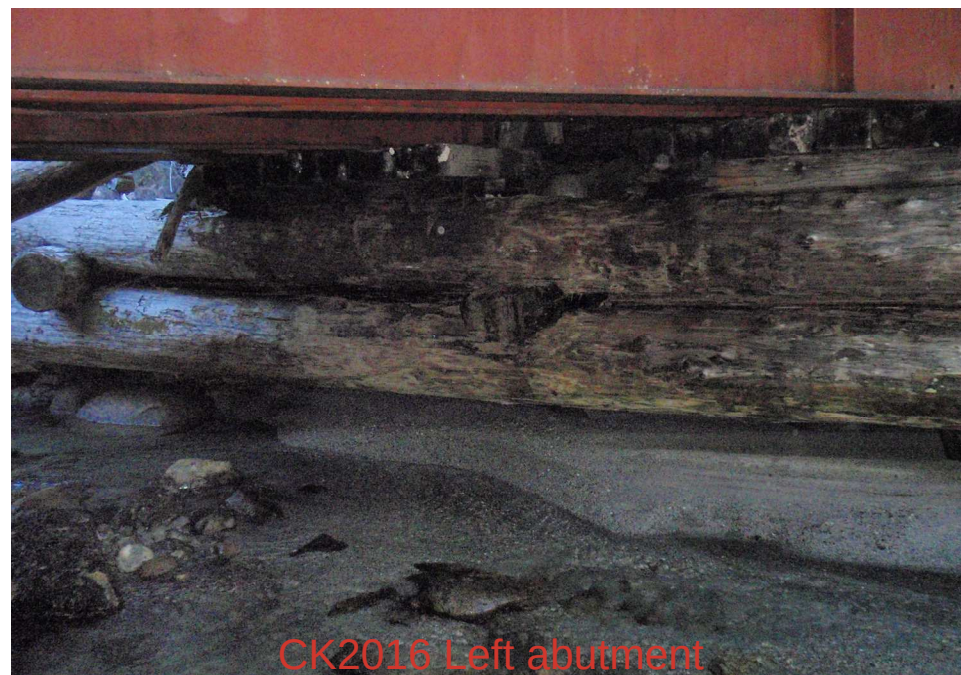
| Item | Present Condition (circle) | Comments (a comment is mandatory if condition "Poor" is selected) |
|---|---|---|
| Ballast Wall | E G <u>(P)</u> P N/A UR | LOG TOP EXPOSED ON LEFT ABUTMENT. |

CK2016 Left abutment

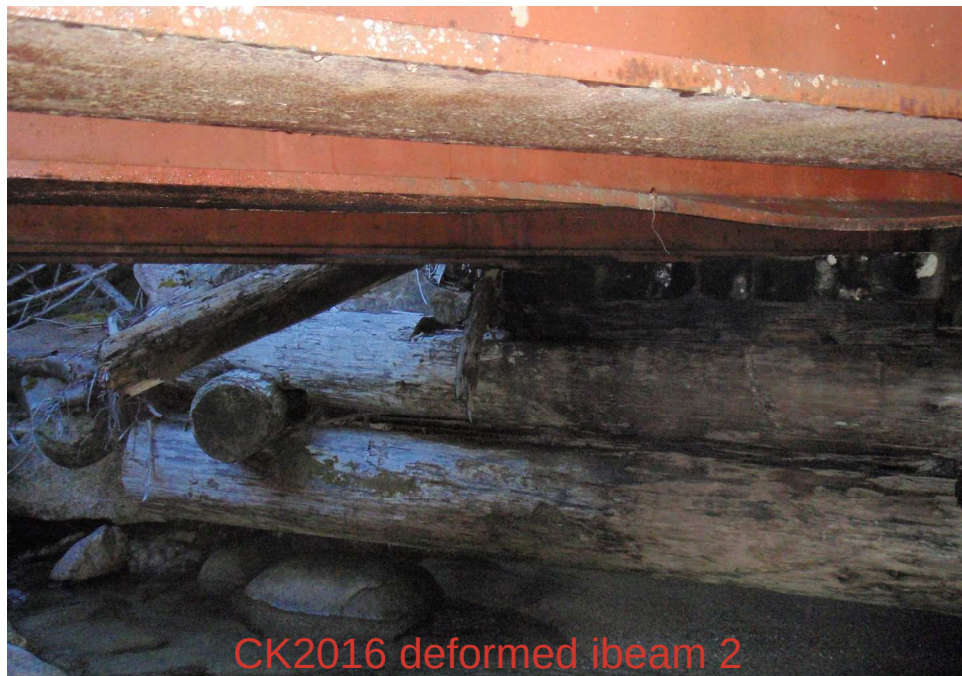
| GENERAL INFORMATION | | | |
|---|---|---|---|
| Girders | E G F <b>(P)</b> UR | 4 X STEEL - I-BEAM = 3rd I-BEAM FROM UPSTREAM. | |
| Diaphragms | E G F P <b>(N/A)</b> UR | BOTTOM FLANGE | |
| Bracing | E G <b>(F)</b> P N/A UR | SEVERELY DISTORTED | |
| Under-trussing | E G F P <b>(N/A)</b> UR | THE WEB STILL LOOK | |
| Hardware | E G F P <b>(N/A)</b> UR | STABLE. | |

CK2016 deformed ibeam 2

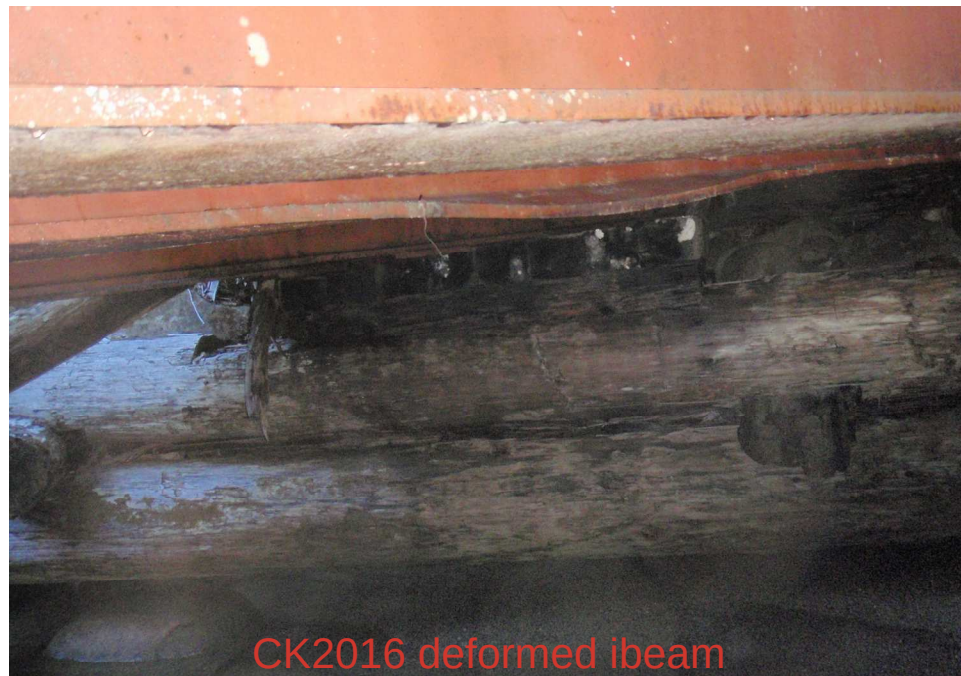
CK2016 deformed ibeam

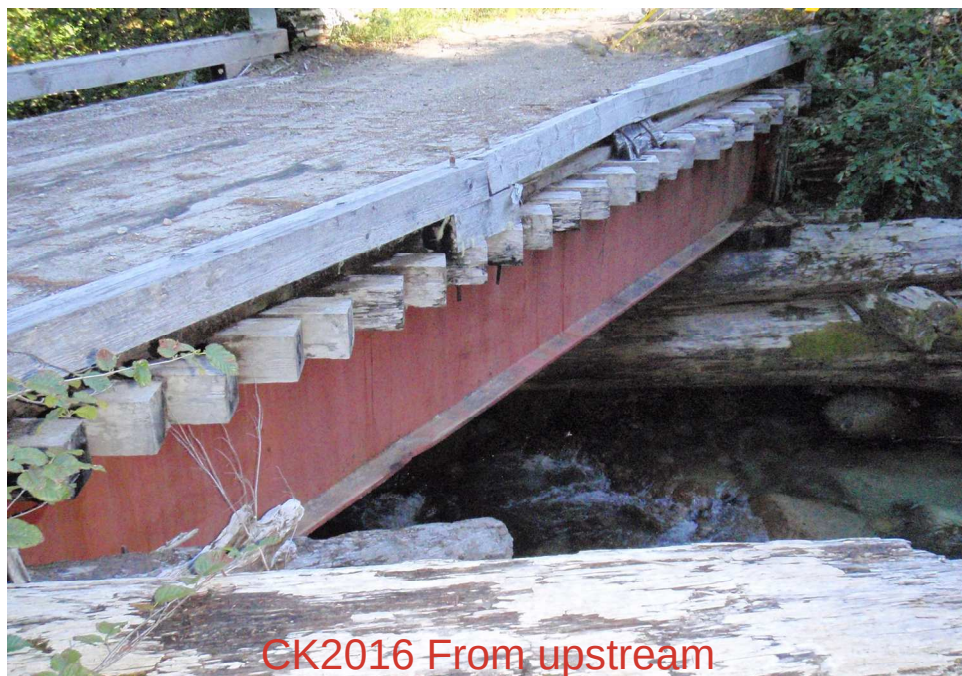
CK2016 From upstream

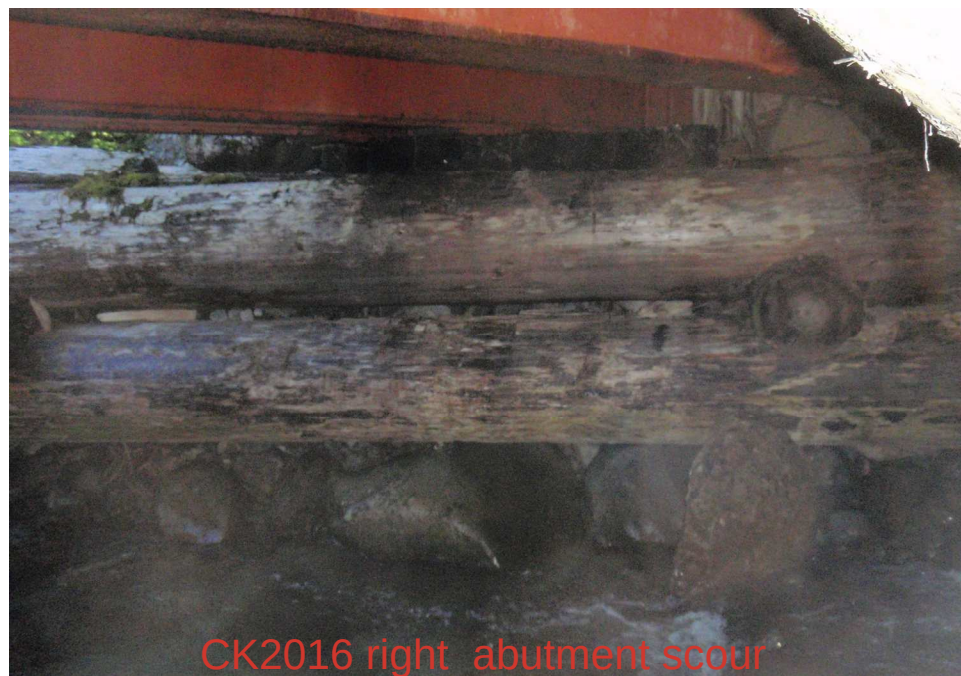
CK2016 right abutment scour

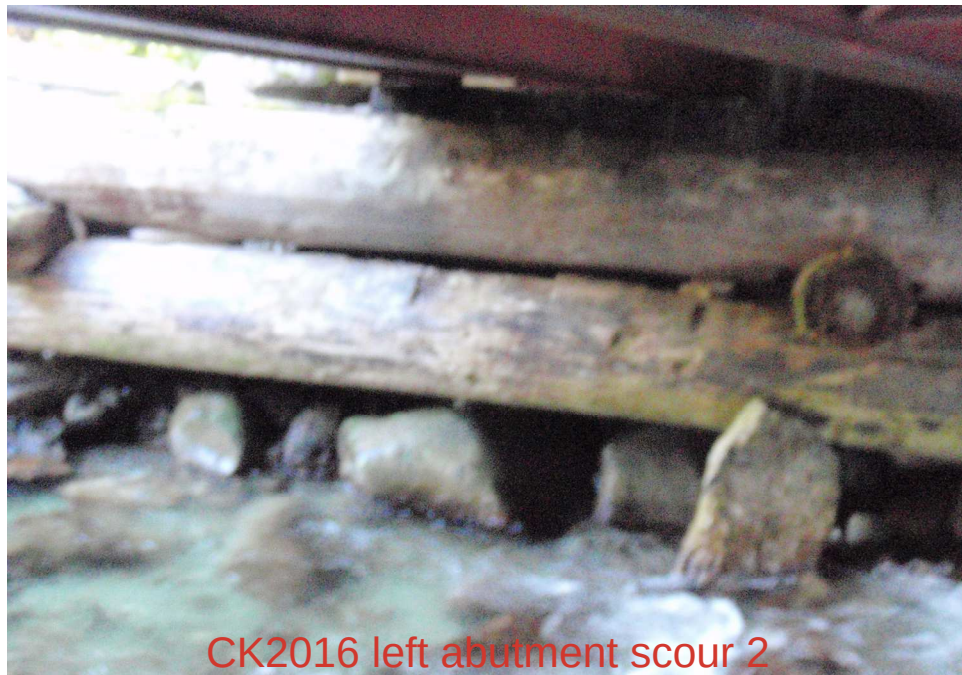
CK2016 left abutment scour 2

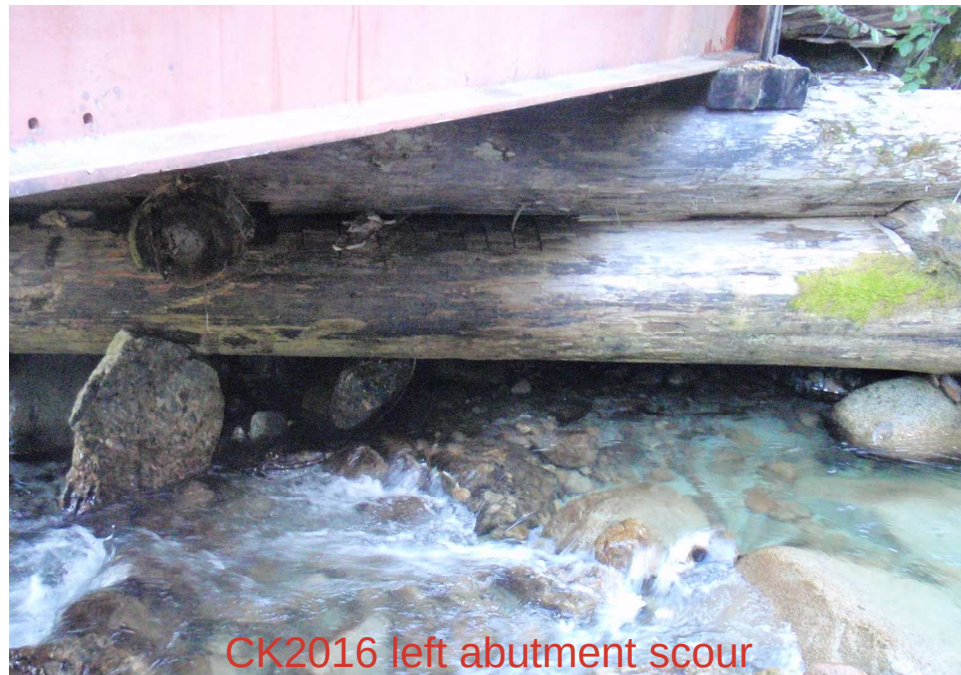
CK2016 left abutment scour

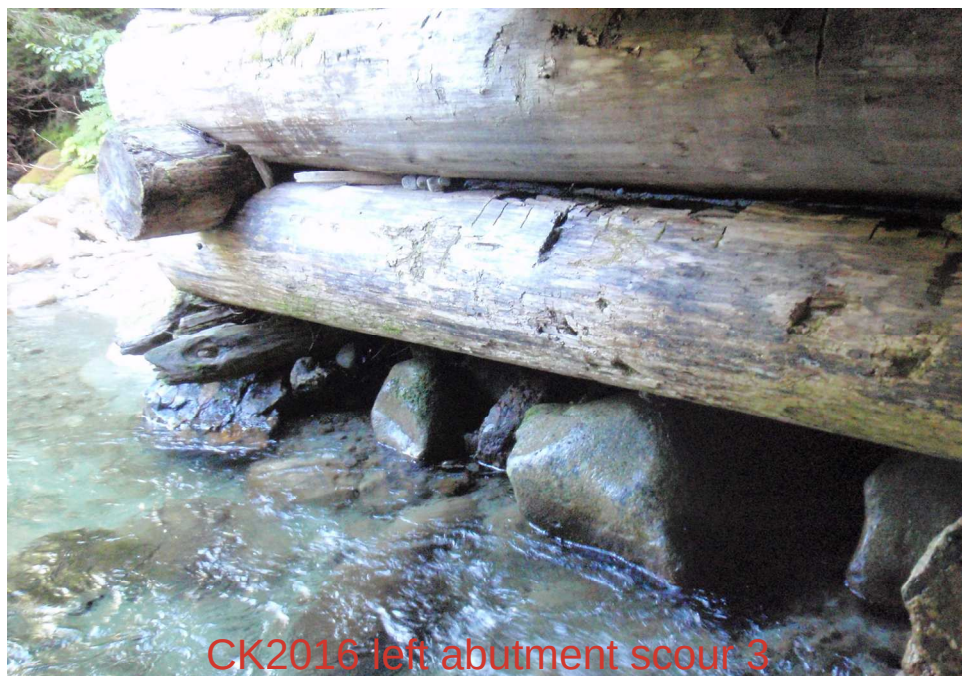
CK2016 left abutment scour 3

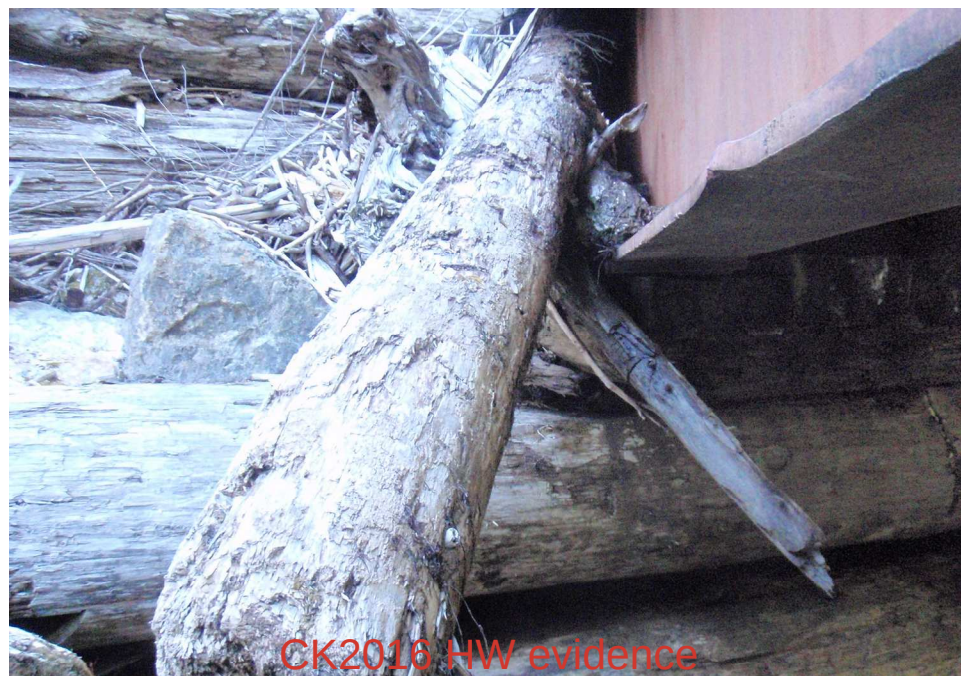
| GENERAL INFORMATION | | | |
|---|---|---|---|
| Comments EVIDENCE OF HW + DEBRIS UP & ABOVE GIRDERS. | | | |

CK2016 HW evidence

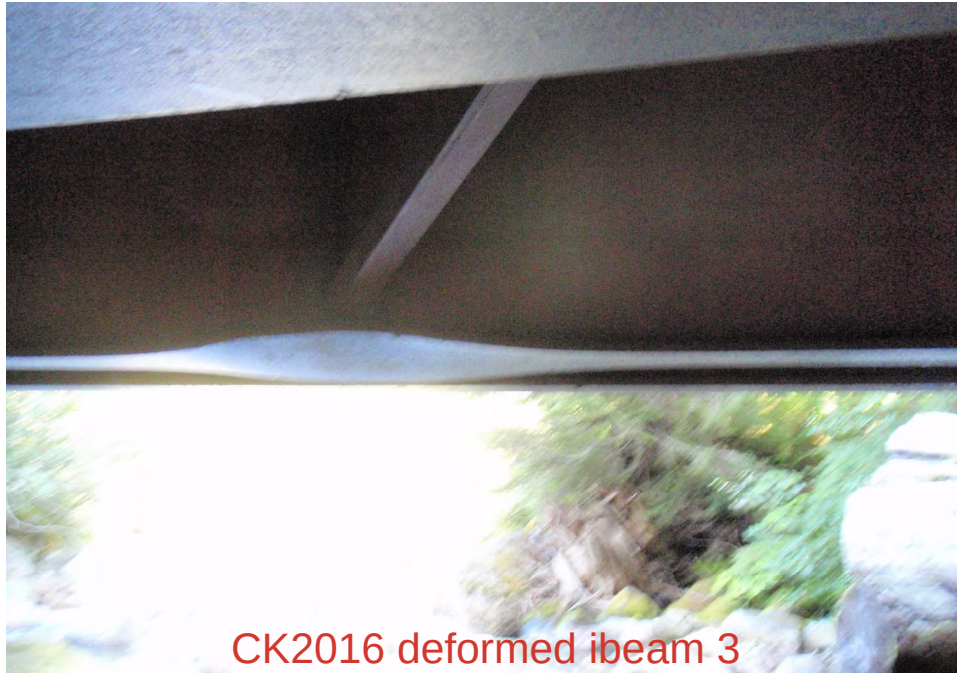
CK2016 deformed ibeam 3
