## Corporate Bridge Register (CBR) Structure Inventory Data Form "BRIDGES"

| *Structure # | *Site #: CK-2065 |
| *Forest Service Road: CHILLIWACK - TAMIAH | Kilometres: 8.3 |

**Routine Condition Bridge Inspection Form**  
(for log stringer or timber stringer bridges)**GENERAL INFORMATION**

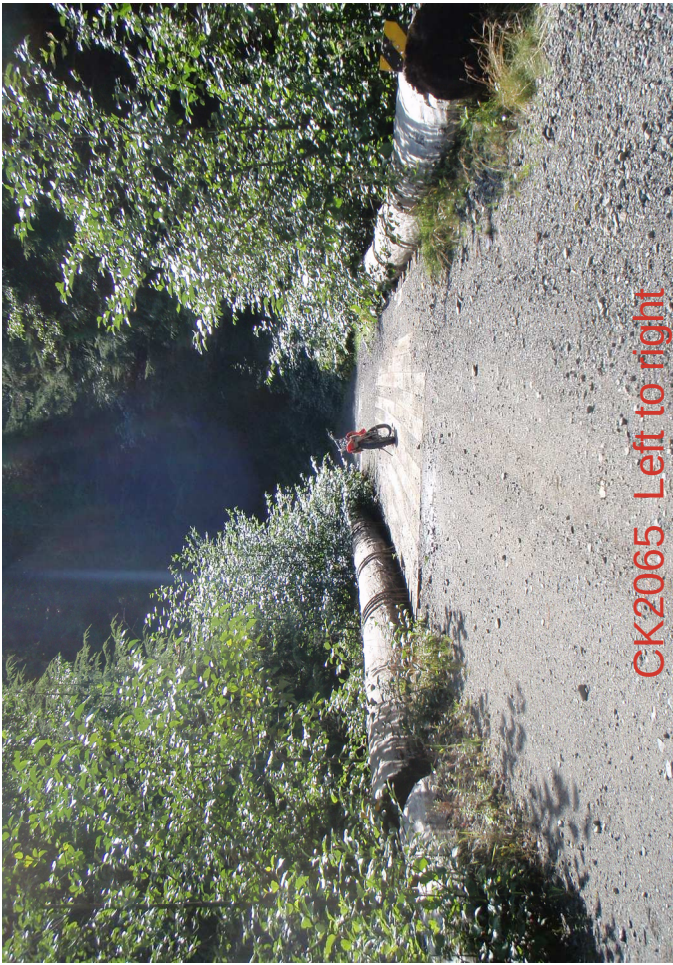
CK2065 Left to right

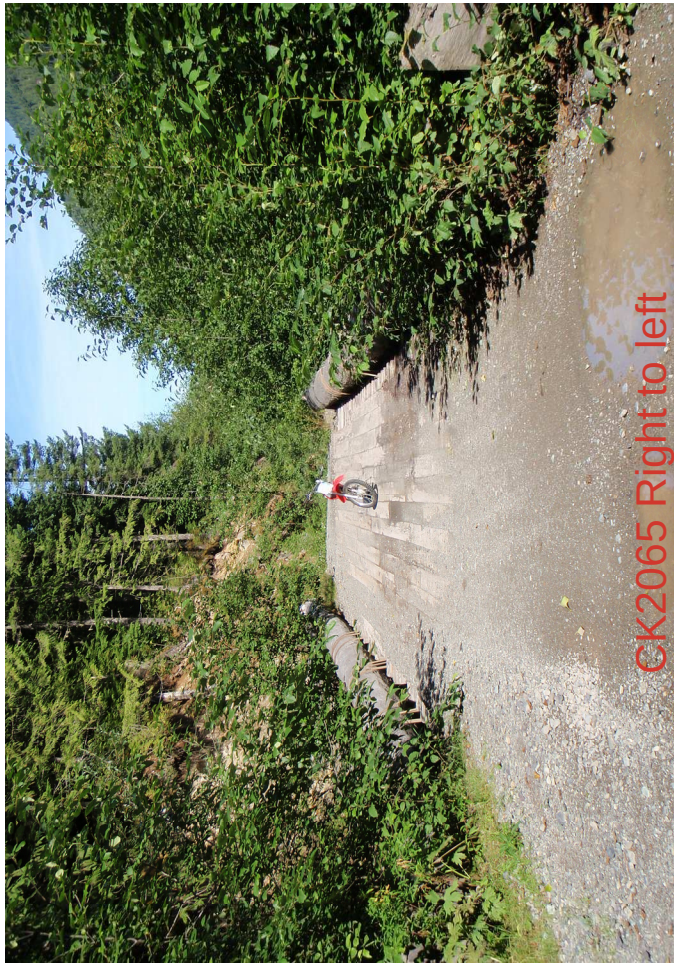
CK2065 Right to left

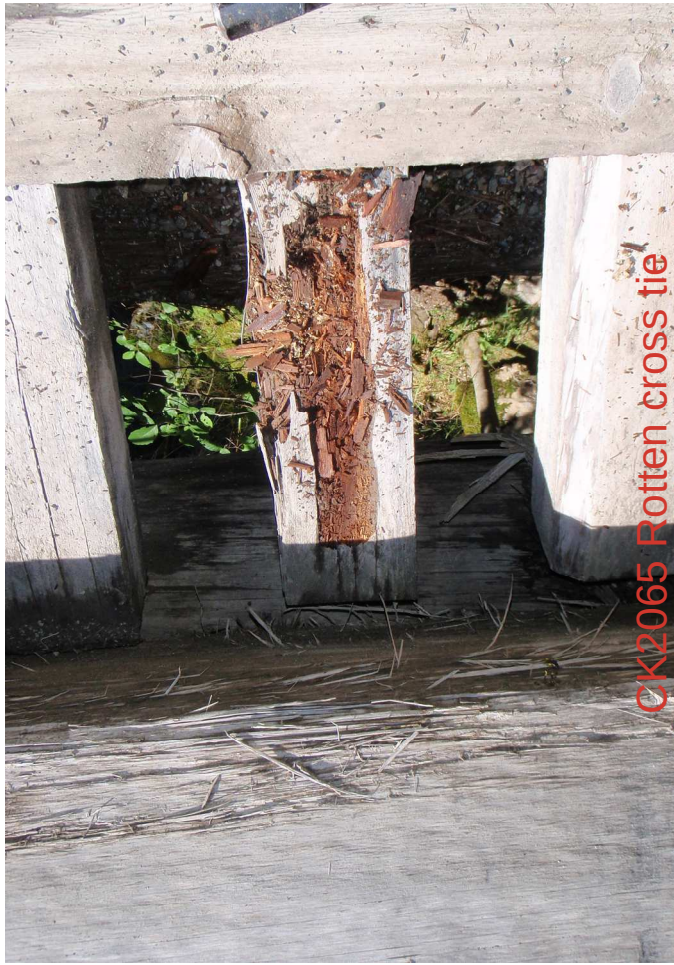
| Item | Present Condition<br>(circle) | Comments<br>(a comment is mandatory if condition "Poor" is selected) |
|---|---|---|
| Ties | E G F <u>(P)</u> N/A UR | SAME OF TIES VERY ROTTEN. 200 x 200 |

CK2065 Rotten cross tie

| GENERAL INFORMATION | | | | | | | | | | | | | | |
|---|---|---|---|---|---|---|---|---|---|---|---|---|---|---|
| 1 | (H) M L | | REPLACE STRUCTURE w/ VEHICLE TRAFFIC | | | | | | | | | | | |

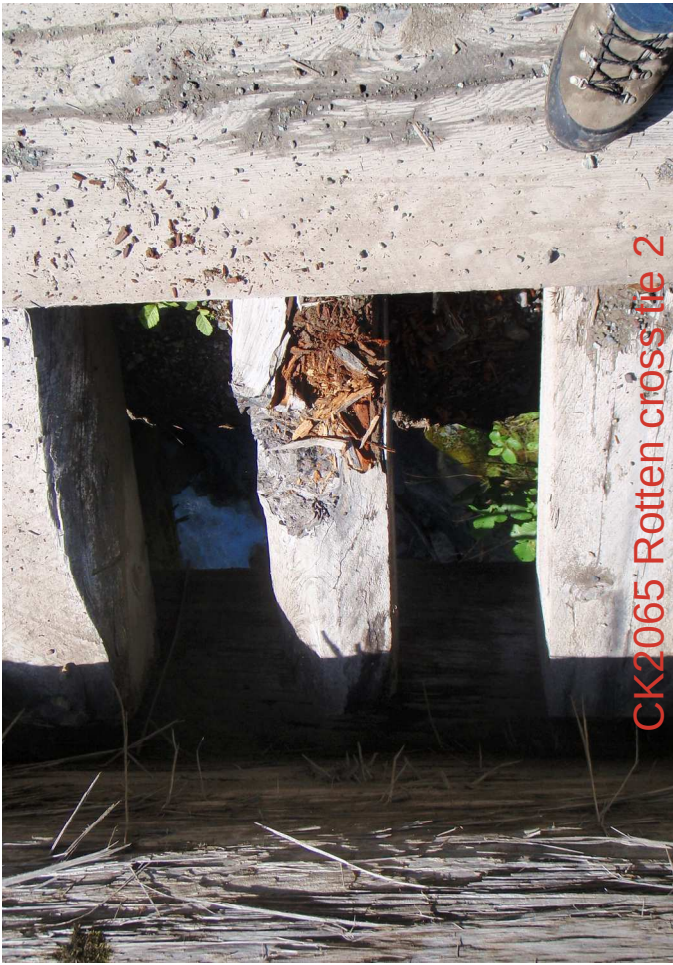
CK2065 Rotten cross tie 2

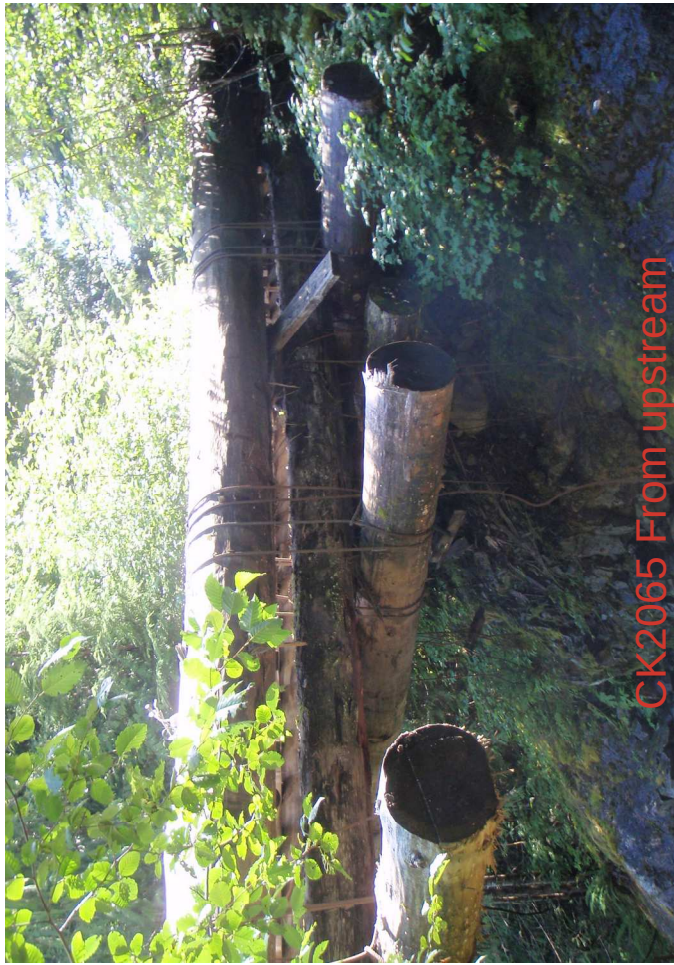
CK2065 From upstream

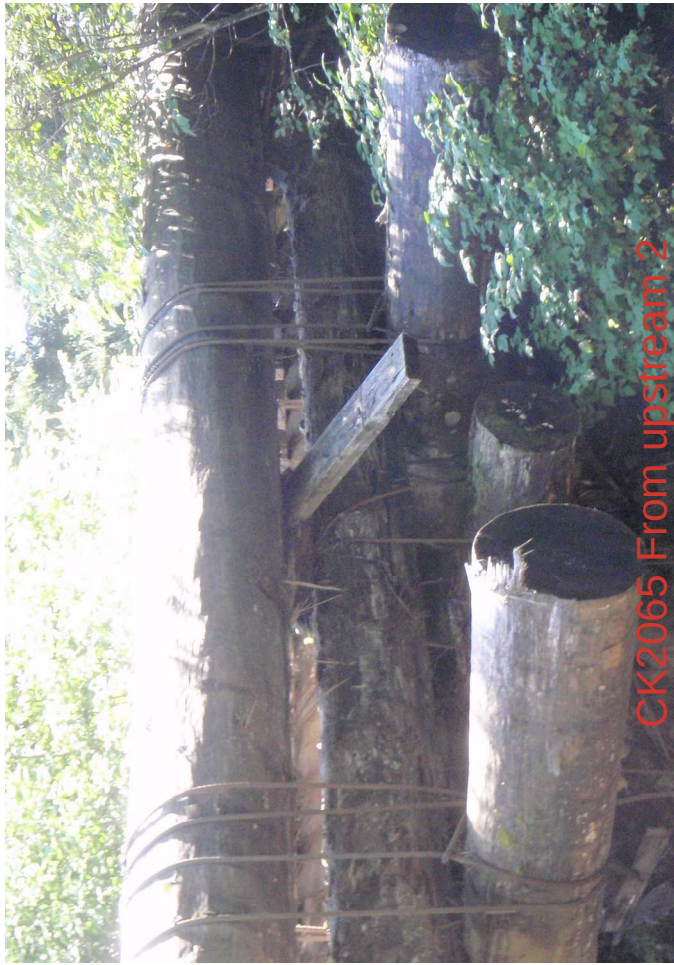
CK2065 From upstream 2

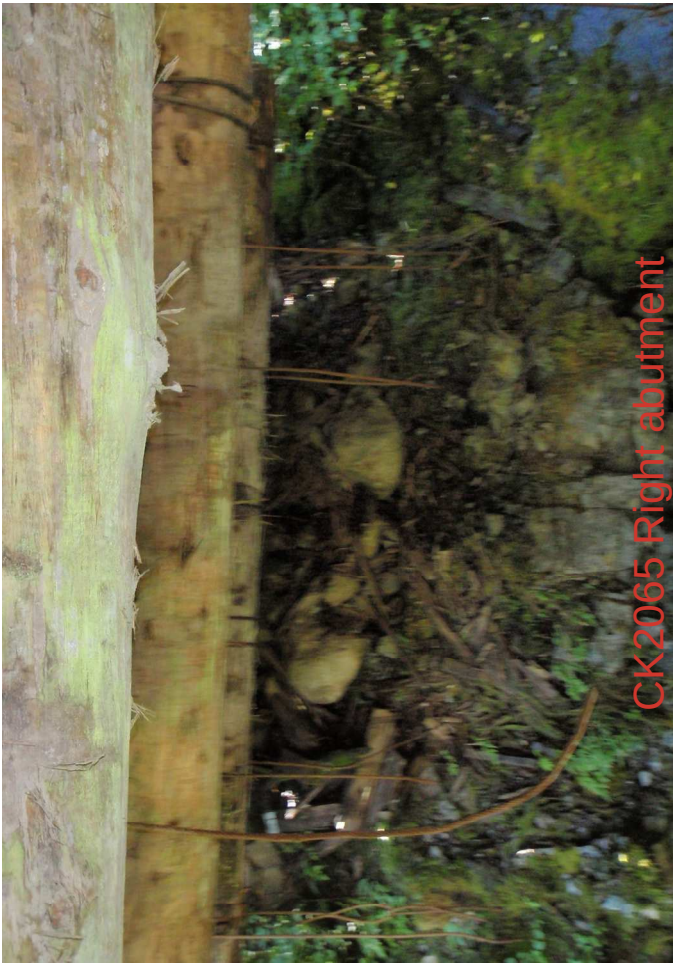
| Item | Present Condition<br>(circle) | Comments<br>(a comment is mandatory if condition "Poor" is selected) |
|---|---|---|
| Caps or Sills | E G <u>(F)</u> P N/A UR | 100-200mm of ROT ON LOG SILL. |
| Piles or Posts | E G <u>(F)</u> P N/A UR | LOG SILL ON 3 PILES. |

CK2065 Right abutment

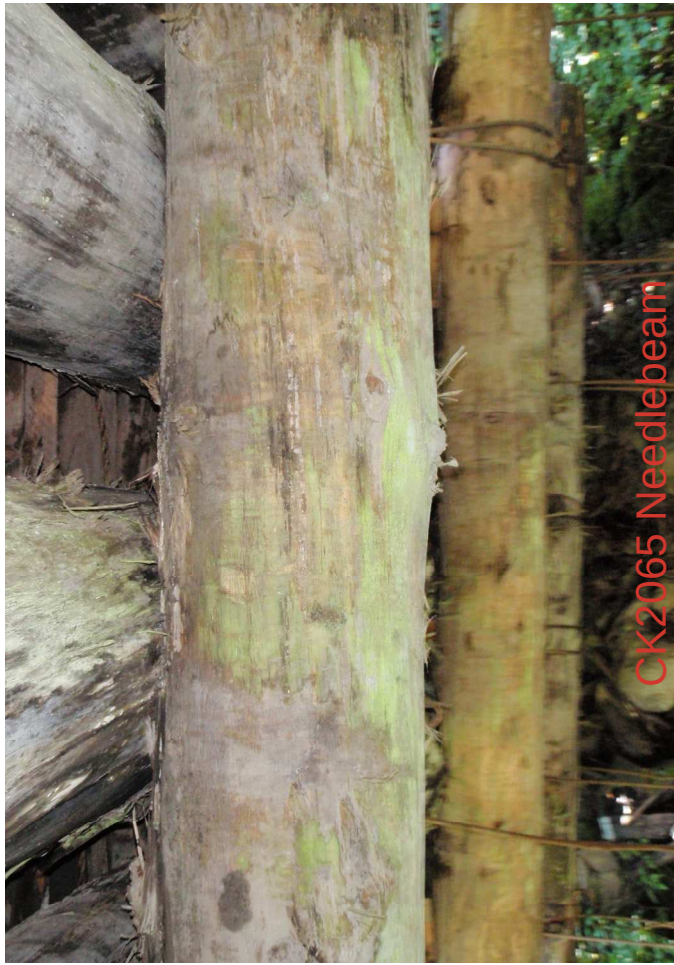
| GENERAL INFORMATION | | | | | | | | | | | | | | |
|---|---|---|---|---|---|---|---|---|---|---|---|---|---|---|
| Needle Beams and Shims | | E G F (P) N/A UR | | <u>X3 - ONLY LASHED TO OUTSIDE STRINGERS.</u> | | | | | | | | | | |

CK2065 Needlebeam

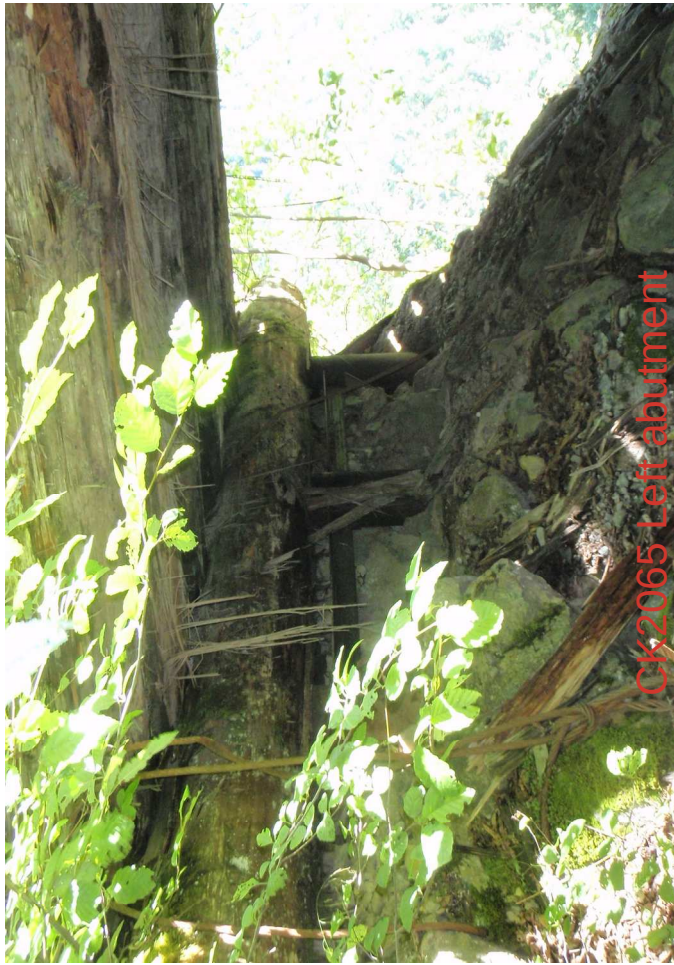
CK2065 Left abutment
