## Corporate Bridge Register (CBR) Structure Inventory Data Form "BRIDGES"

| <b>*Structure #</b> | <b>*Site #:</b> CK-2068 |
| <b>*Forest Service Road:</b> SLESSE CRK | <b>Kilometres:</b> 6.1 |

**Routine Condition Bridge Inspection Form**  
(except for log stringer or timber stringer bridges)

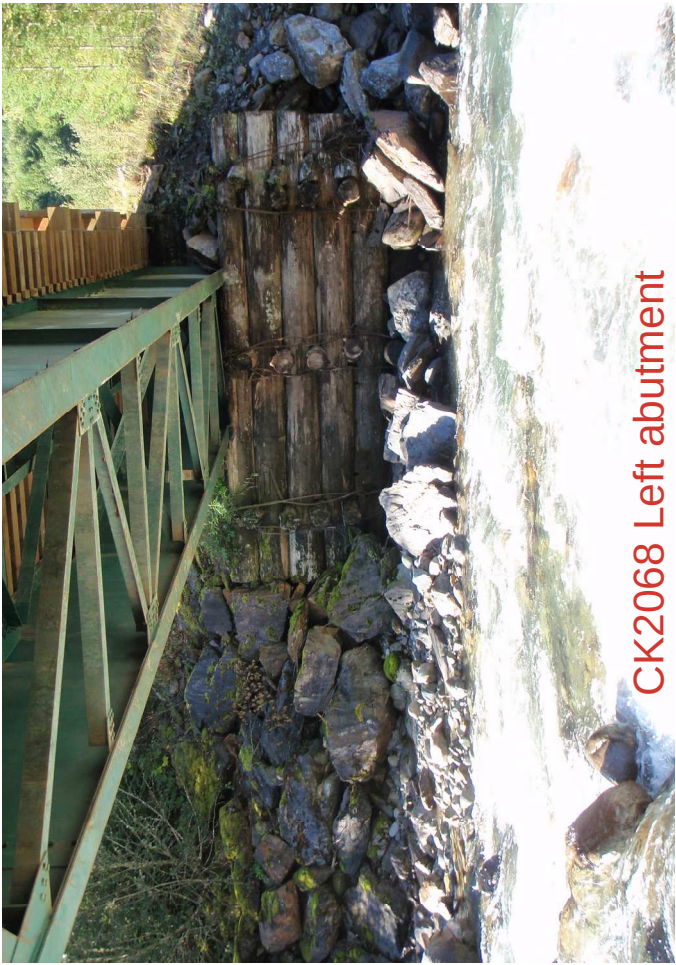
CK2068 Left abutment

| GENERAL INFORMATION | | | | (enter either long/lat or UTM below - not both) | | | |
|---|---|---|---|---|--|--|--|
| Log/Timber Cribs | E G (F) P N/A UR | 5x CRIB ON LEFT ABUT, 1x ON RIGHT. CLOSED FACED. | | | | | |

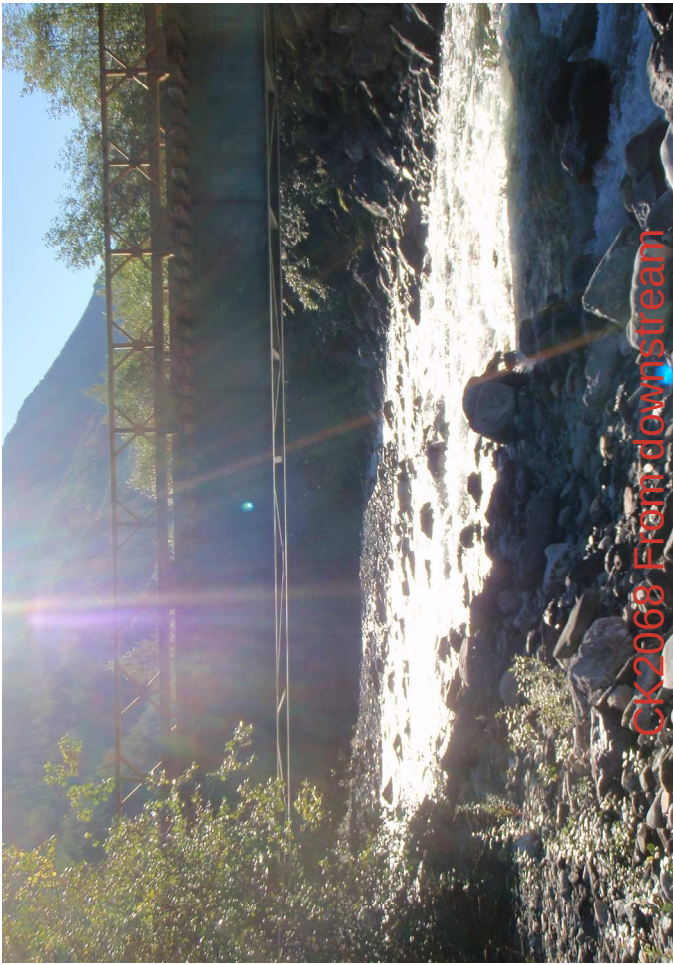
CK2068 Fram downstream

| GENERAL INFORMATION | | | | (enter either long/lat or UTM below - not both) | | | |
|---|---|---|---|---|--|--|--|
| Riprap | E (G) F P N/A UR | WELL RIPRAPED UPSTREAM ALONG CHANNEL. | | | | | |

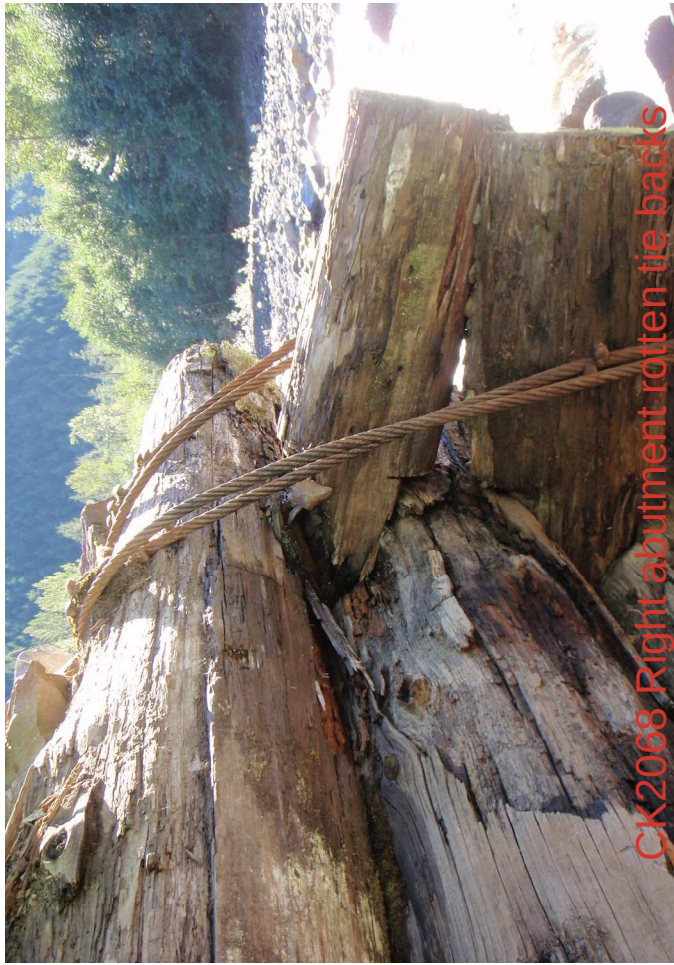
| GENERAL INFORMATION | | | | (enter either long/lat or UTM below - not both) | | | |
|---|---|---|---|---|--|--|--|
| Tie-backs | E G (F) P N/A UR | 3x, ONE OF THE TIEBACKS ROTTEN & NOW BROKEN. ~ 10-20cm off S&P ROT. | | | | | |

CK2068 Right abutment rotten tie backs

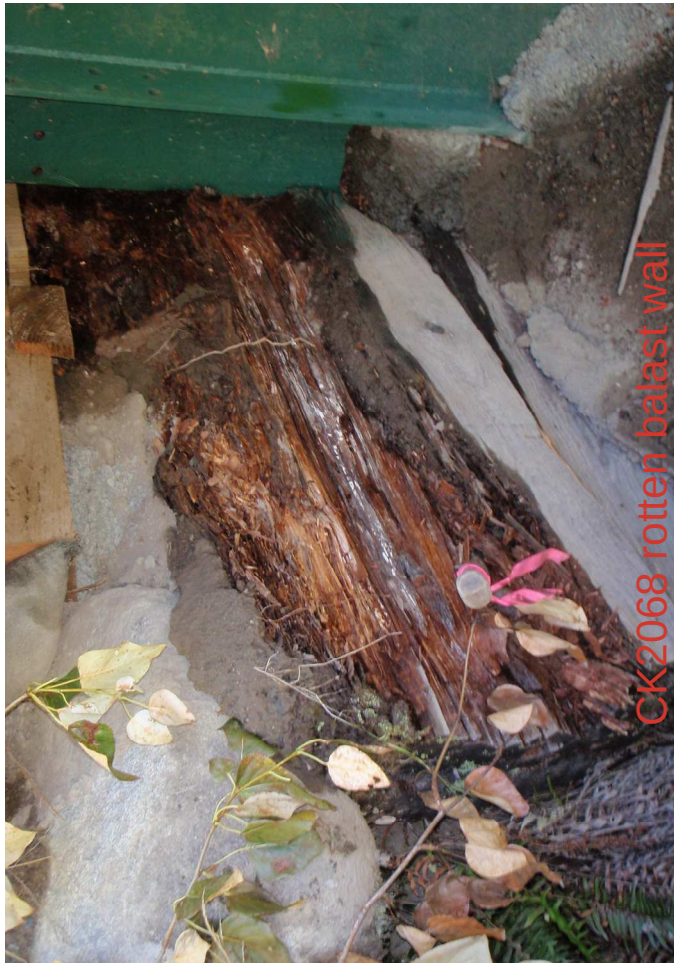
| GENERAL INFORMATION | | | | (enter either long/lat or UTM below - not both) | | | |
|---|---|---|---|---|--|--|--|
| Ballast Wall | E G (P) P N/A UR | TIMBER. | | | | | |

ROTATION BALAST WALL

CK2068 rotten balast wall
