CK 2073

# Corporate Bridge Register (CBR) Structure Inventory Data Form "BRIDGES"

| *Forest Service Road: CHIPMUNK CRK | Kilometres: 1.5 |

# Routine Condition Bridge Inspection Form (except for log stringer or timber stringer bridges)

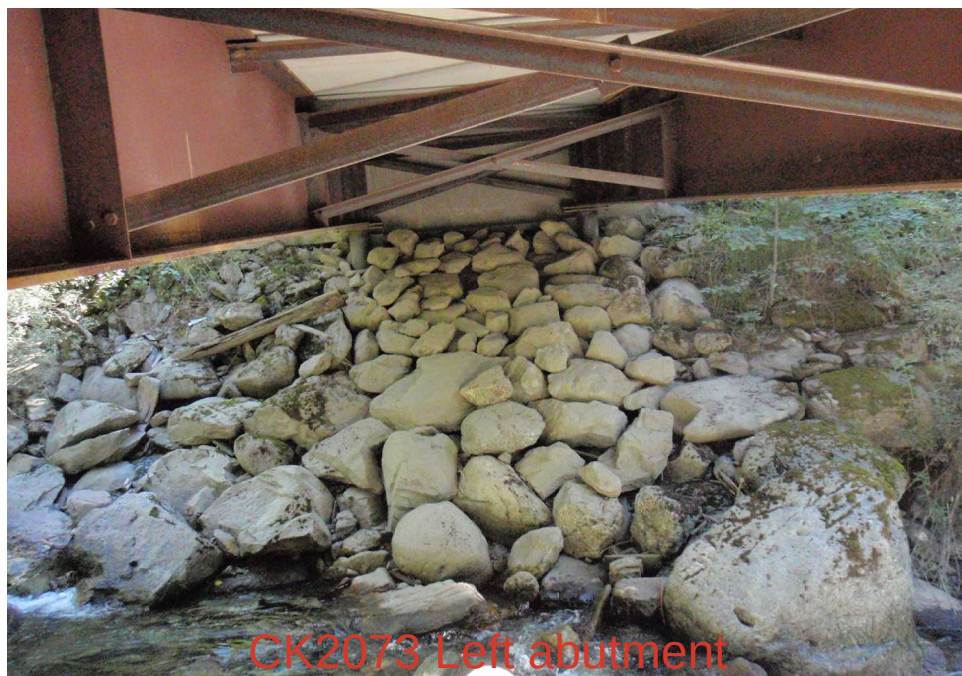
CK2073 Left abutment

| GENERAL INFORMATION | | | | (enter either long/lat or UTM below – not both) | | | |
|---|---|---|---|---|--|--|--|
| Piles or Posts | E | G <u>F</u> P N/A UR | PIPE RISERS ON SPREAD FOOTING. | | | | |
| Ballast Wall | E | G <u>F</u> P N/A UR | PRECAST CONCR. | | | | |

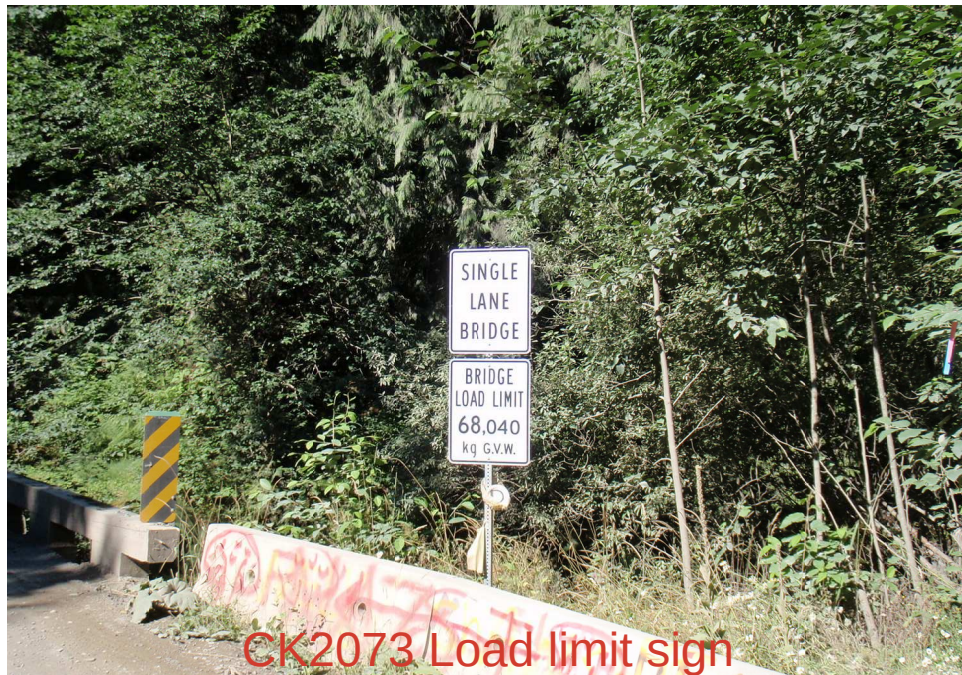
CK2073 Load limit sign

| GENERAL INFORMATION | | | | (enter either long/lat or UTM below – not both) | | | |
|---|---|---|---|---|--|--|--|
| Posted Load Rating | <u>68</u> (tonnes) or None | | | | | | |

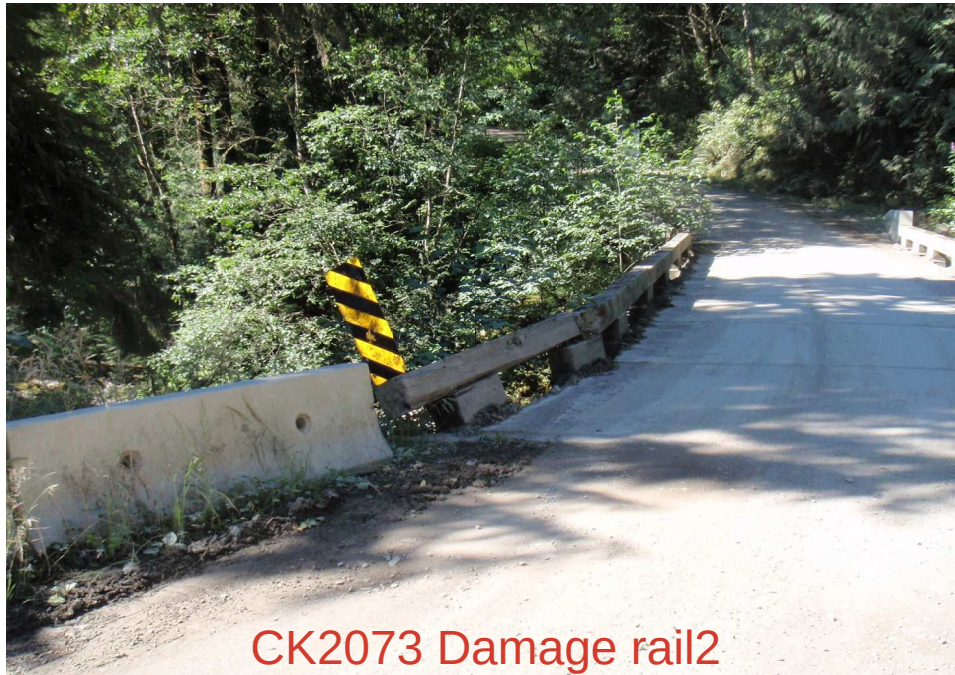
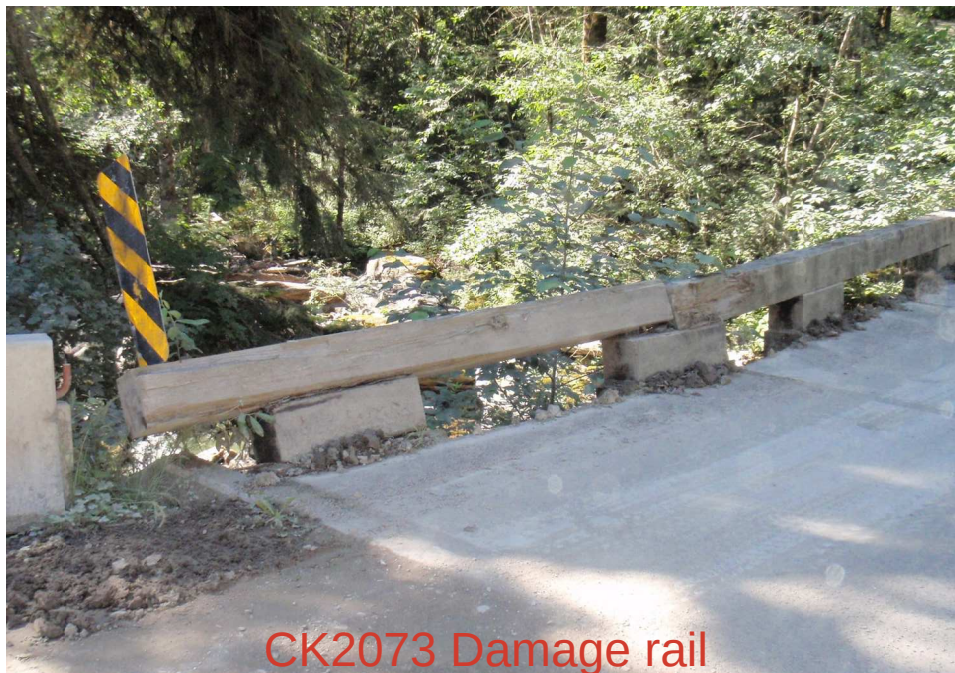
| GENERAL INFORMATION | | | | (enter either long/lat or UTM below – not both) | | | |
|---|---|---|---|---|--|--|--|
| Curb Rail/Blocks/Posts | E | G F <u>P</u> UR | DOWNSTREAM LEFT RAIL DAMAGED DUE TO MECHANICAL IMPACT. IT NO LONGER CAN WITHSTAND ANOTHER IMPACT. | | | | |
| Overall Deck Condition | E | G <u>F</u> P UR | DUE TO RAIL DAMAGE | | | | |

CK2073 Damage rail2

CK2073 Damage rail

| GENERAL INFORMATION | | | |
|---|---|---|---|
| 1 | <b>H</b> M L | | REPAIR DAMAGED RAIL ON DOWNSTREAM LEFT ABUT. |
| PEng Reviewer's Comments<br><b>Damaged curb rail needs repair.</b> | | | |
