# Corporate Bridge Register (CBR) Structure Inventory Data Form "BRIDGES"

**Routine Condition Bridge Inspection Form**  
(except for log stringer or timber stringer bridges)

| GENERAL INFORMATION | | (enter either long/lat or UTM below - not both) | | | |
|---|---|---|---|---|--|
| *Site #: CK-2077 | *Crossing Name: | *Type/Class: <input type="checkbox"/> Temporary bridge<br><input checked="" type="checkbox"/> Permanent bridge | *Project File ID# 5127 | | |
| *FSR Name: AIRPLANE CRK | *Forest District: Chilliwack | *Kilometres: 0.1 | User km: | | |

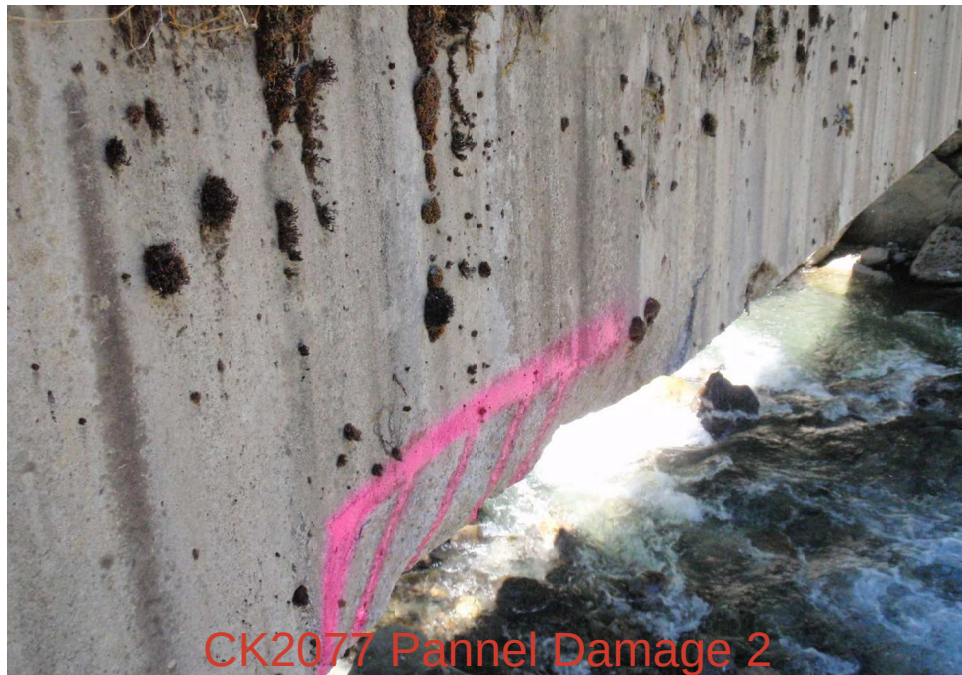
| GENERAL INFORMATION | | | |
|---|---|---|---|
| Girders | E G <u>P</u> UR | 4 x SLAB GIRDERS: UPSTREAM, CLOSE TO LEFT ABUT | |
| Diaphragms | E G F P N/A <u>UR</u> | THE OUTSIDE | |
| Bracing | E G F P N/A <u>UR</u> | PANEL IS | |
| Under-trussing | E G F P N/A <u>UR</u> | DAMAGED. NO | |
| Hardware | E G F P N/A <u>UR</u> | REBAR SHOWING | |

CK2077 Pannel Damage 2

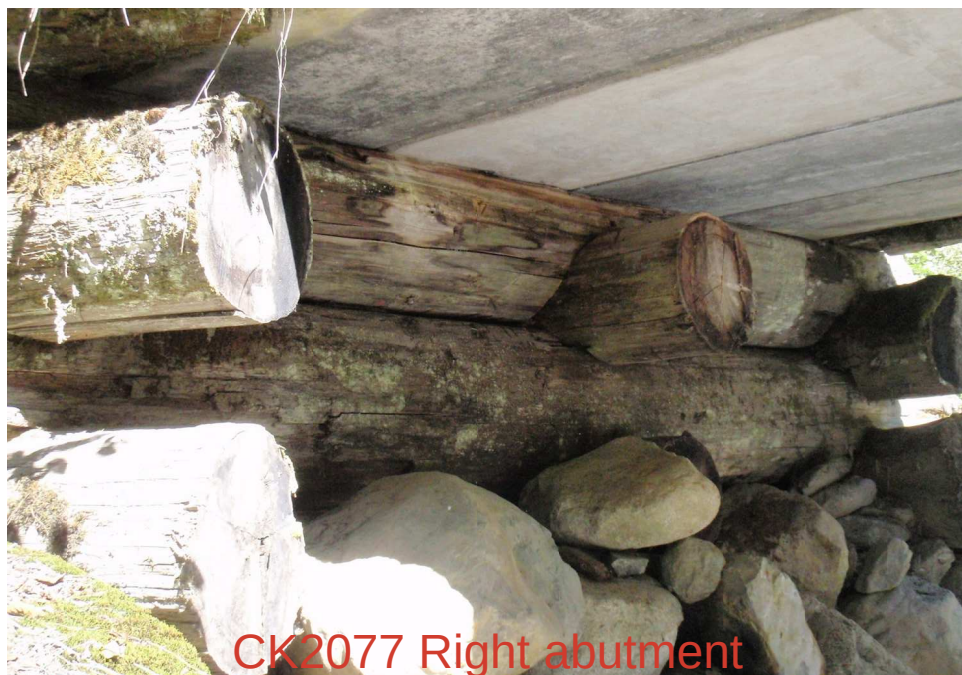
| GENERAL INFORMATION | | (enter either long/lat or UTM below - not both) | | | |
|---|---|---|---|---|--|
| Log/Timber Cribbs | E G <u>F</u> P N/A UR | 3X CLOSED FACED RIGHT ABUT, 2X N. SIDEFACE LEFT. | | | |
| Tie-backs | E G <u>F</u> P N/A UR | 3X | | | |

CK2077 Right abutment

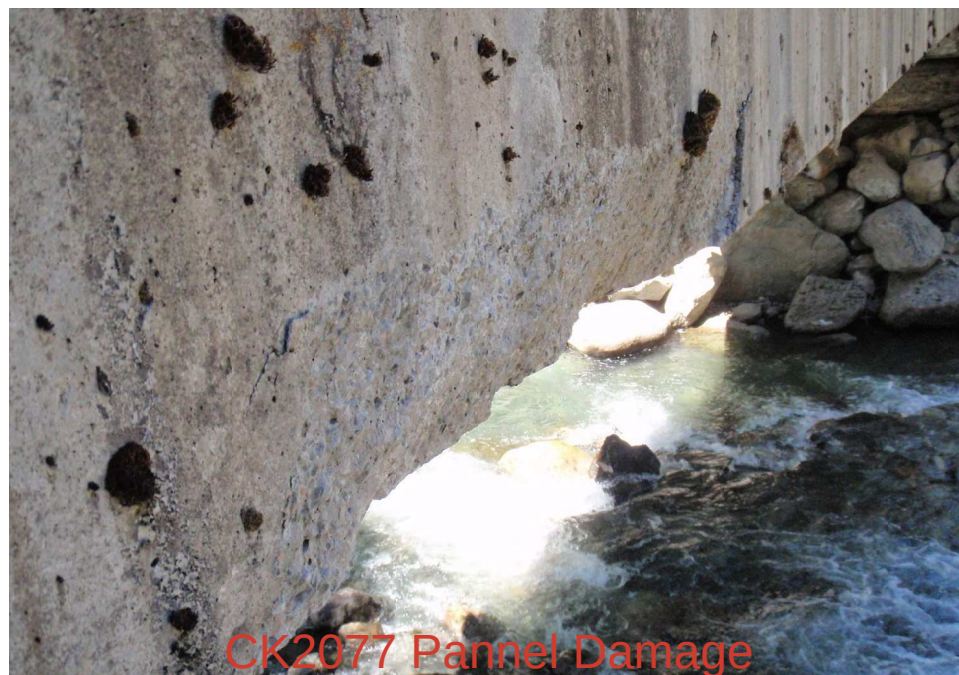
CK2077 Pannel Damage

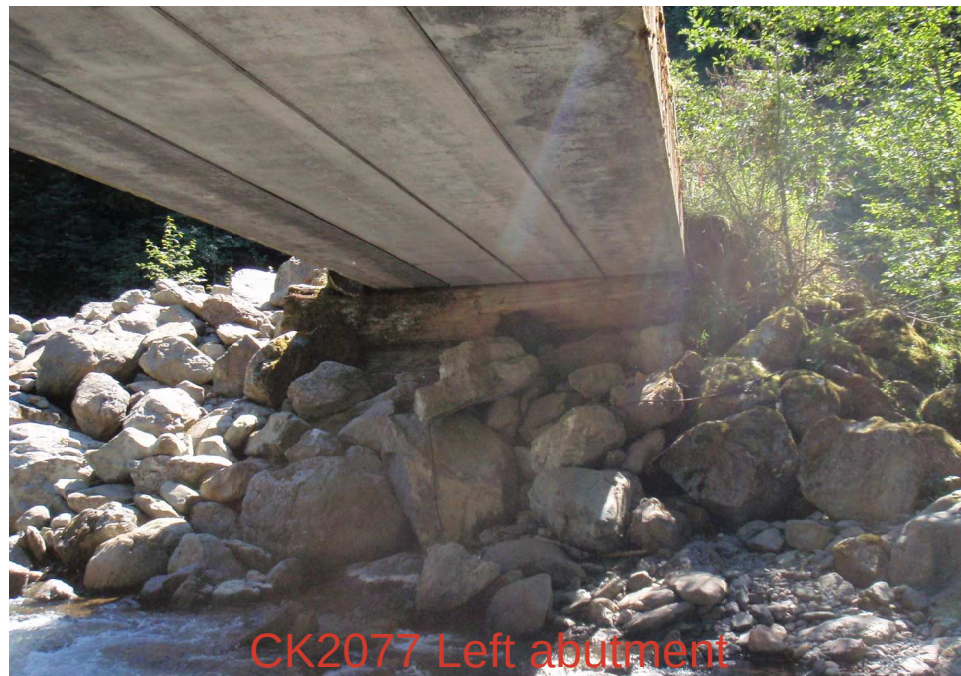
CK2077 Left abutment

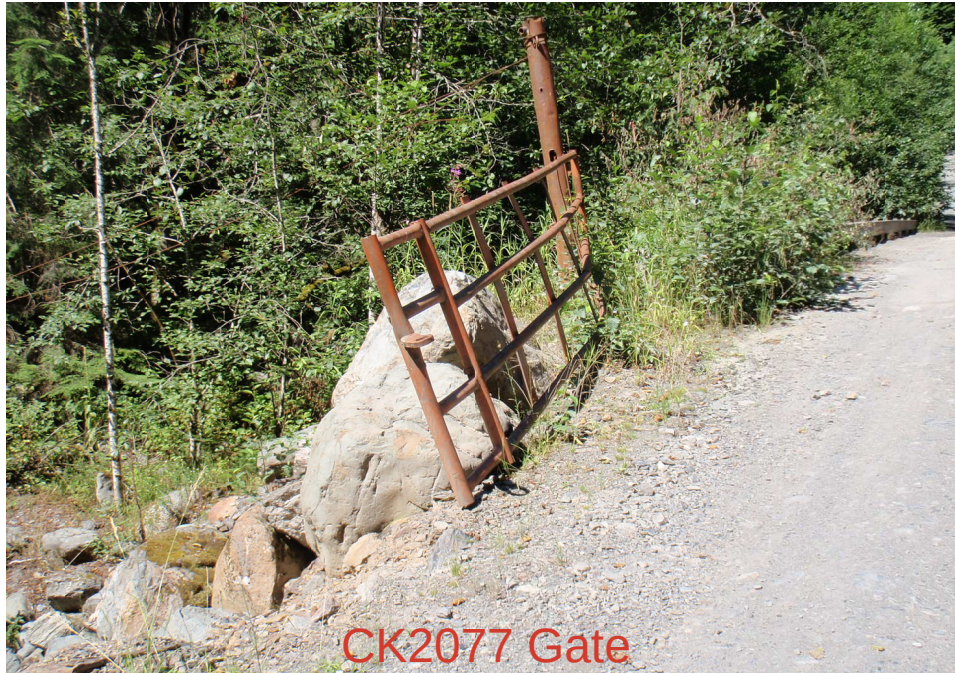
| GENERAL INFORMATION | | | |
|---|---|---|---|
| 1 | OLD GATE MIGHT BE CONSIDERED A HAZARD. (SEE PHOTOS) | | |
