| | <b>Corporate Bridge Register (CBR)</b><br><b>Structure Inventory Data Form "BRIDGES"</b> |

**Routine Condition Bridge Inspection Form**  
(except for log stringer or timber stringer bridges)

| GENERAL INFORMATION | | | |
|---|---|---|---|
| *Site #: CK-2140 | *Crossing Name: | *Type/Class: <input type="checkbox"/> Temporary bridge<br><input checked="" type="checkbox"/> Permanent bridge | *Project File ID# 6314 |
| *FSR Name: Harrison West | *Forest District: Chilliwack | *Kilometres: 46.5 | User km: 45.5 |

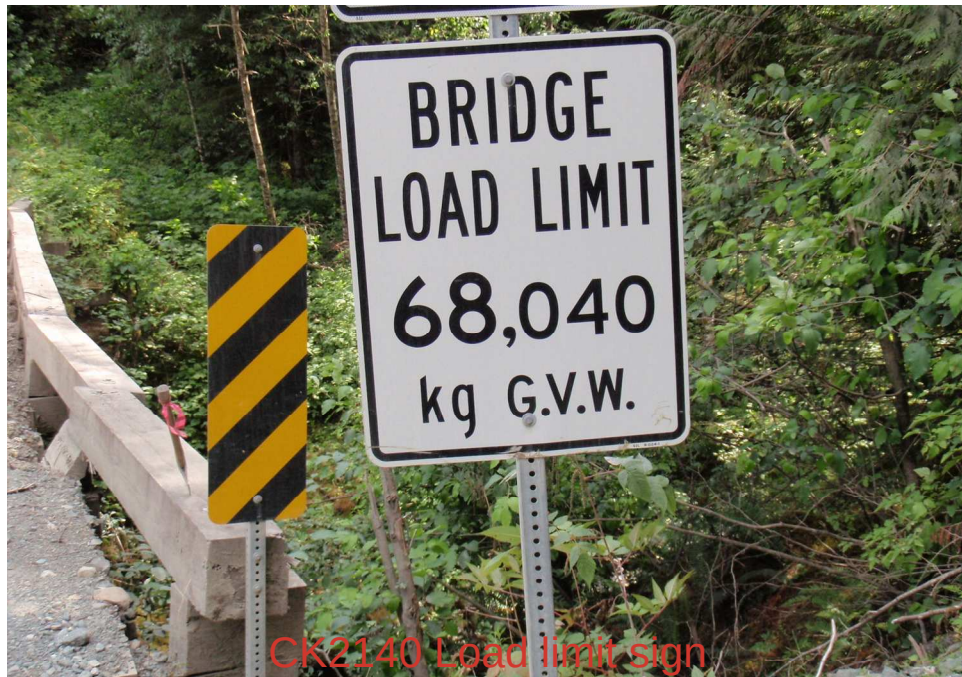
CK2140 Load limit sign

| GENERAL INFORMATION | | | |
|---|---|---|---|
| Posted Load Rating | 68 (tonnes) or None | | |

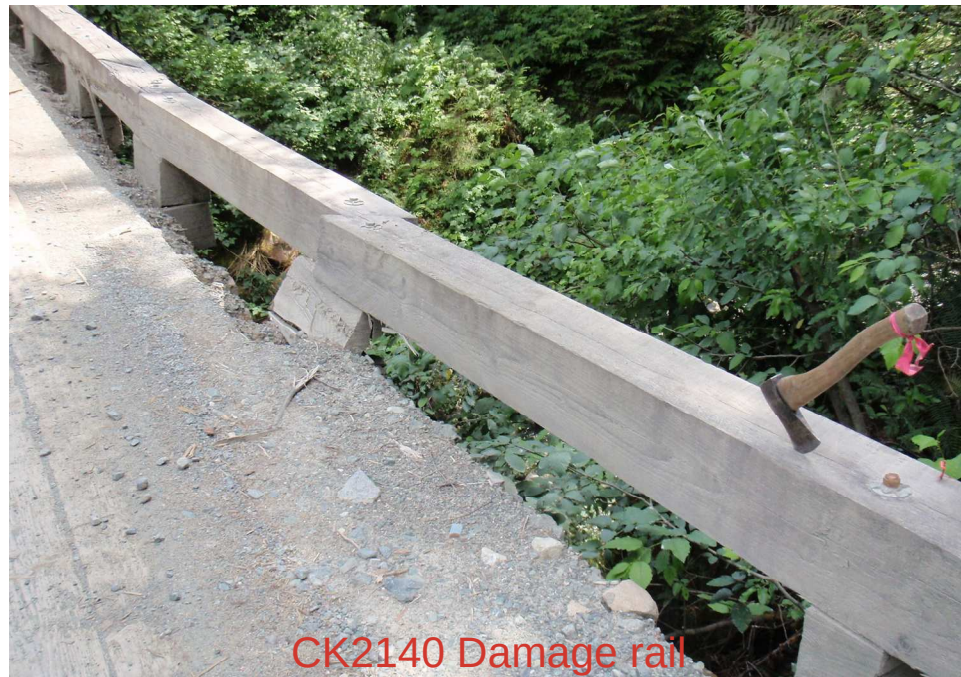
CK2140 Damage rail

| GENERAL INFORMATION | | | |
|---|---|---|---|
| Curb Rail/Blocks/Posts | E G F (P) UR | DAMAGED & WILL REQUIRE REPLACING RISERS. | |
| Hardware | E G F (P) N/A UR | LOOSE DUE TO IMPACT | |

Immediate works are to replace broken curb rails and monitor ties from underside over winter to ensure they are not cracking or showing other signs of failure. In order to keep this industrial load rating, the wooden deck will need to be replaced next summer (including ties)

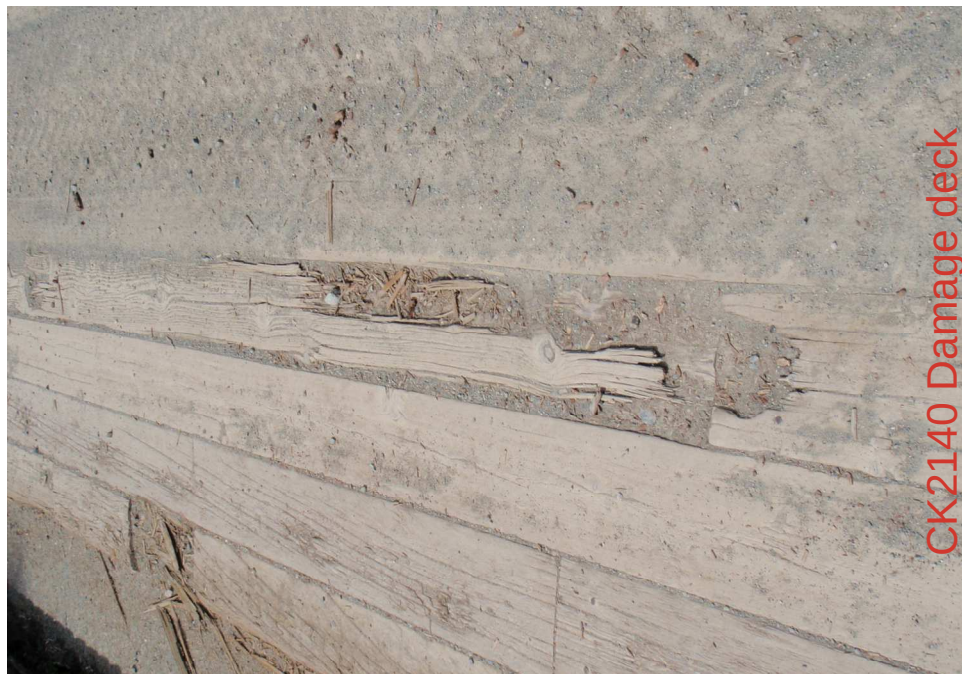
CK2140 Damage deck

| GENERAL INFORMATION | | | |
|---|---|---|---|
| Running Planks | E G F (P) N/A UR | SOME DAMAGE & ROT. | |
| Nails | E G F (P) N/A UR | SOME STICKING OUT HAVE BEEN DAMAGED THE TIE IS ROTTEN | |

| GENERAL INFORMATION | | | |
|---|---|---|---|
| 1 | <u>(H)</u> M L | | REPLACE ROTTEN & DAMAGED RUNNING PLANKS. |
| 2 | <u>(H)</u> M L | | REPLACE NAILS. |

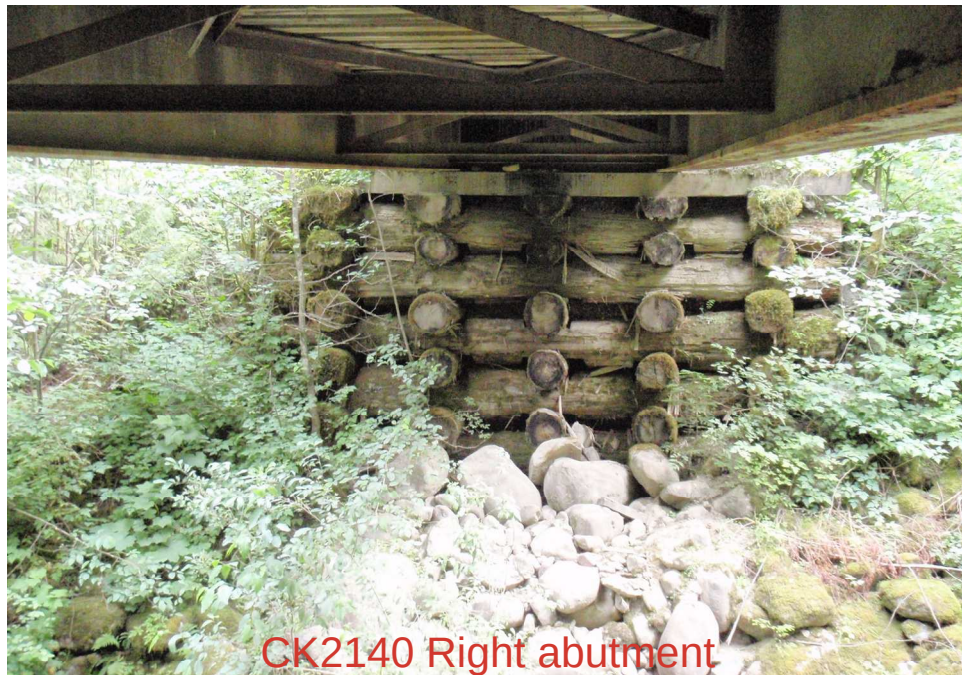
CK2140 Right abutment

| GENERAL INFORMATION | | | |
|---|---|---|---|
| Log/Timber Crib | E G (F) P N/A UR | RIGHT ABUT: 6x LOG CRIB 1x DIAM: 60-80cm w/ 200mm of | |
| Tie-backs | E G (F) P N/A UR | 5x (55-70 cm) w/ 150mm of Rot. | |
| Bin Wall | E G F P (N/A) UR | ROT. TOP FACE LOG SQUARE TIMBER X2. | |

| GENERAL INFORMATION | | | |
|---|---|---|---|
| 1 | CRB IS OLD. SHOULD BE MONITORED ANNUALLY. | | |

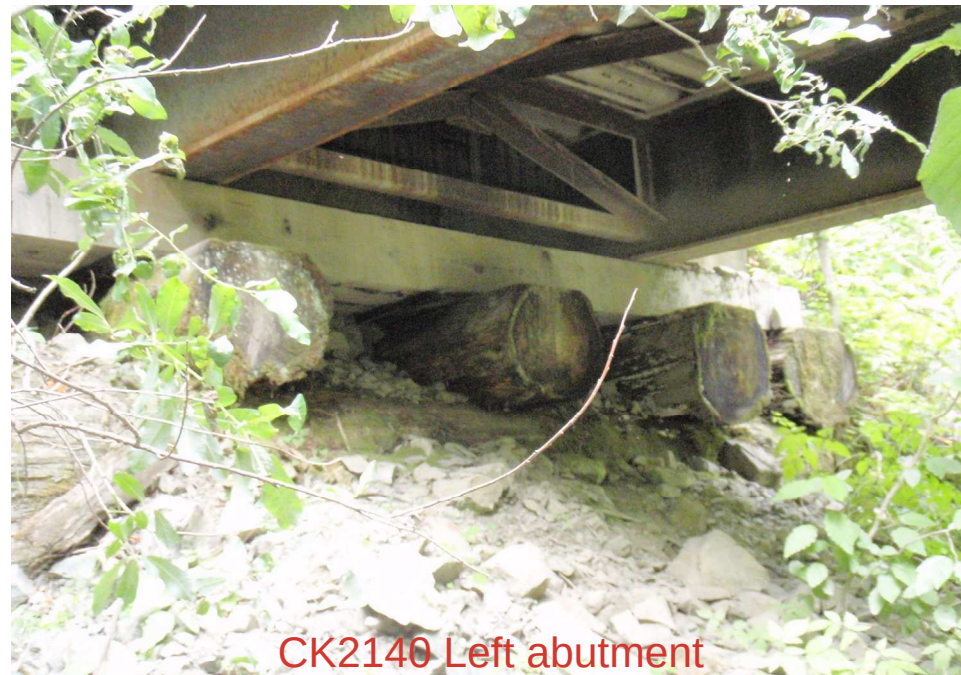
CK2140 Left abutment

| GENERAL INFORMATION | | | |
|---|---|---|---|
| Fender Condition | E G F (P) None UR | ONLY INSTALLED ON DOWNSTREAM LEFT ABUT. | |
| Concrete (cast in place; lock blocks, precast) | E G F P (N/A) UR | LEFT ABUT: 2x LOG CRIB, w/ TOP | |
| Caps or Sills | E G F P (N/A) UR | FACE LOG AS SQUARE TIMBER. | |
| Riprap | E G (F) P N/A UR | BEDROCK CONTROLLED ON LEFT ABUT. | |

| GENERAL INFORMATION | | | |
|---|---|---|---|
| 3 | <u>(H)</u> M L | | INSTALL FENDER LOGS. |
