BC Ministry of  
Forests and Range

# Corporate Bridge Register (CBR) Structure Inventory Data Form "BRIDGES"

| *Forest Service Road: Harrison - Wallian Ck. | Kilometres: 7.2 |

**Routine Condition Bridge Inspection Form**  
(for log stringer or timber stringer bridges)

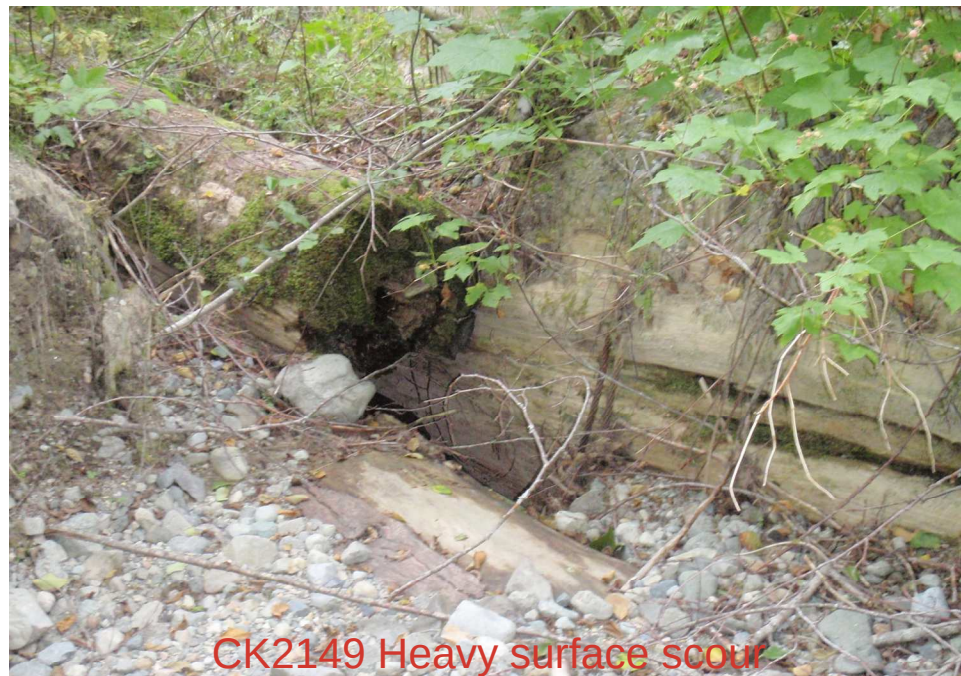
| GENERAL INFORMATION | | | | (enter either long/lat or UTM below - not both) | | | |
|---|---|---|---|---|---|--|--|
| Fill | E G F <u>(P)</u> N/A UR | | <u>DOWNSTREAM CORNERS &amp; SURFACE HEAVILY SLOURED.</u> | | | | |

CK2149 Heavy surface scour

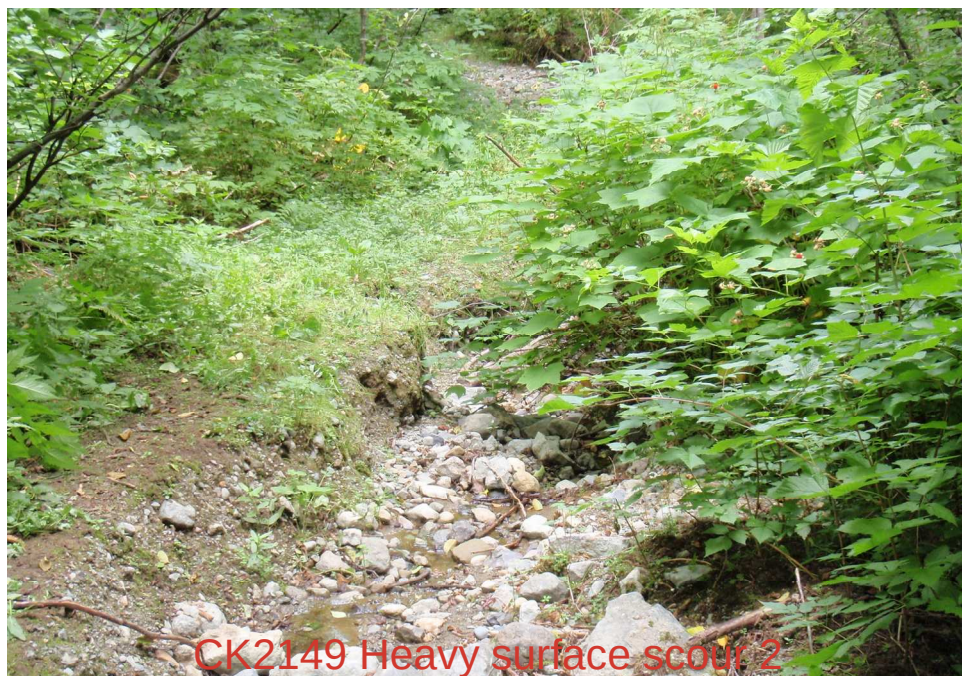
CK2149 Heavy surface scour 2

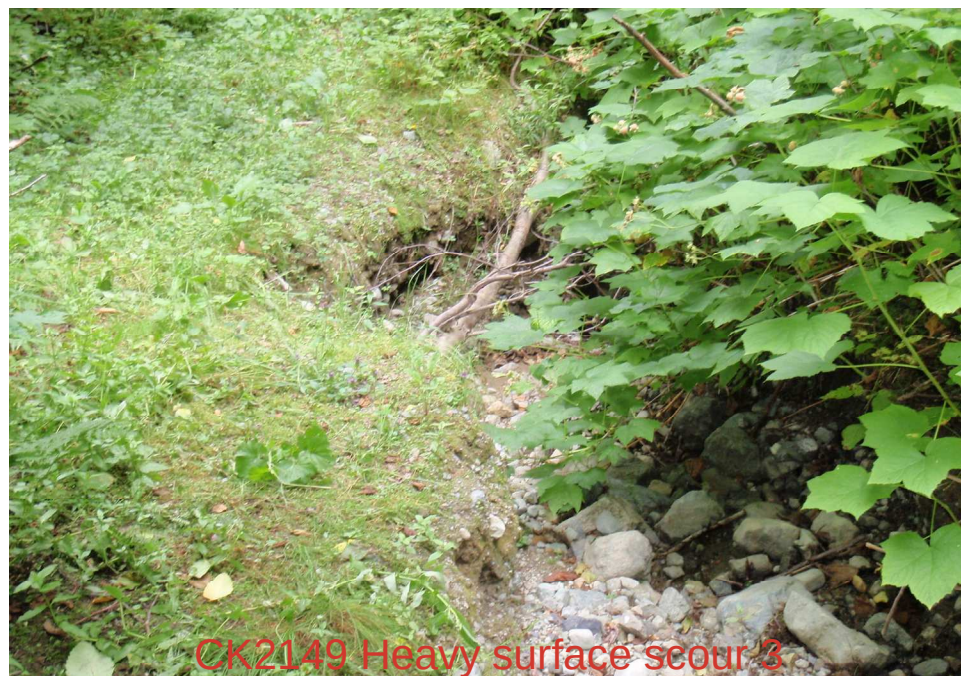
CK2149 Heavy surface scour 3

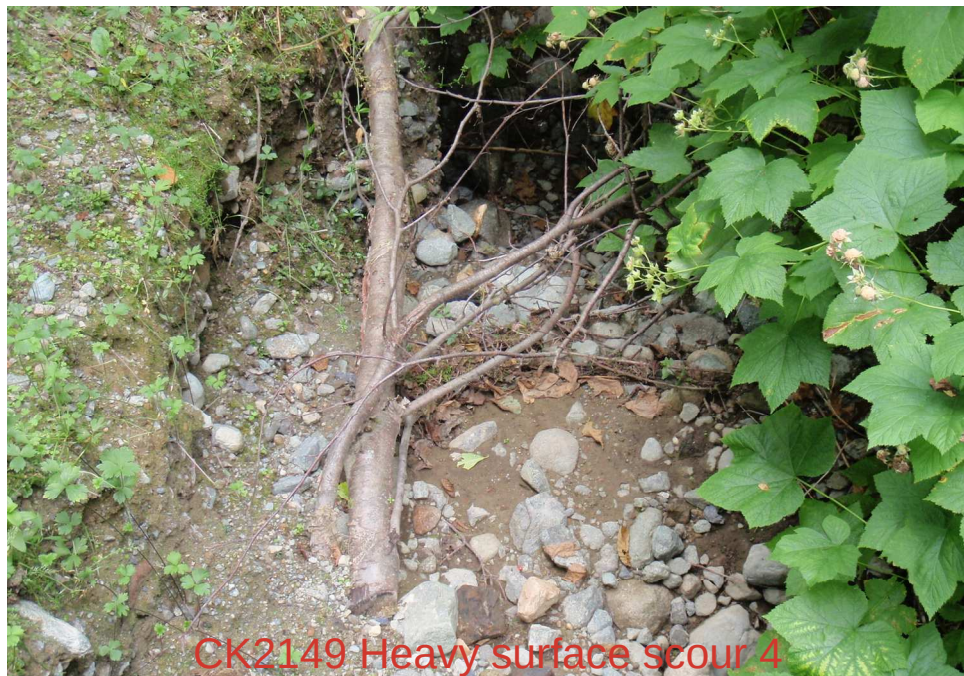
CK2149 Heavy surface scour 4

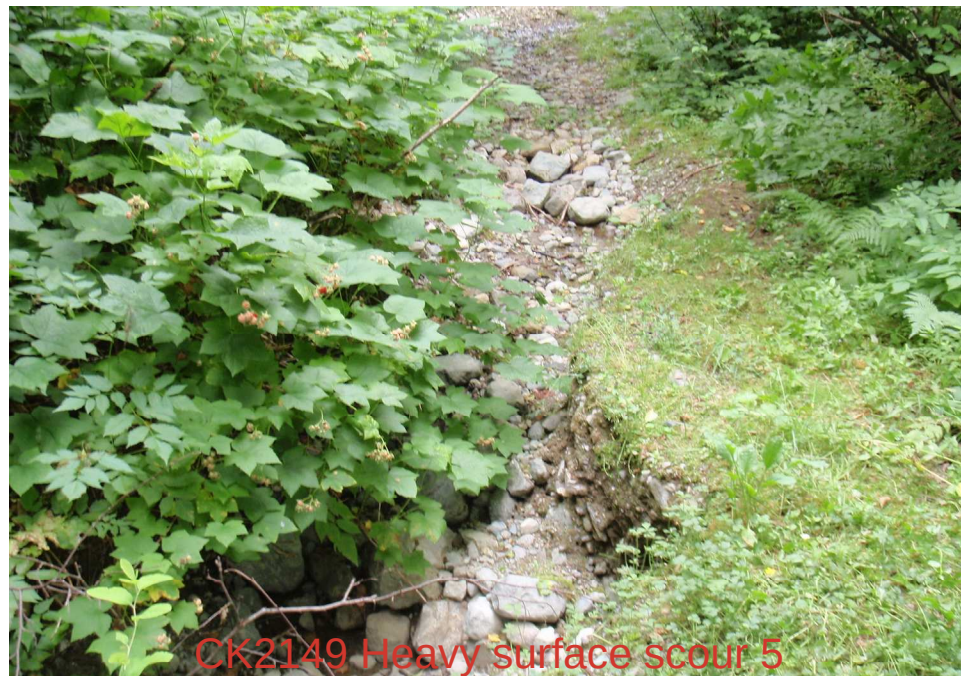
CK2149 Heavy surface scour 5

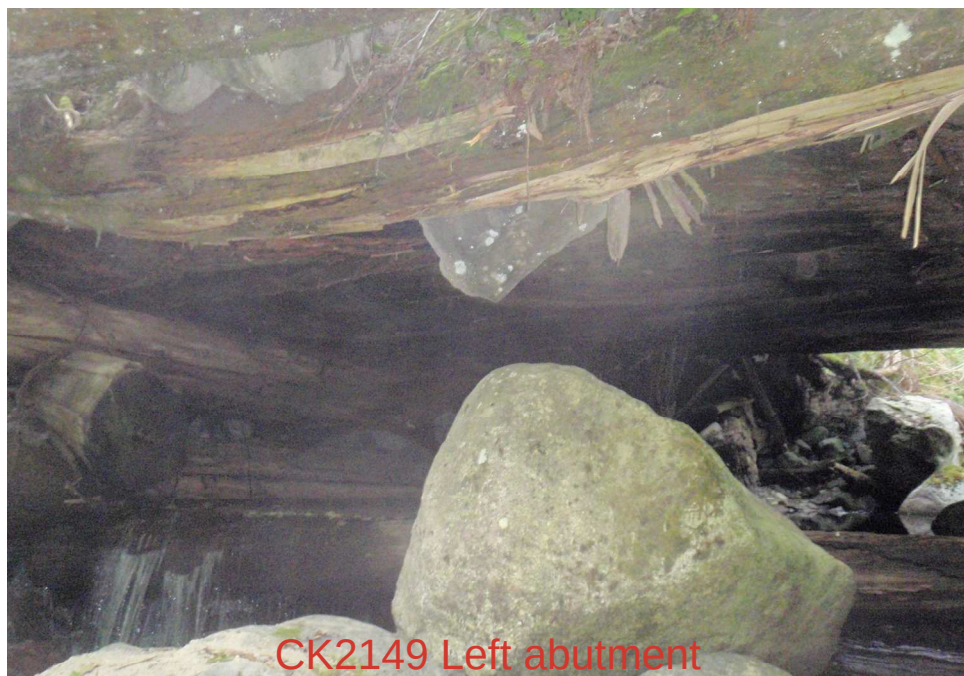
CK2149 Left abutment

| GENERAL INFORMATION | | | | (enter either long/lat or UTM below - not both) | | | |
|---|---|---|---|---|---|--|--|
| Bin Wall | E G F P <u>(N/A)</u> UR | | <u>LEFT 2x CRIB: HEAVILY SLOURED.</u> | | | | |

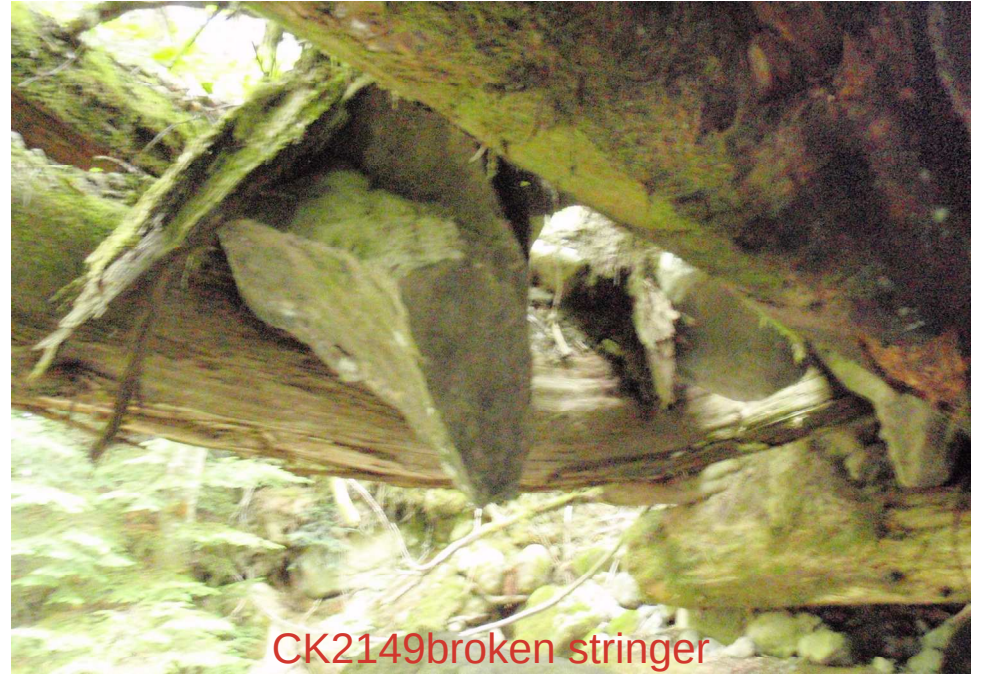
| GENERAL INFORMATION | | | | | | | | |
|---|---|---|---|---|---|---|---|---|
| 1 | | Y N | | | | | <u>THERE ARE 8 stringers but could not access stringers completely outside stringer is cracked w/ large boulder sticking out.</u> | |

CK2149broken stringer

| GENERAL INFORMATION | | | | | | | | |
|---|---|---|---|---|---|---|---|---|
| 1 | <u>H</u> M L | | <u>REPLACE STRUCTURE</u> | | | | | |
| P Eng Reviewer's Comments<br><u>Close bridge by barricades or remove bridge.</u> | | | | | | | | |

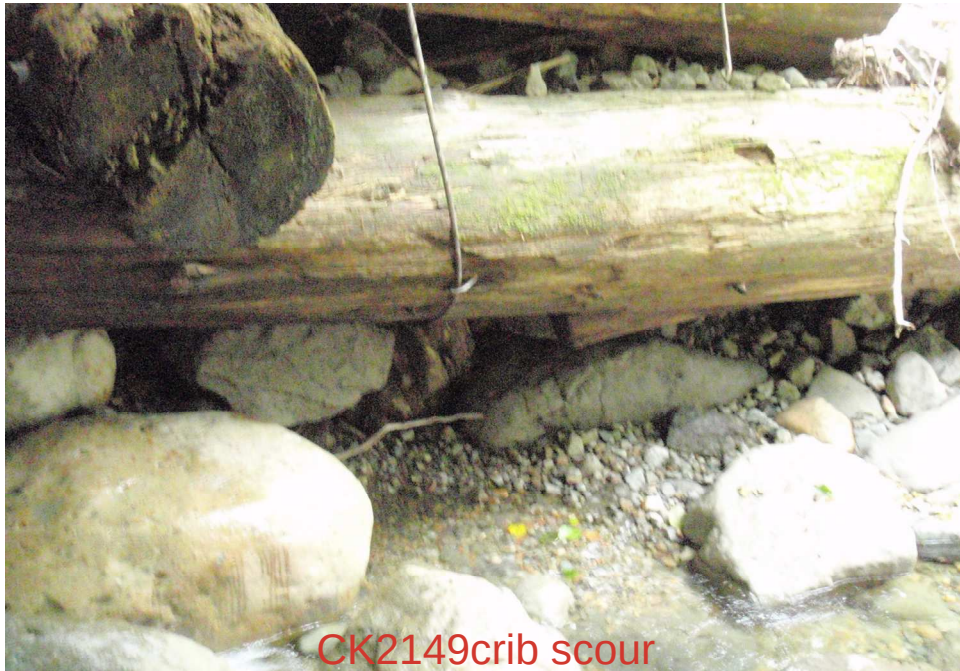
| GENERAL INFORMATION | | | | (enter either long/lat or UTM below - not both) | | | |
|---|---|---|---|---|---|--|--|
| * Log/Timber Crib | E G F <u>(P)</u> N/A UR | | <u>RIGHT CRIB HAS A LARGE CRACK PERPENDICULAR TO THE LOAD. IT'S A 2x.</u> | | | | |

CK2149crib scour

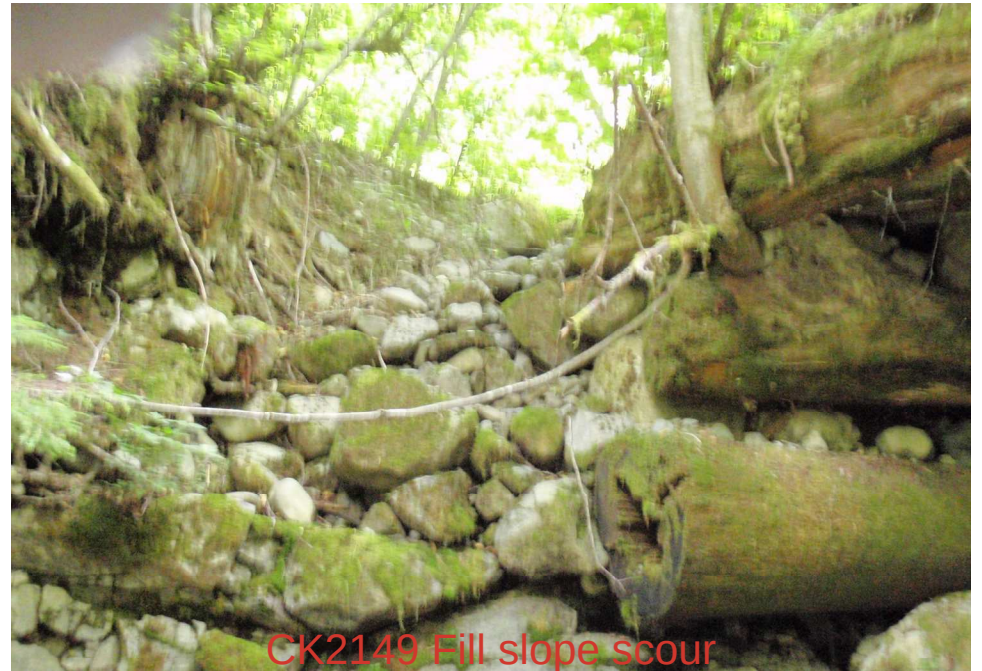
CK2149 Fill slope scour
