CK 2166

# Bridge Register Structure Inventory Data Form BRIDGES

**Routine Condition Bridge Inspection Form**  
(except for log stringer or timber stringer bridges)

| GENERAL INFORMATION | | | | (enter either long/lat or UTM - not both) | | |
|---|---|--|---|---|---|---|
| FSR Name | LOSTCRK FSR | | | User km | 50 | Project File ID |

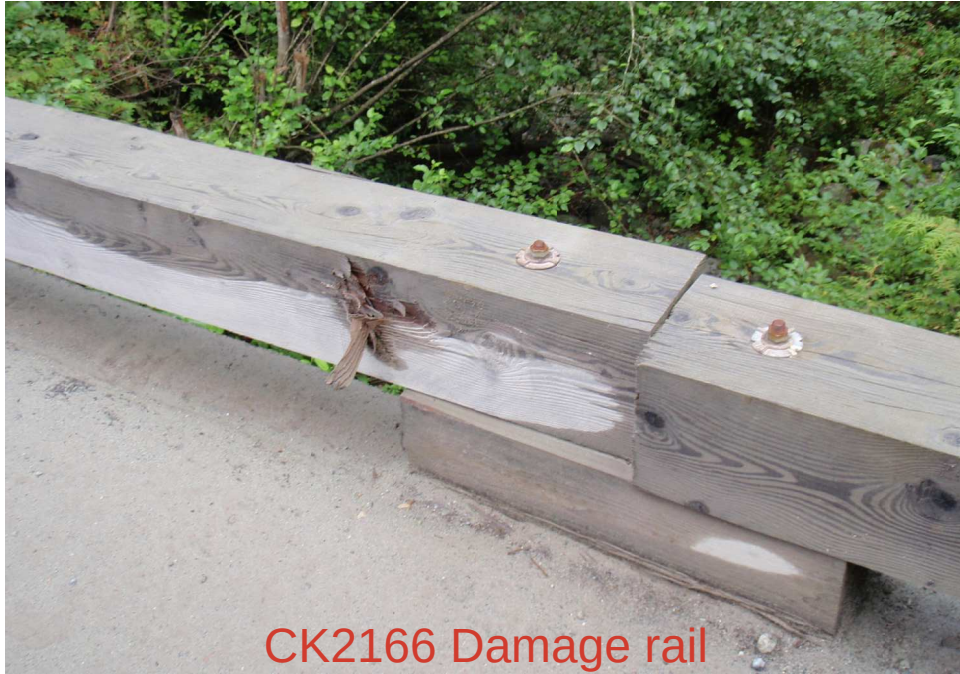
| GENERAL INFORMATION | | | | (enter either long/lat or UTM - not both) | | |
|---|---|--|---|---|---|---|
| Curb Rail/Blocks/Posts | E G <u>F</u> P | | DAMAGED + ROTTEN RISERS | | | |

CK2166 Damage rail

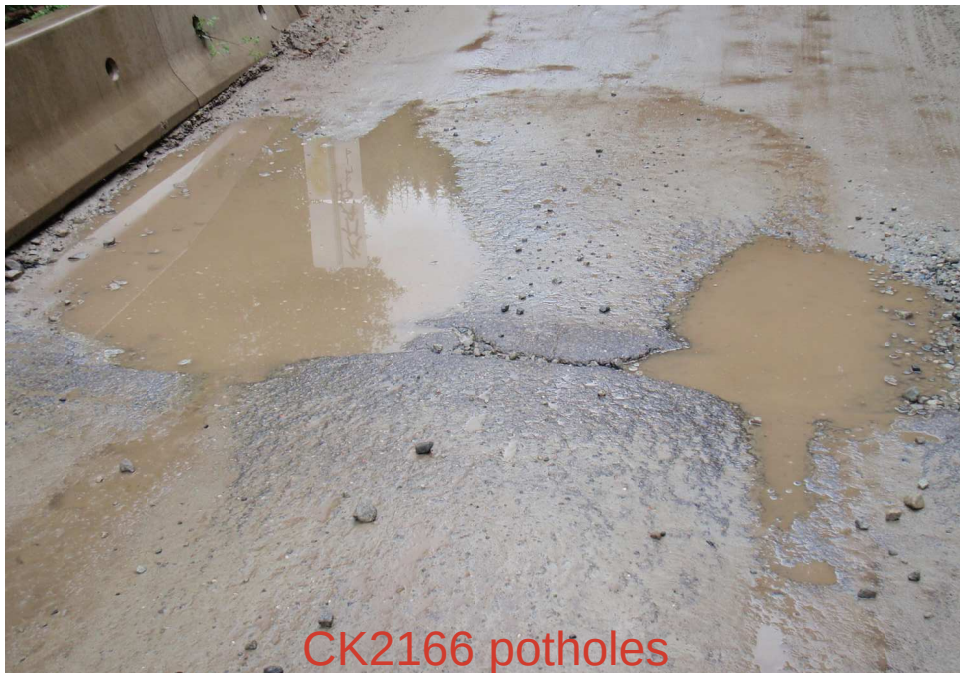
| GENERAL INFORMATION | | | | (enter either long/lat or UTM - not both) | | |
|---|---|--|---|---|---|---|
| Road Surface | E G <u>P</u> | | LARGE POTHOLE ON LEFT APPROACH. | | | |

| GENERAL INFORMATION | | | |
|---|---|---|---|
| 1 | POTHOLES ON RIGHT APPROACH, -> CONTINUOUS EROSION DECK COULD BE DAMAGED. | | |

CK2166 potholes

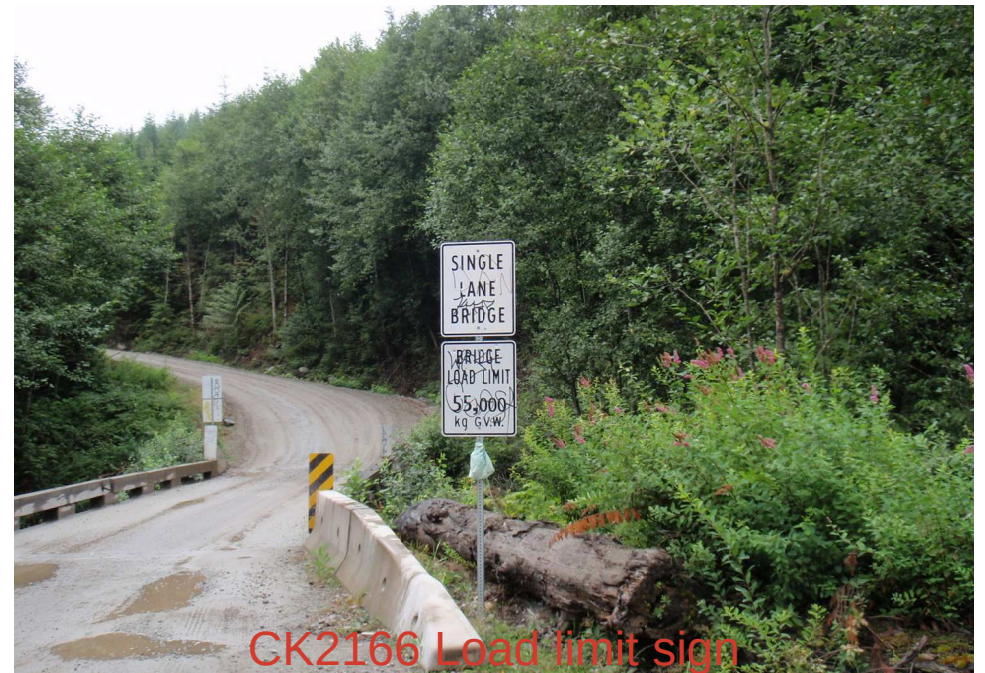
CK2166 Load limit sign

| GENERAL INFORMATION | | | | (enter either long/lat or UTM - not both) | | |
|---|---|--|---|---|---|---|
| Posted Load Rating (tonnes) | 55 | | | | | |

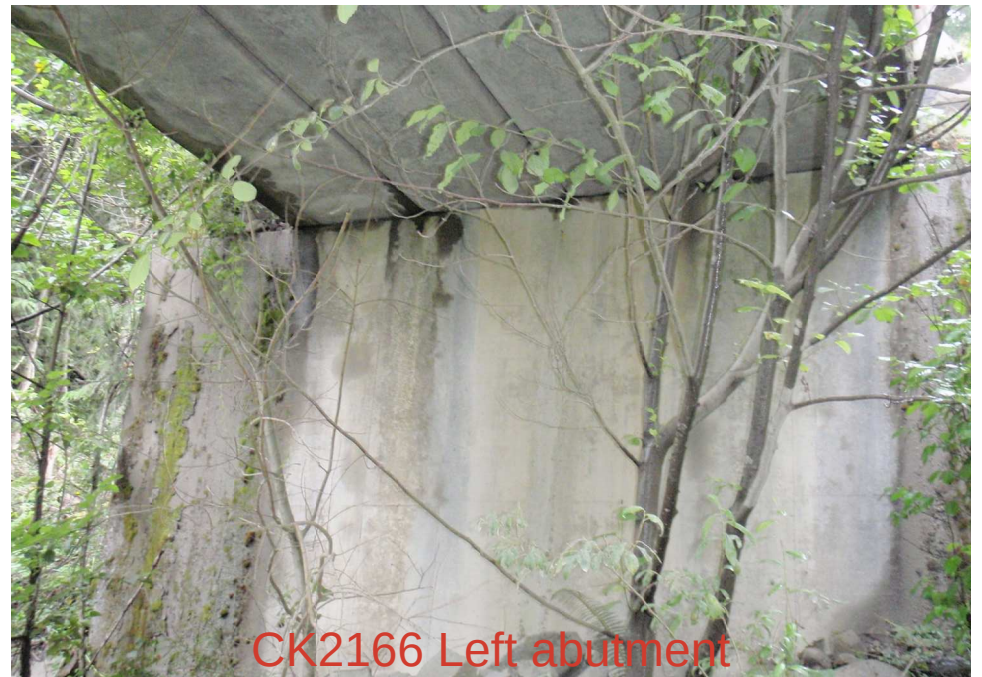
CK2166 Left abutment

| GENERAL INFORMATION | | | | (enter either long/lat or UTM - not both) | | |
|---|---|--|---|---|---|---|
| Cap or Sills | E <u>G</u> F P | | CONCRETE CRACK IN PLACE. | | | |
| Riprap | E <u>G</u> F P <u>N/A</u> | | BEP ROCK CONTROLLED ON LEFT ABUTMENT. | | | |

| GENERAL INFORMATION | | | |
|---|---|---|---|
| 2 | DOWNSTREAM LEFT ABUTMENT: STEEP FULL SLOPE SIGNIFYING MONITOR. | | |

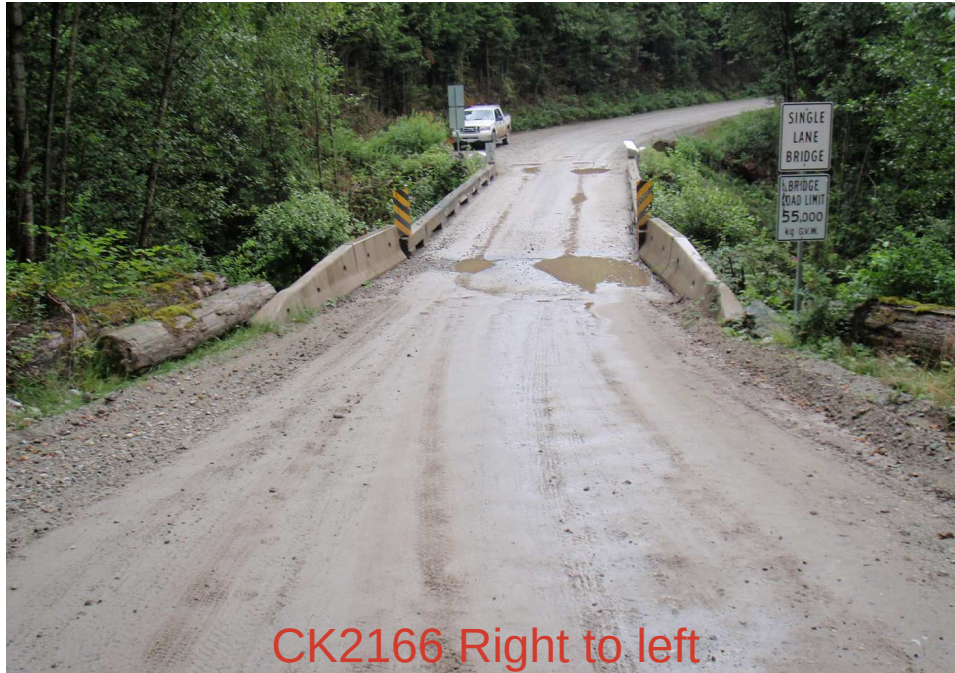
CK2166 Right to left

| GENERAL INFORMATION | | | | (enter either long/lat or UTM - not both) | | |
|---|---|--|---|---|---|---|
| Alignment | E G F <u>P</u> | | VERY TIGHT VER. CURVE ON RIGHT APPROACH | | | |
