BC Ministry of  
Forests and Range

## Corporate Bridge Register (CBR) Structure Inventory Data Form "BRIDGES"

| *Structure # | *Site #: CK-2169 |

**Routine Condition Bridge Inspection Form**  
(except for log stringer or timber stringer bridges)

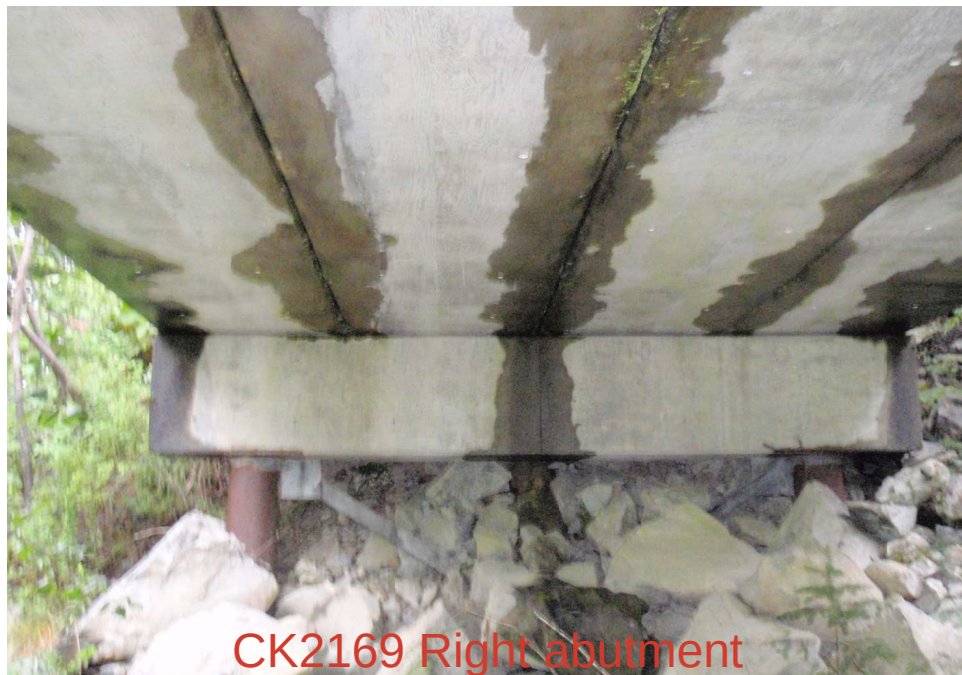
CK2169 Right abutment

| GENERAL INFORMATION | | | | (enter either longlat or UTM - not both) | | |
|---|---|---|---|---|---|--|
| Caps or Sills | E <u>(G)</u> F P | PRECAST CONCRETE CAPS | | | | |
| Piles or Posts | E <u>(G)</u> F P <u>(N/A)</u> | PIPE RISE ON SPREAD FOOTING. | | | | |
| Bearings | E <u>(G)</u> F P | RUBBER PADS | | | | |
