# Corporate Bridge Register (CBR) Structure Inventory Data Form "BRIDGES"

| *Structure # | *Site #: CK-2170 |
| *Forest Service Road: LOS 7 CCK FSR | Kilometres: 17.1 |

**Routine Condition Bridge Inspection Form**  
(except for log stringer or timber stringer bridges)

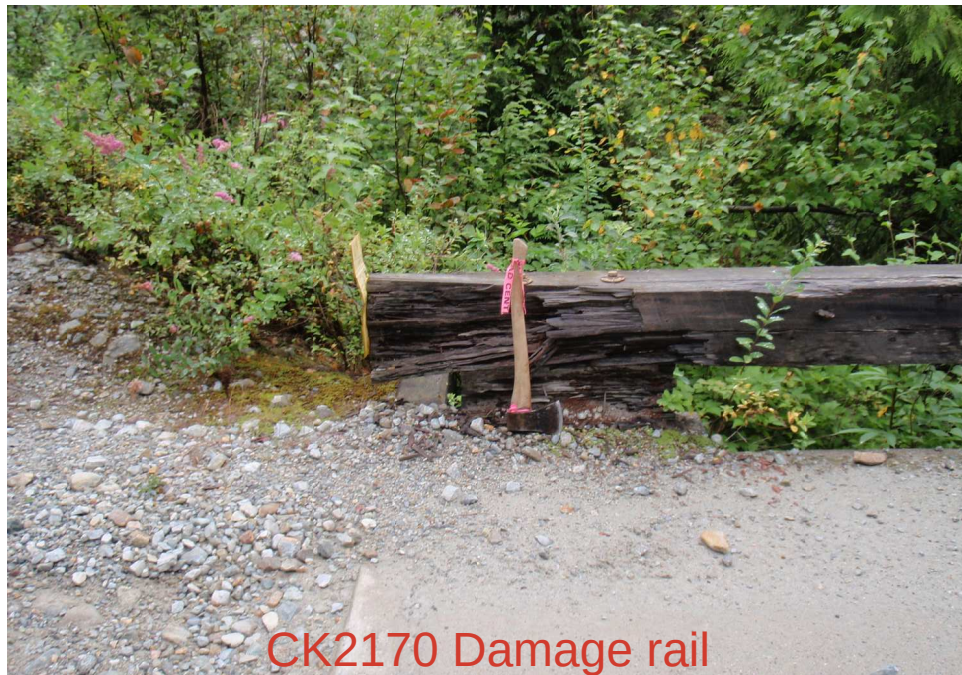
| GENERAL INFORMATION | | (enter either long/lat or UTM - not both) | | |
|---|---|---|---|---|
| Curb Rail/Blocks/Posts | E G F <b>(P)</b> | ROTTEN TIMBER RAIL | | |
| Overall Deck Condition | E G <b>(F)</b> P | POOR TIMBER RAILS | | |

CK2170 Damage rail

| GENERAL INFORMATION | | | |
|---|---|---|---|
| 1 | (H) M L | | REPLACE RAILS w/ INCREASE INDUSTRIAL USE |
| Comments <u>Recommended that curbs be repaired/replaced</u> | | | |

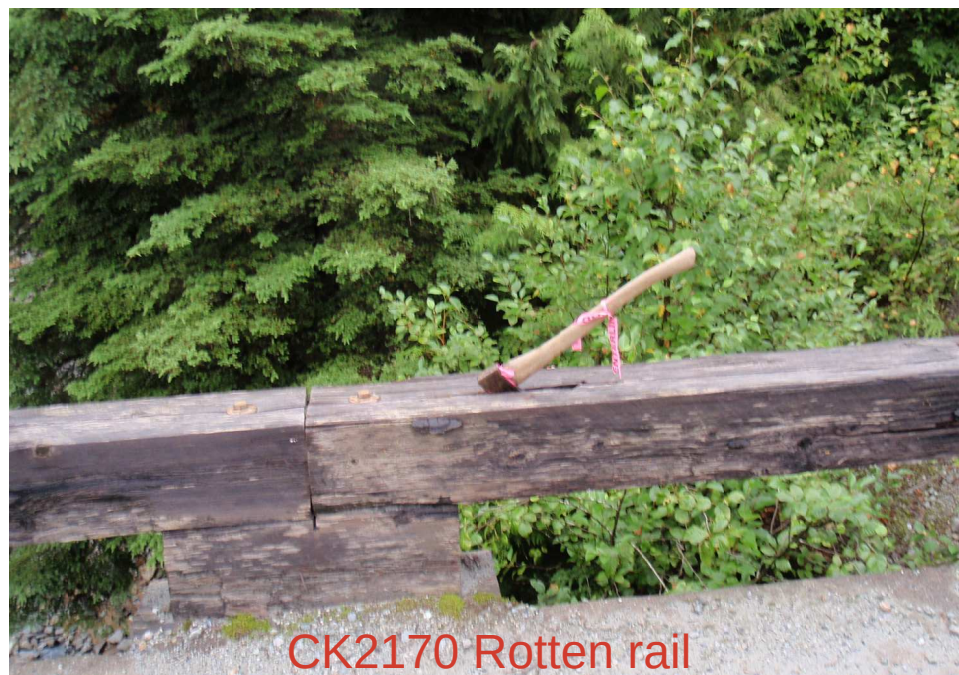
CK2170 Rotten rail

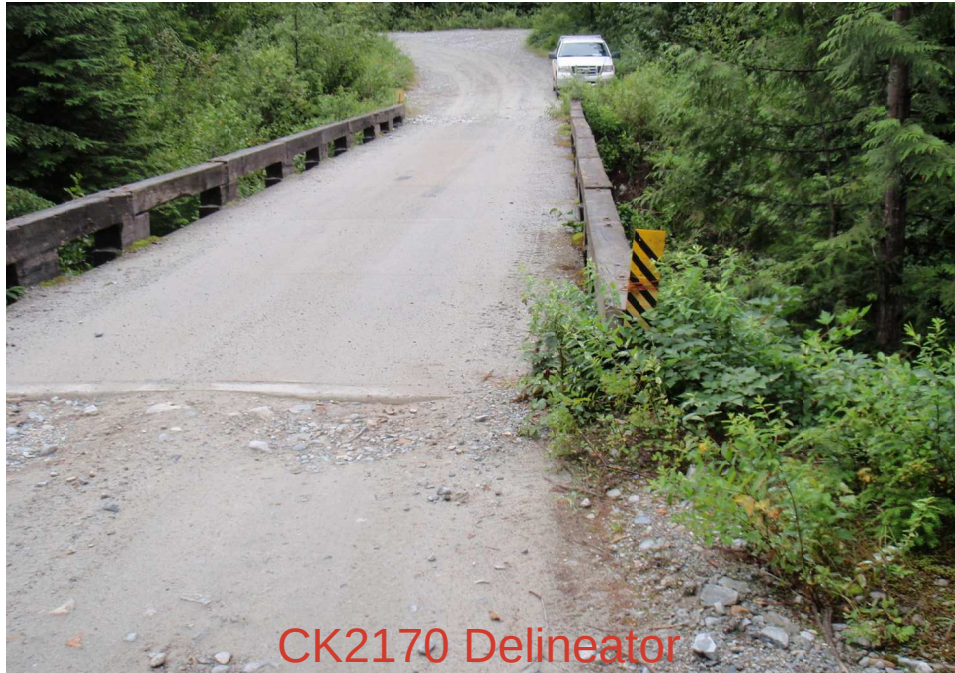
CK2170 Delineator

| GENERAL INFORMATION | | (enter either long/lat or UTM - not both) | | |
|---|---|---|---|---|
| Delineator Missing Left | <b>(0)</b> 1 2 | CONSIDER INSTALLING LATER - REFLECTIVE DELINE. | | |
