## Corporate Bridge Register (CBR) Structure Inventory Data Form "BRIDGES"

| *Structure # | *Site #: <u>CK-2171</u> |

**Routine Condition Bridge Inspection Form**  
(except for log stringer or timber stringer bridges)

| GENERAL INFORMATION | | | | (enter either long/lat or UTM - not both) | | | |
|---|---|--|--|---|---|---|---|
| FSR Name | LOST CRK FSR | | | User km | 17.8 | Project File ID | 8013 |

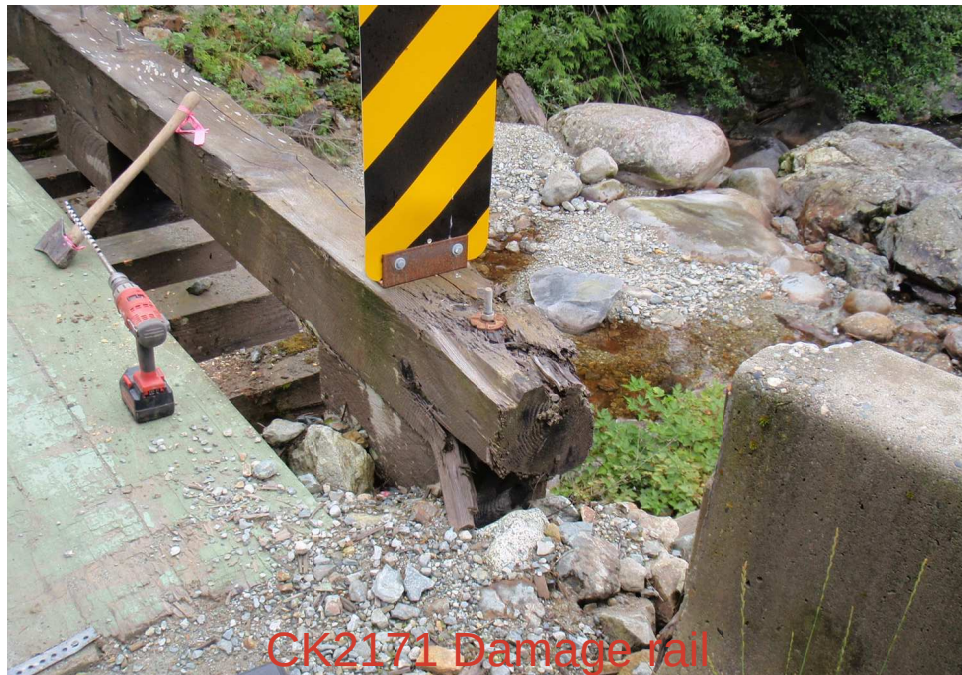
| GENERAL INFORMATION | | | | (enter either long/lat or UTM - not both) | | | |
|---|---|--|--|---|---|---|---|
| Curb Rail/Blocks/Posts | E G (F) P | | | SLIGHTLY RASPY | | | |

CK2171 Damage rail

| GENERAL INFORMATION | | | |
|---|---|---|---|
| 1 | H M <u>L</u> | | ROKEN RAILS. |
