**Corporate Bridge Register (CBR)  
Structure Inventory Data Form "BRIDGES"**

| *Forest Service Road: LOST CRK FSR | Kilometres: 18.8 |

# Routine Condition Bridge Inspection Form (for log stringer or timber stringer bridges)

| GENERAL INFORMATION | | | | (enter either longlat or UTM - not both) | | |
|---|---|---|---|---|---|---|
| Site # <u>CK2172</u> | | Structure # | | | | |

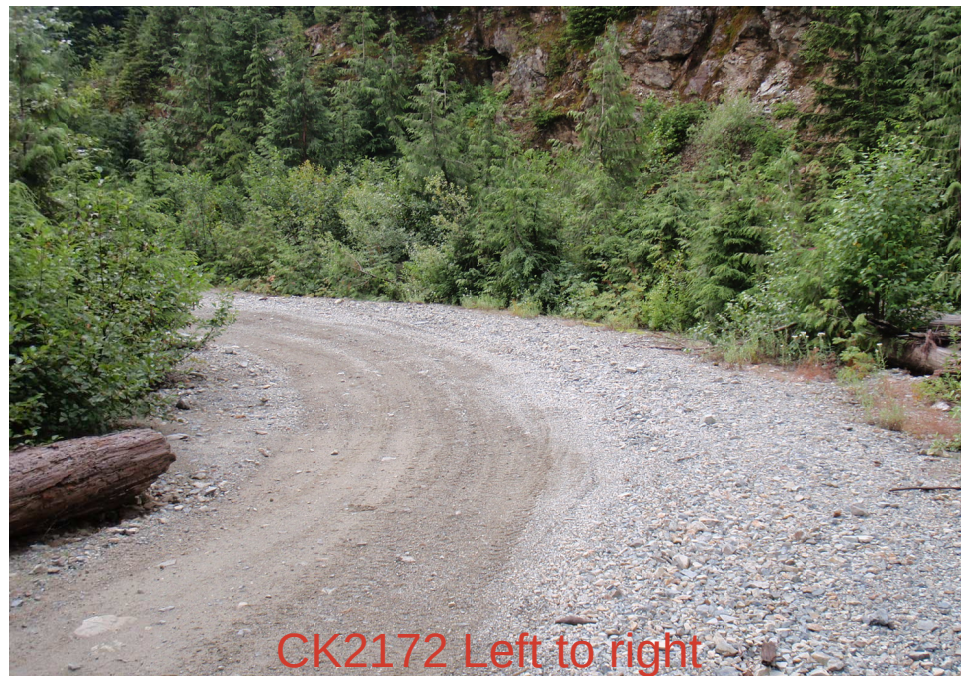
CK2172 Left to right

| GENERAL INFORMATION | | | | (enter either longlat or UTM - not both) | | |
|---|---|---|---|---|---|---|
| Alignment | E G F <u>(P)</u> | TIGHT HUE CURVE w/ LIMITED VISIBLTY! | | | | |

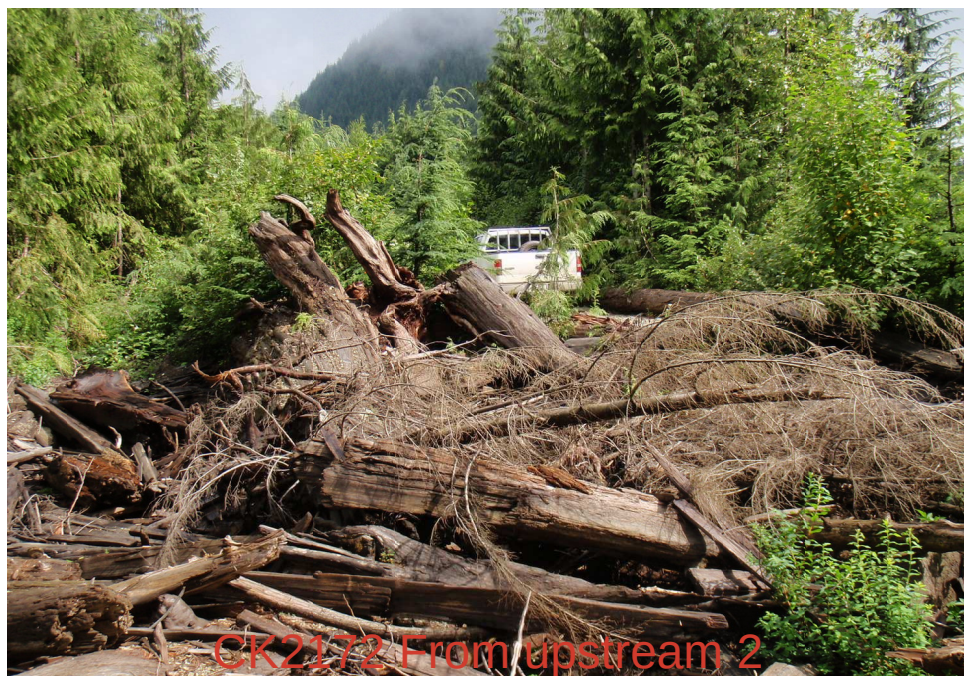
CK2172 From upstream 2

Comments: STRUCTURE FULLY PLUGGED W/ DEBRIS

| REPAIRS (H = High, M = Medium, L = Low) | | | |
|---|---|---|---|
| 1 | H M L | | CLEAN INLET IMMEDIATELY. |

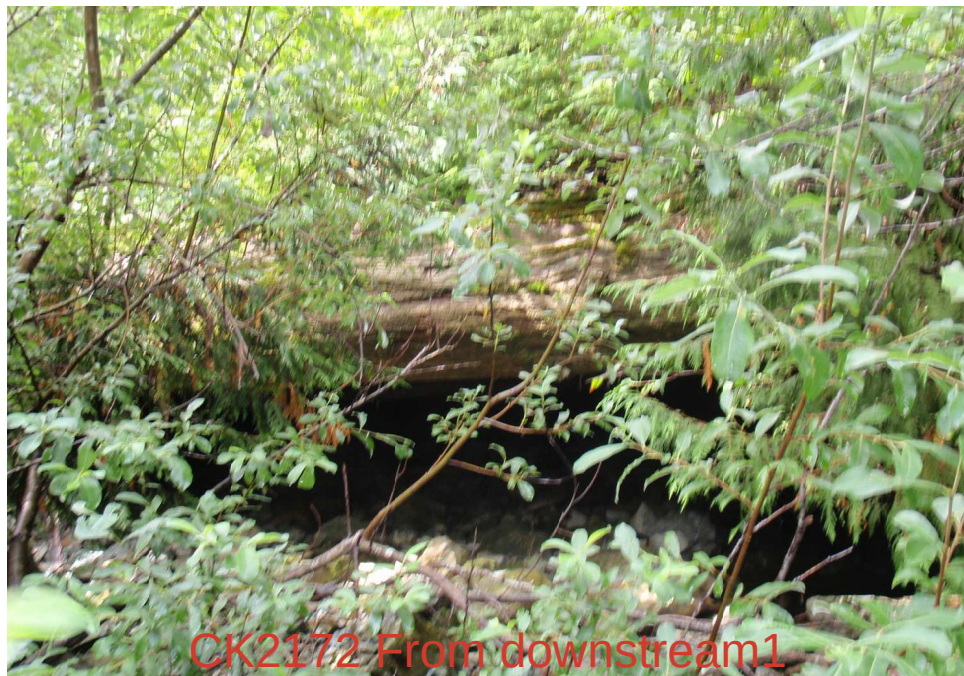
CK2172 From downstream1

ONLY THE 3 STRINGERS FROM D/S COULD BE ASSESSED VERY LOW CLEARANCE DUE TO DEER JAM

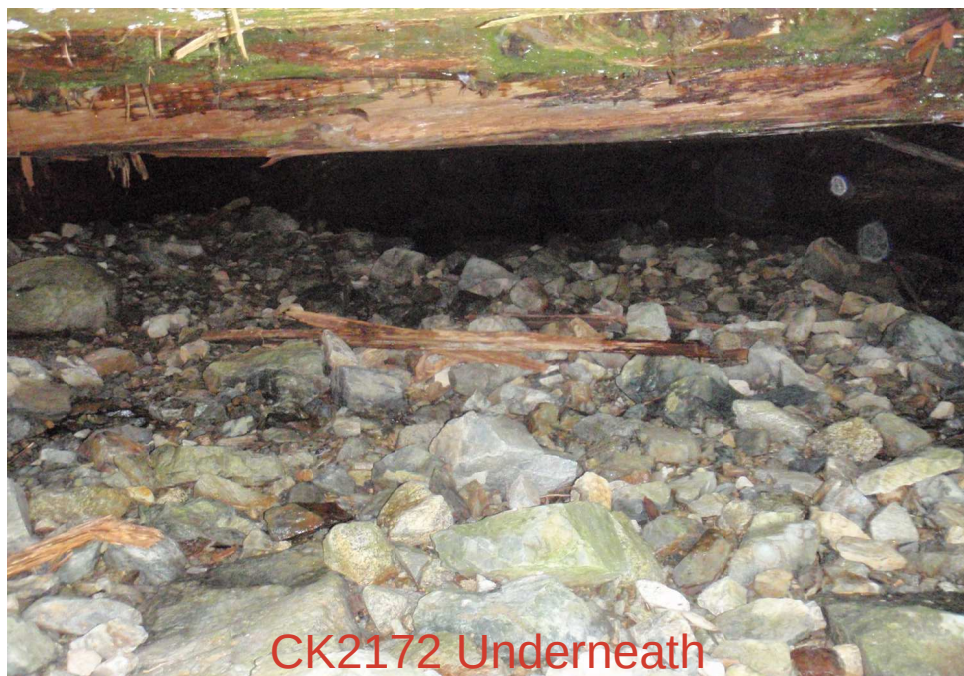
CK2172 Underneath

| PROFESSIONAL ENGINEER TO COMPLETE THIS SECTION | | |
|---|---|---|
| Comments<br><u>Stringer rot observed. Based on previous as-built information for stringer sizes downrate to 20 tonnes.</u> | | |

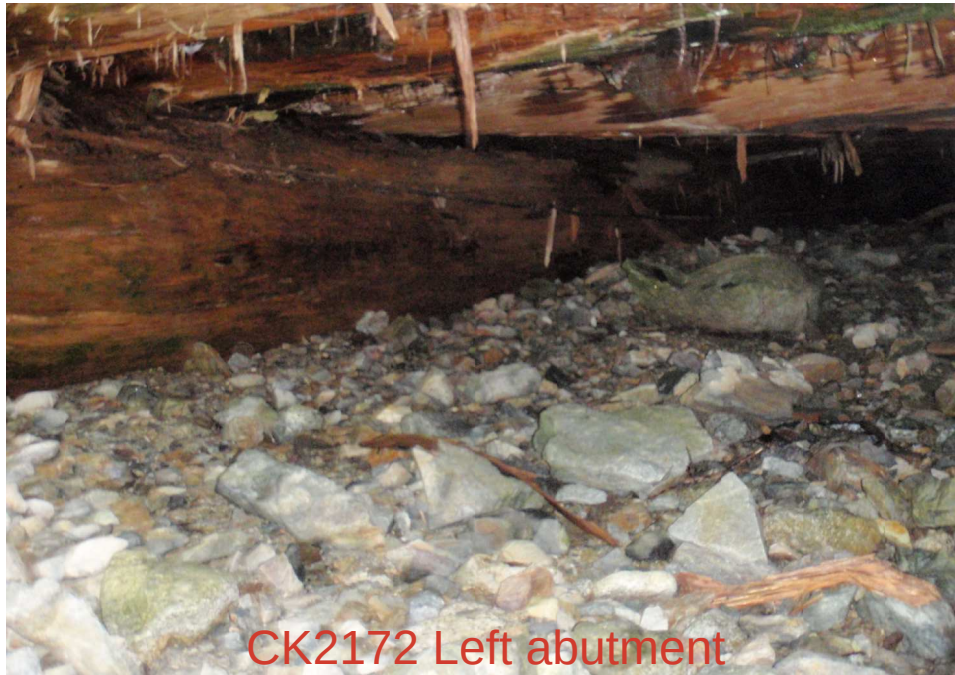
CK2172 Left abutment

| GENERAL INFORMATION | | | | (enter either longlat or UTM - not both) | | |
|---|---|---|---|---|---|---|
| Log/Timber Cribbs | E G F <u>(P)</u> N/A | SINGLE SILL, LEFT ABUT. BEING UNDERMINED | | | | |
| Caps or Sills | E G F <u>(P)</u> | SINGLE SILLS | | | | |
| Riprap | E G F <u>(P)</u> N/A | LEFT ABUT. BEING UNDERMINED | | | | |

| REPAIRS (H = High, M = Medium, L = Low) | | | |
|---|---|---|---|
| 2 | H M L | | REPLACE STRUCTURE W/ INDUSTRIAL ACTIVITY. |

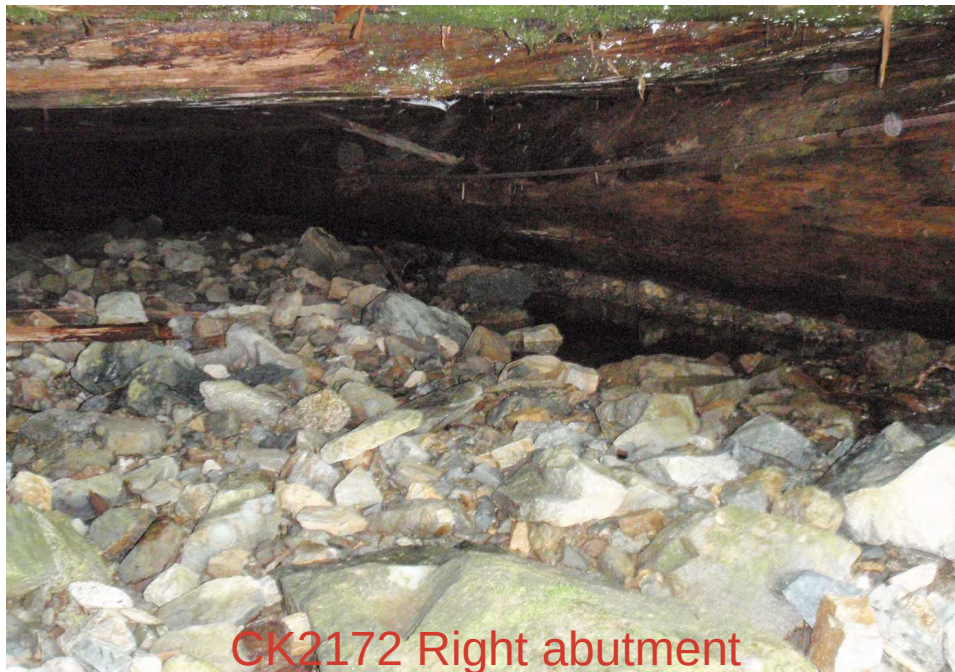
CK2172 Right abutment

INLET IS 100% PLUGGED WITH LOGS + DEBK. FILL SLOPE

ON RIGHT ABUTMENT BEING SLOWED DUE TO FIRM UNDERPINNING STRUCTURE
