BC Ministry of  
Forests and Range

## Corporate Bridge Register (CBR) Structure Inventory Data Form "BRIDGES"

| *Structure # | *Site #: CK-2177 |
| *Forest Service Road: Lost-South | Kilometres: 4.9 |

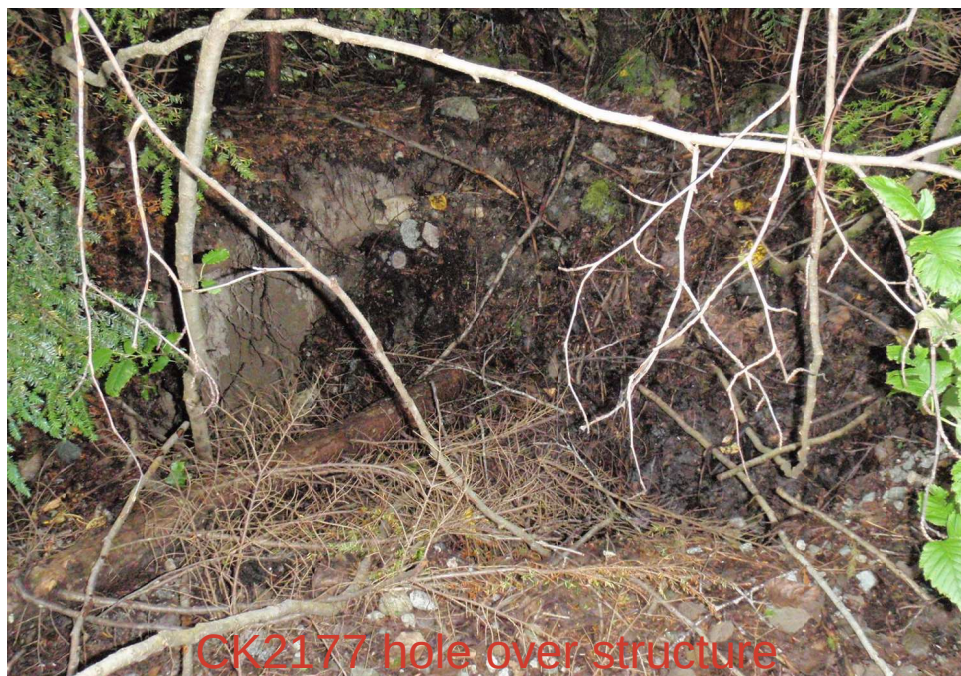
CK2177 hole over structure

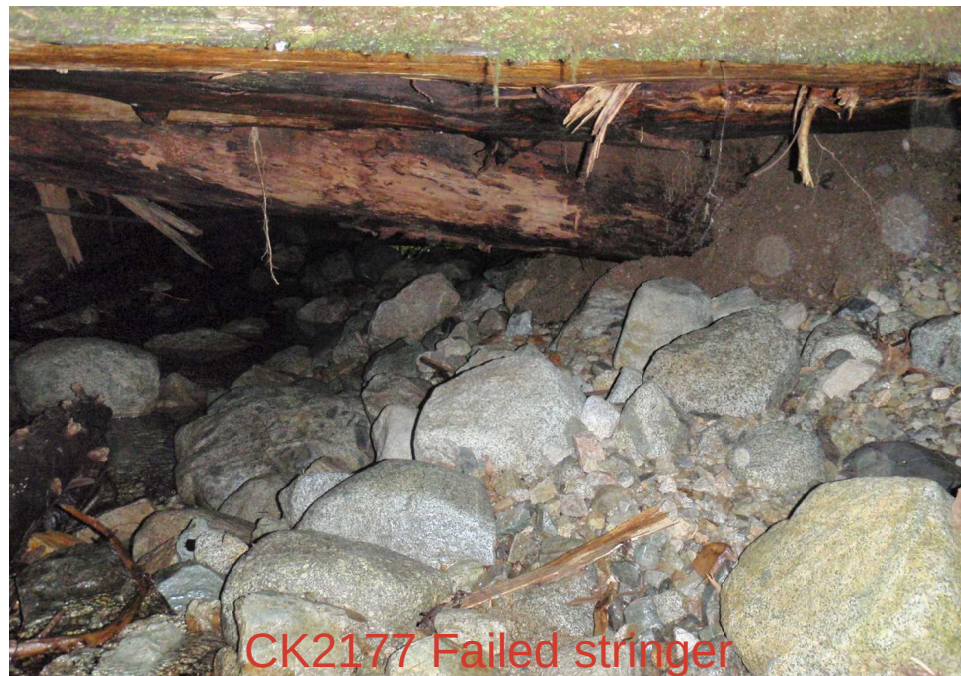
| GENERAL INFORMATION | | | | | | | |
|---|---|---|---|---|---|---|---|
| 1 | | Y N | | | | | STRINGERS # 2+3 HAVE FAILED AND ARE NOW LEANING IN STREAM. |

CK2177 Failed stringer

| GENERAL INFORMATION | | | | | | | |
|---|---|---|---|---|---|---|---|
| 1 | <u>(H)</u> M L | | REPLACE STRUCTURE PRIOR TO VEHICLE TRAFFIC | | | | |
| Comments<br><u>Close bridge by barricades or remove bridge.</u> | | | | | | | |

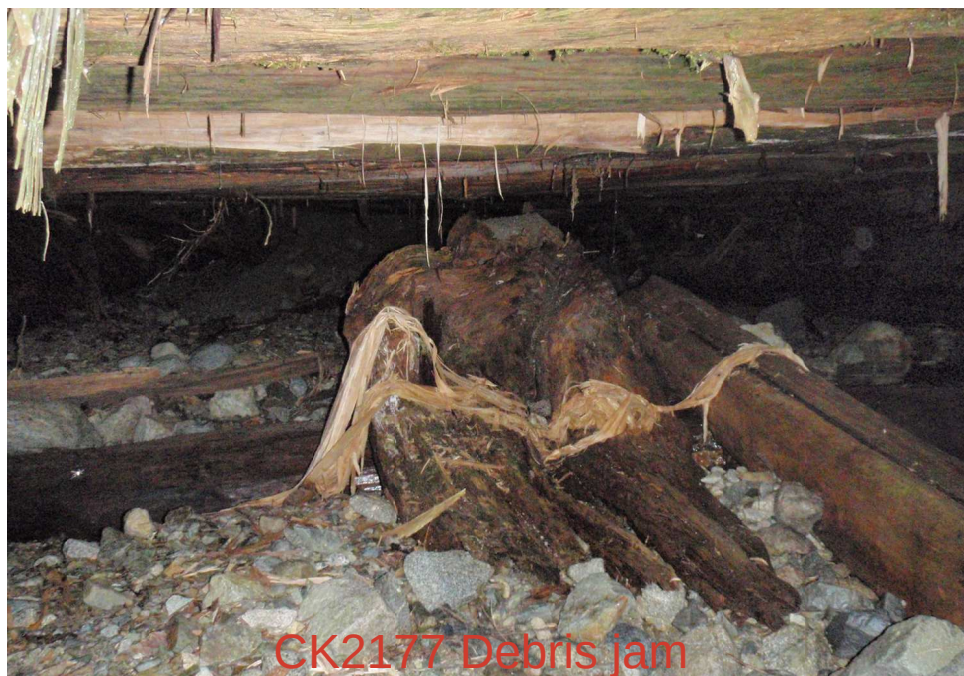
CK2177 Debris jam

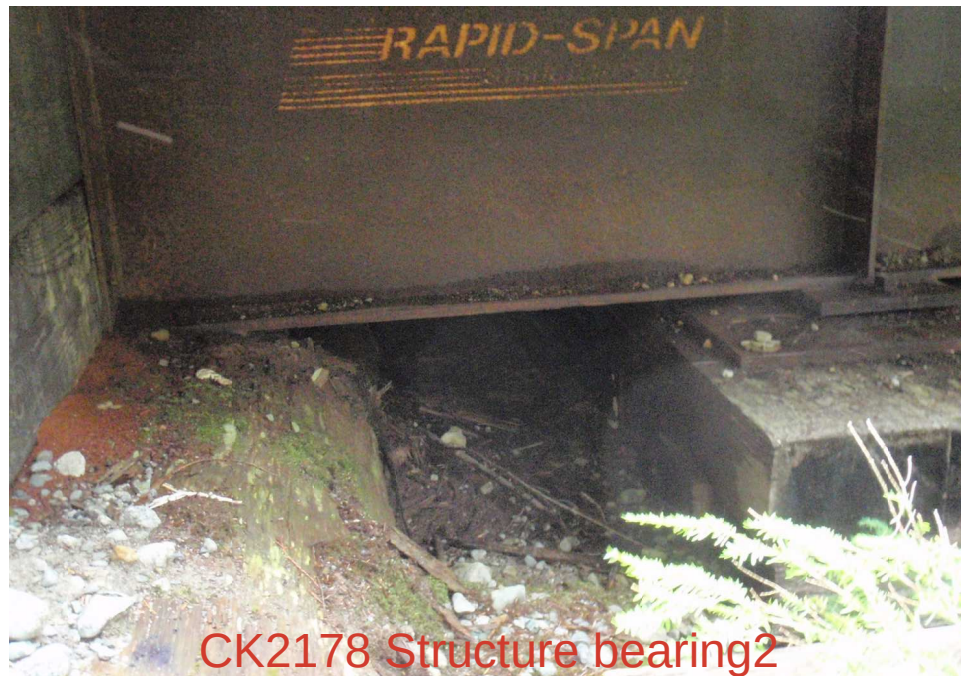
| Item | Present Condition (circle) | Comments (a comment is mandatory if condition "Poor" is selected) |
|---|---|---|
| Corrosion Protection | E G F (P) N/A | STRUCTURE BEARING OVER OLD CRIB, CONSIDER REDUCING LOADING. |

STRUCTURE BEARING  
OVER OLD CRIB.THE CRIB  
AREAS IN FILL  
CONATION, THERE  
SHOULD BE NO IND.  
USTIAL ACTIVITY  
OVER CROSSING.L-5  
PICKUP ACCESS  
ONLY.

CK2178 Structure bearing2

| GENERAL INFORMATION | | | |
|---|---|---|---|
| Comments <b>Downrate to 5 tonnes. Please post. Recommend planning to replace deck.</b> | | | |

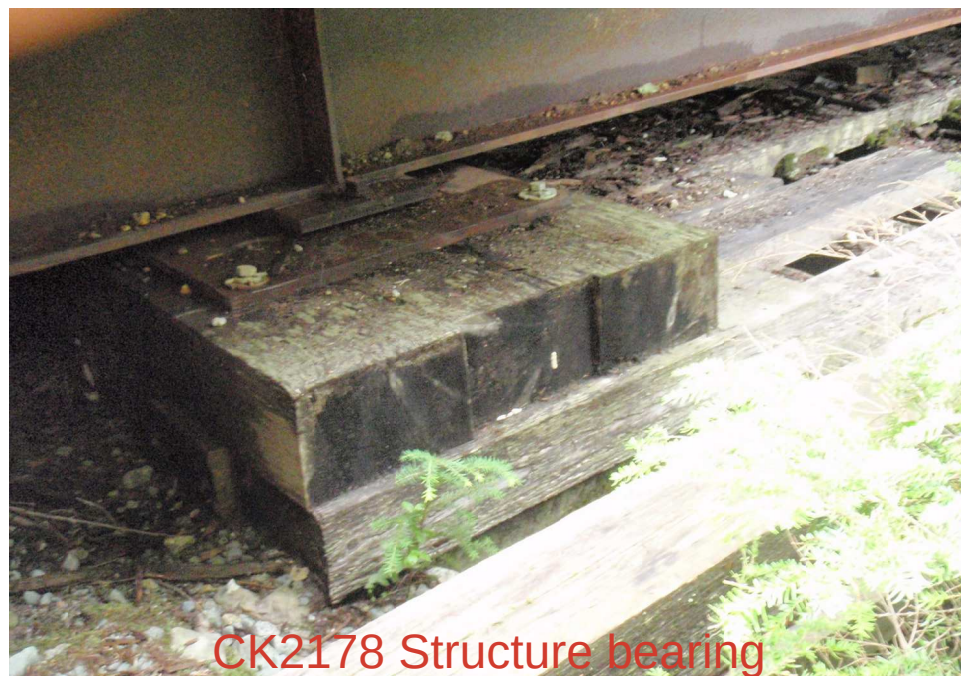
CK2178 Structure bearing

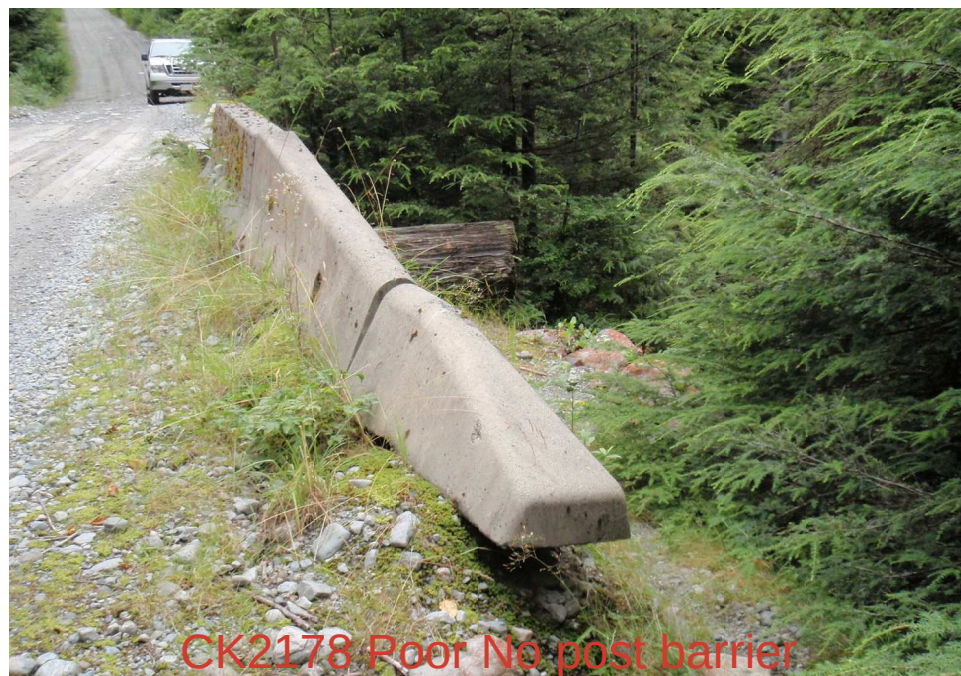
| Item | Present Condition (circle or fill-in) | Comments (a comment is mandatory if condition "Poor" is selected) |
|---|---|---|
| Fender Condition | E G (F) P None | NO POST BARRIERS INSTALLED PROPERLY. |

CK2178 Poor No post barrier

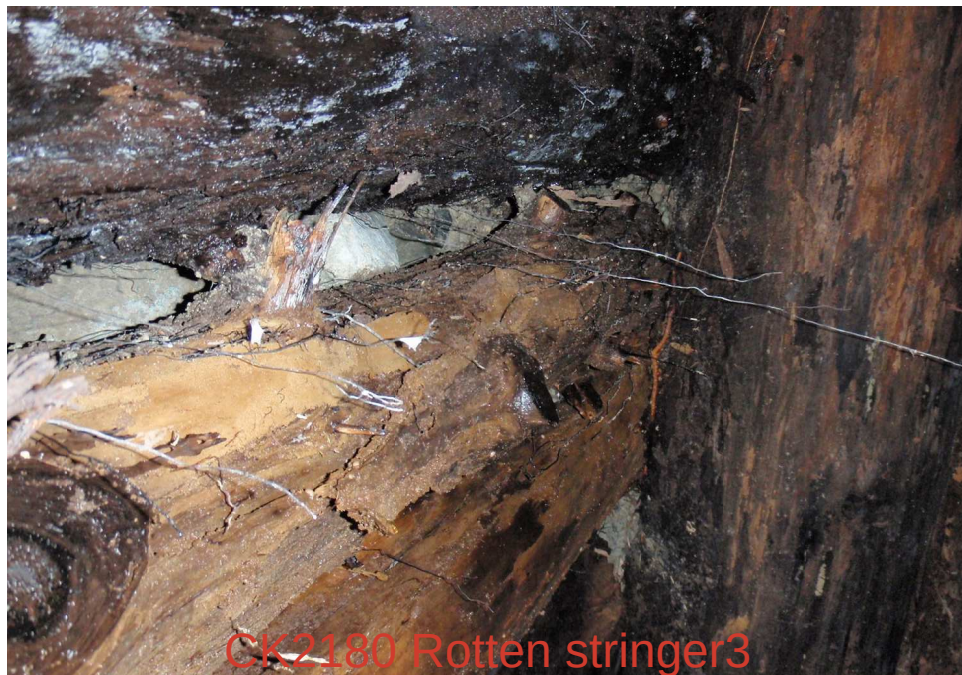
LOG STRINGERS IN A VERY POOR CONDITION. CRIB IS ALSO ROTTEN

CK2180 Rotten stringer3

| GENERAL INFORMATION | | | | | | | |
|---|---|---|---|---|---|---|---|
| 1 | <b>(H)</b> M L | | REPLACE STRUCTURE PRIOR TO ANY TRAFFIC | | | | |
| Comments <b>Close bridge by barricades or remove bridge.</b> | | | | | | | |

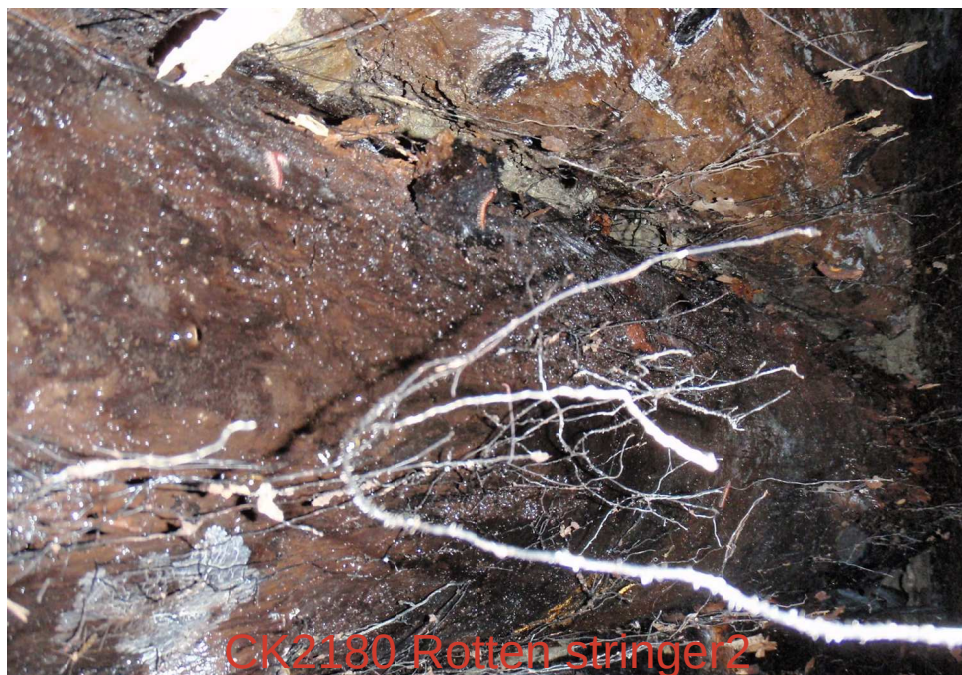
CK2180 Rotten stringer2

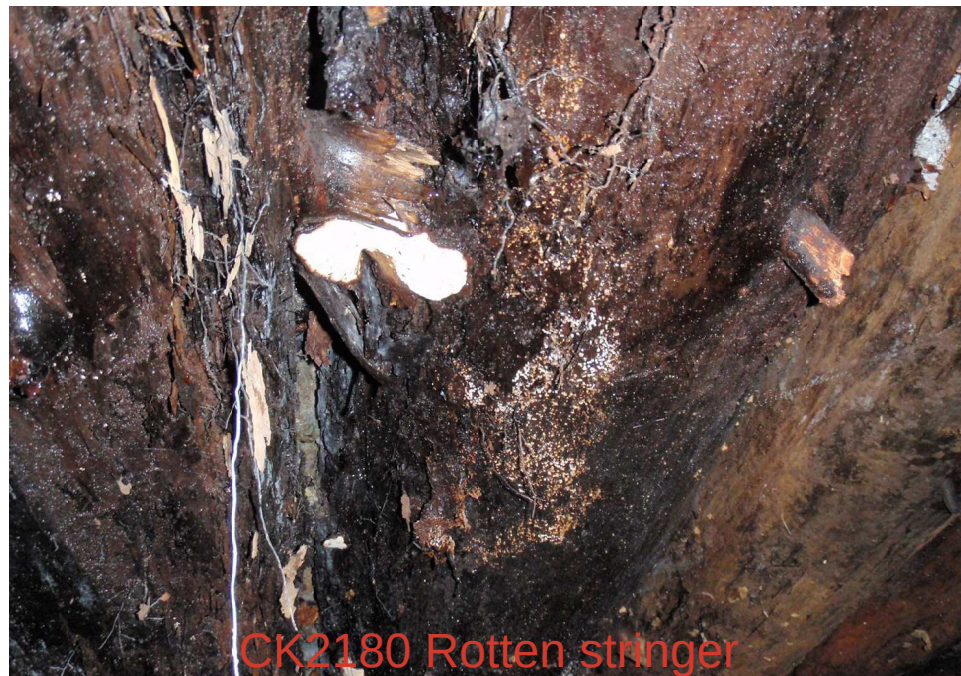
CK2180 Rotten stringer

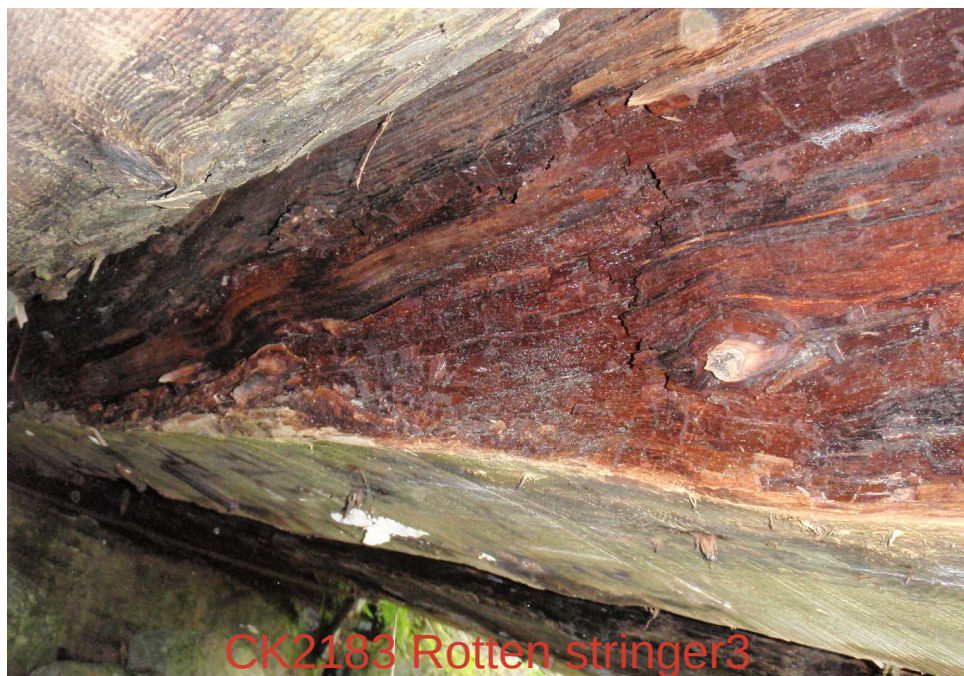
CK2183 Rotten stringer3

| GENERAL INFORMATION | | | | | | | |
|---|---|---|---|---|---|---|---|
| Comments <u>Close bridge by barricades or remove bridge.</u> | | | | | | | |

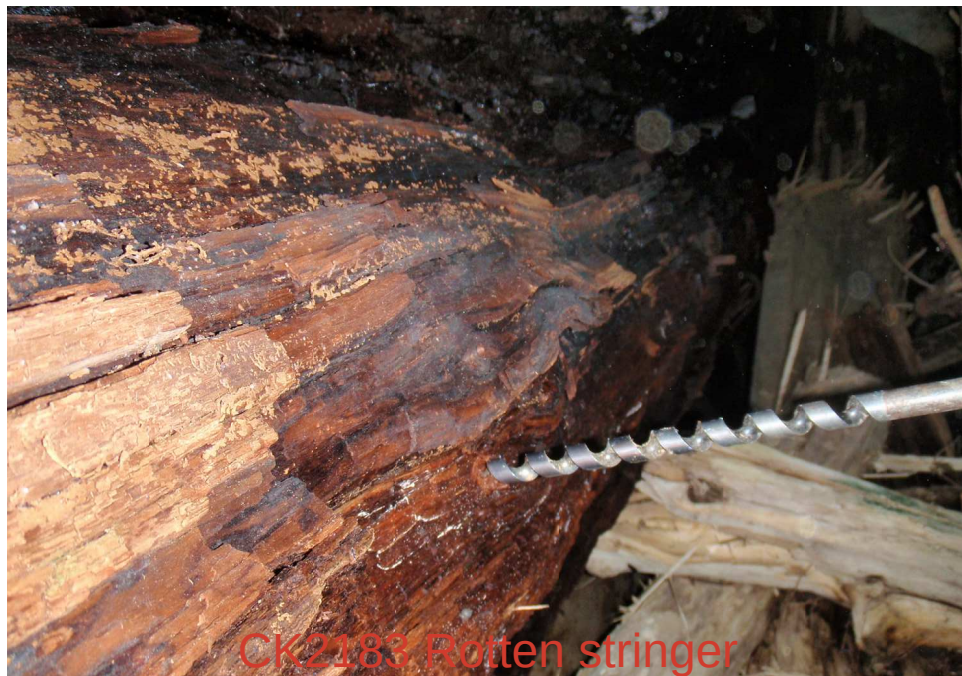
CK2183 Rotten stringer

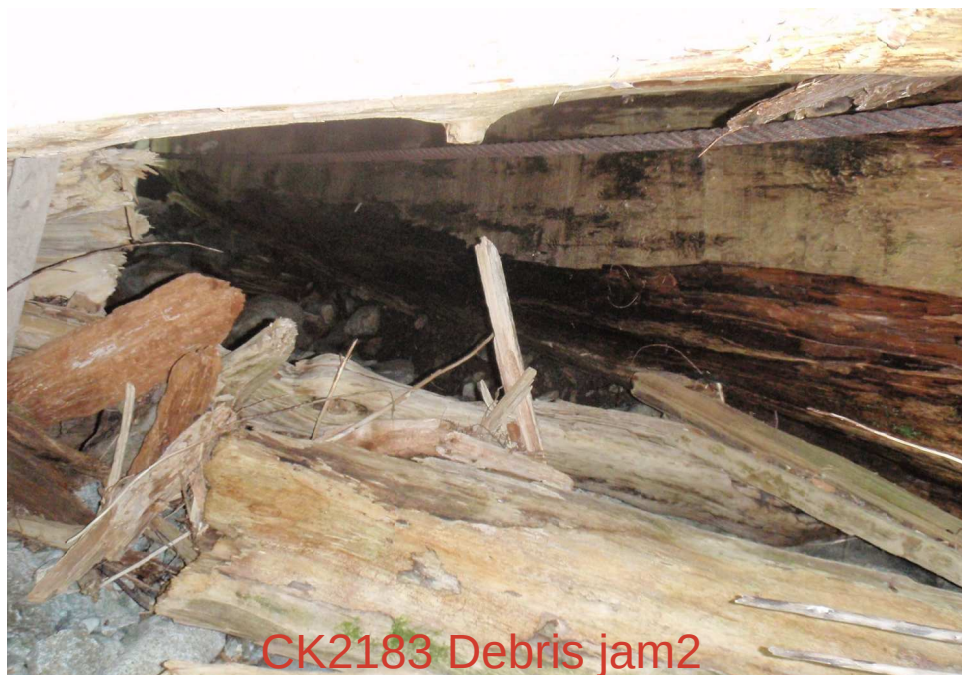
CK2183 Debris jam2

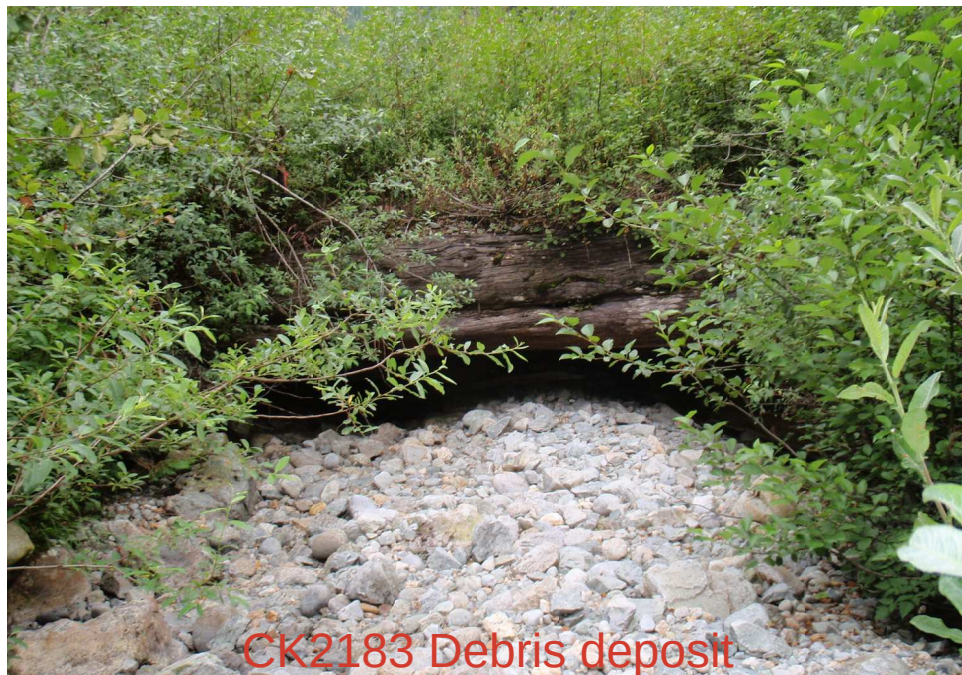
CK2183 Debris deposit

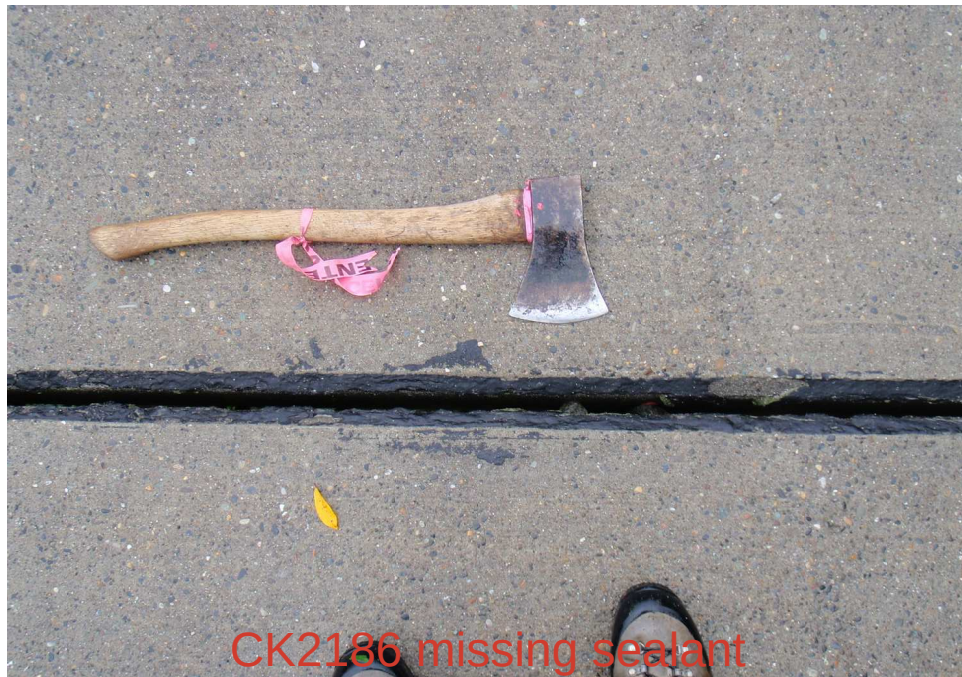
| GENERAL INFORMATION | | | |
|---|---|---|---|
| | LEFT ABUT. | | MISSING SEALANT |

CK2186 missing sealant

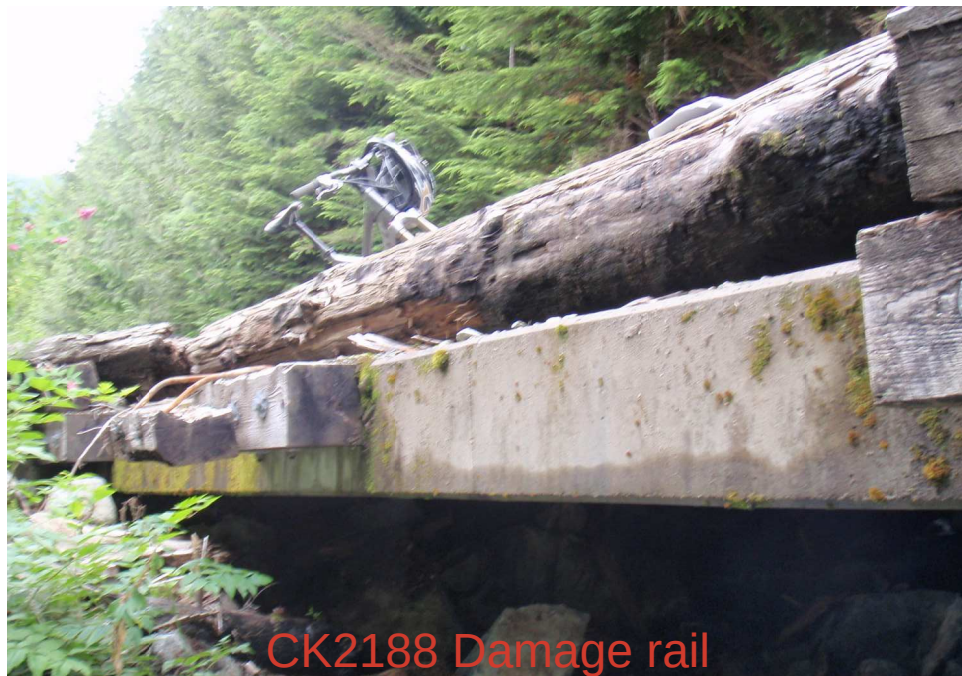
CK2188 Damage rail

Recommended that curbs be repaired/replaced.

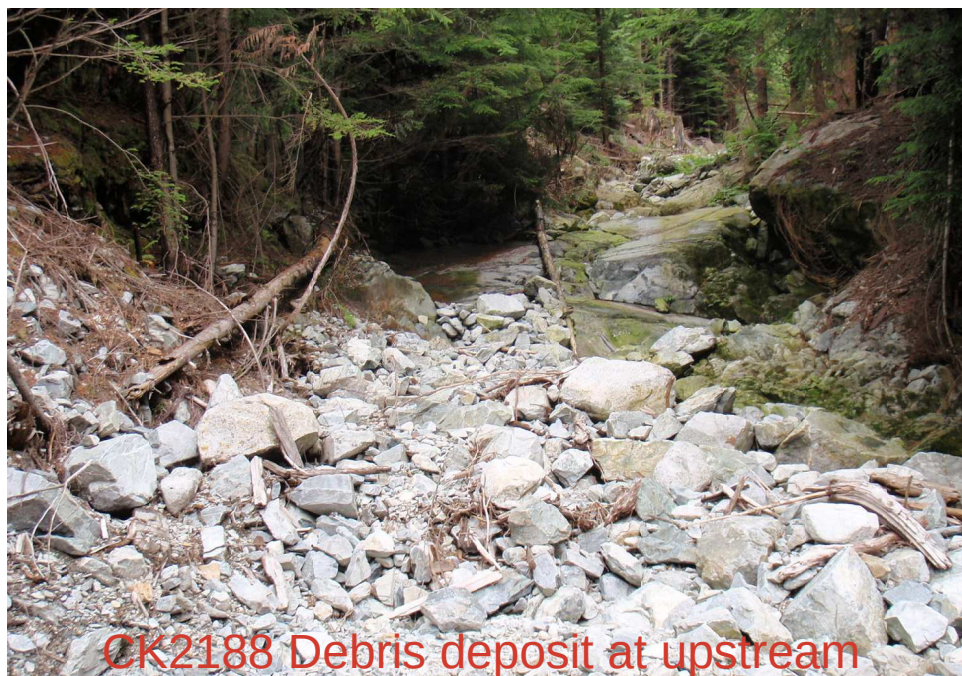
CK2188 Debris deposit at upstream

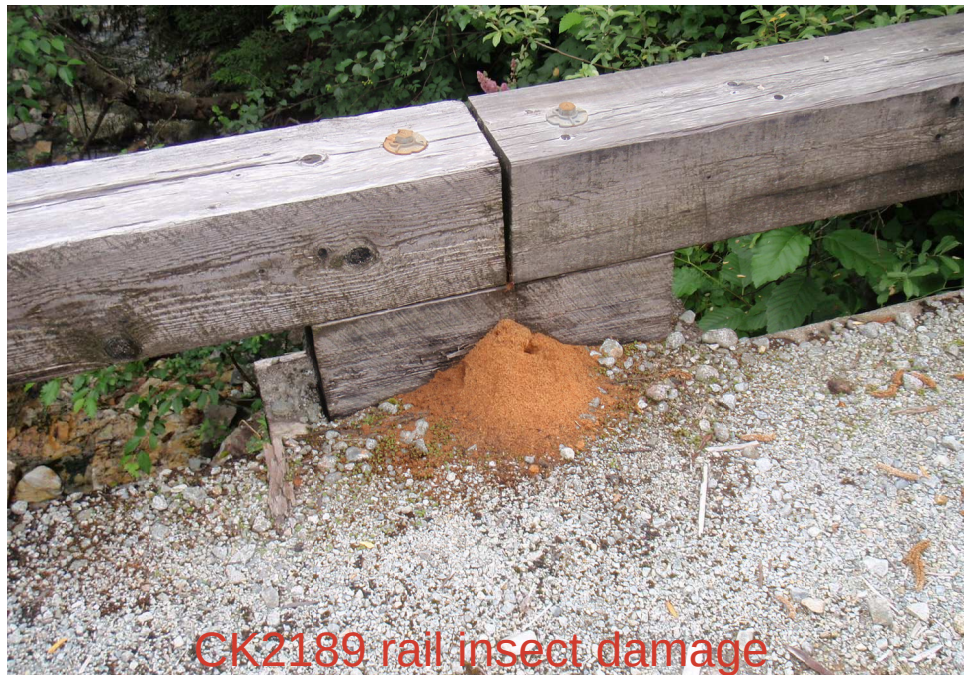
| GENERAL INFORMATION | | | |
|---|---|---|---|
| | <u>FROM UP STREAM</u> | | <u>DAMAGED RAIL X3</u> |

CK2189 rail insect damage

| GENERAL INFORMATION | | | |
|---|---|---|---|
| 1 | H M <u>(L)</u> | | REPLACE ROTTEN RAILS. |

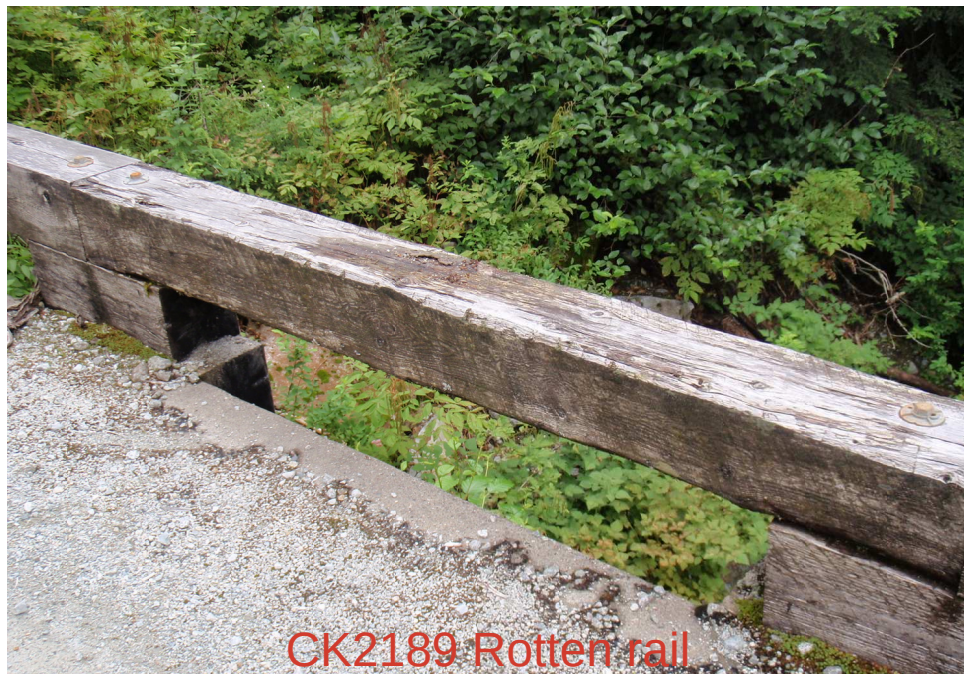
CK2189 Rotten rail

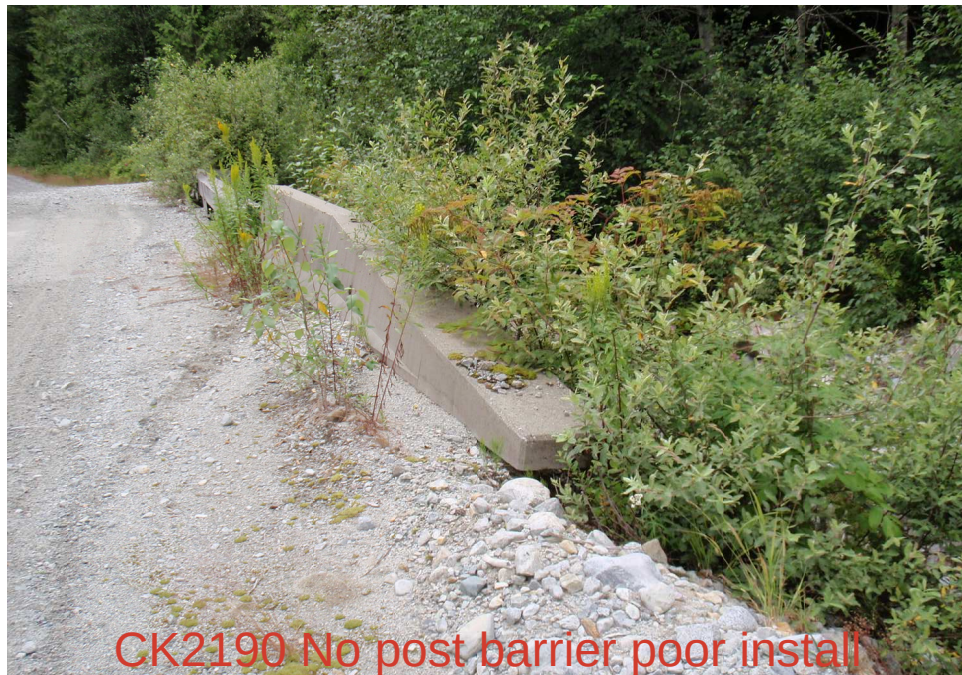
| Item | Present Condition (circle or fill-in) | Comments (a comment is mandatory if condition "Poor" is selected) |
|---|---|---|
| Fender Condition | E G F (P) None | LEFT APPROACH EITHER INSTALLED POORLY OR SLID DOWN STEEP FULL SLOPE. |

CK2190 No post barrier poor install

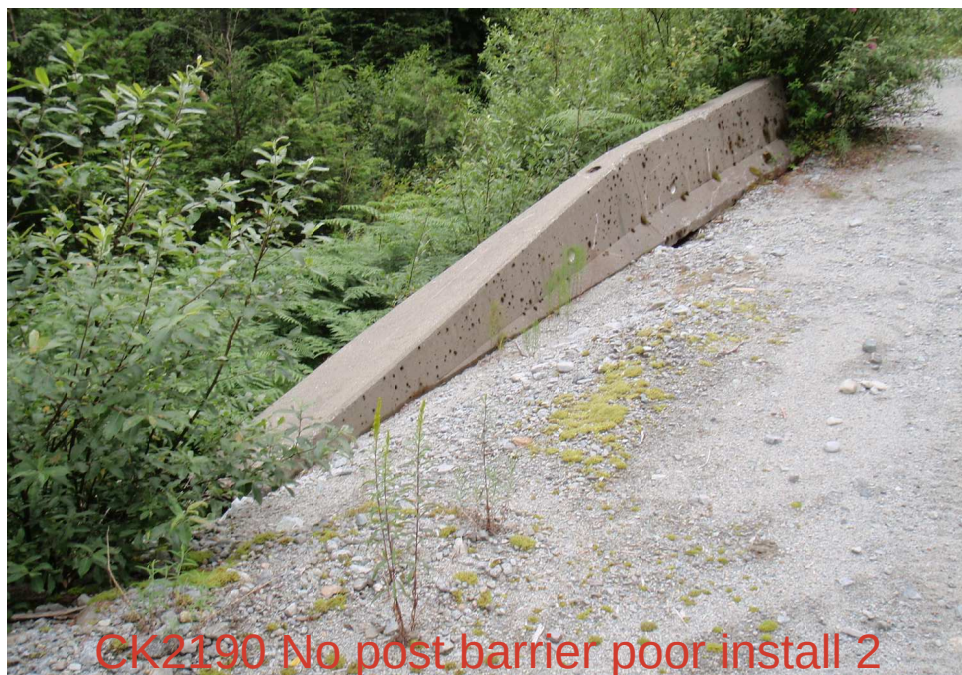
CK2190 No post barrier poor install 2

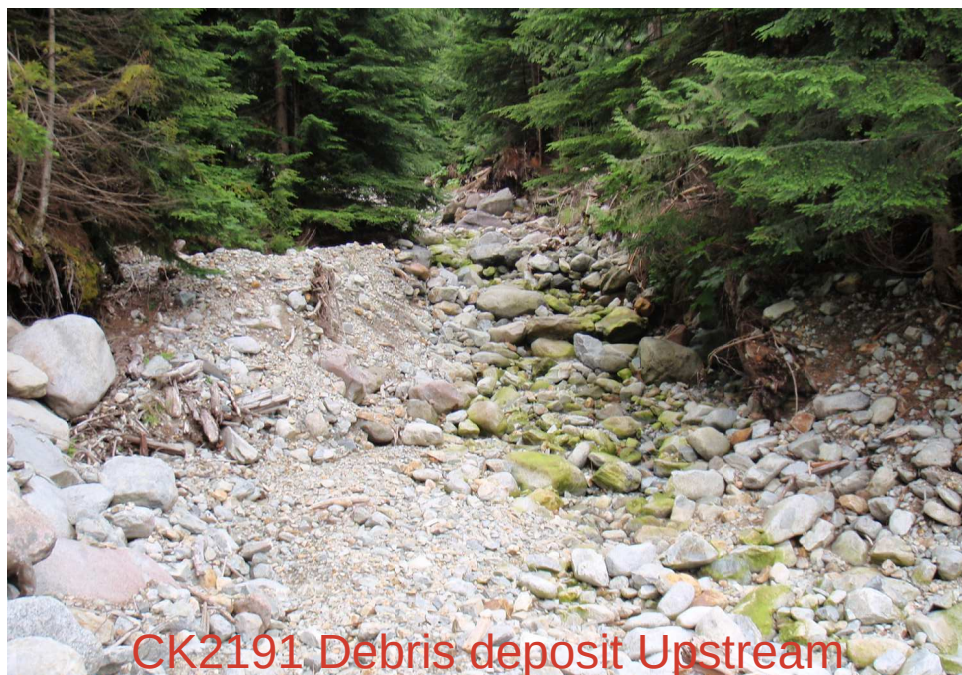
CK2191 Debris deposit Upstream

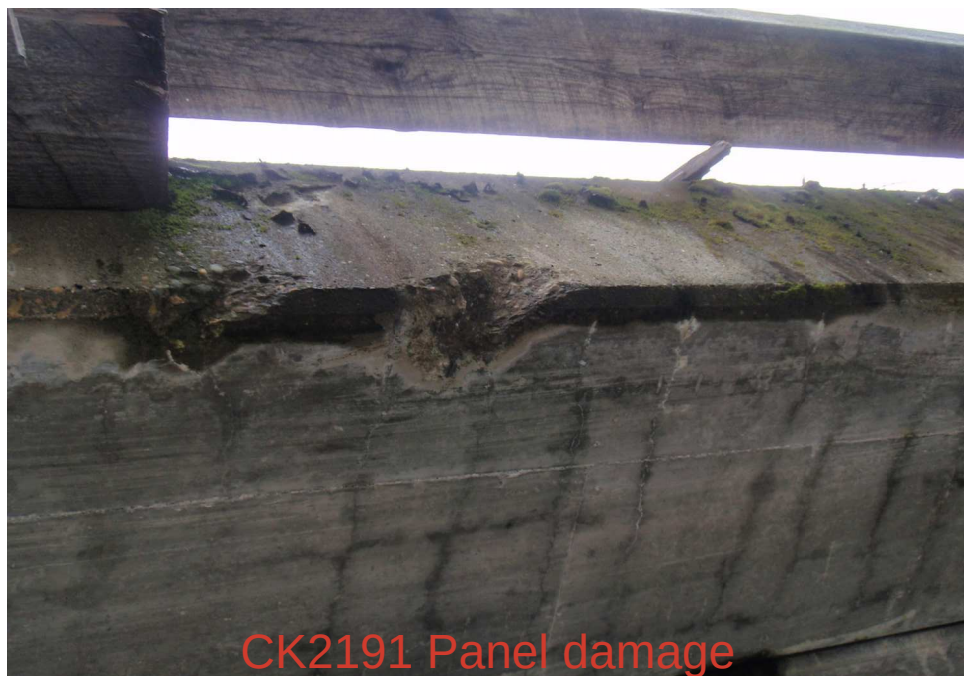
FROM DIS  
SPEC  
PANEL DAMAGE  
X2

CK2191 Panel damage
