## Corporate Bridge Register (CBR) Structure Inventory Data Form "BRIDGES"

| *Structure # <u>CK-2254</u> | *Site #: <u>CK-2254</u> |
| *Forest Service Road: <u>SQUEAH</u> | Kilometres: <u>6.1</u> |

**Routine Condition Bridge Inspection Form**  
(except for log stringer or timber stringer bridges)

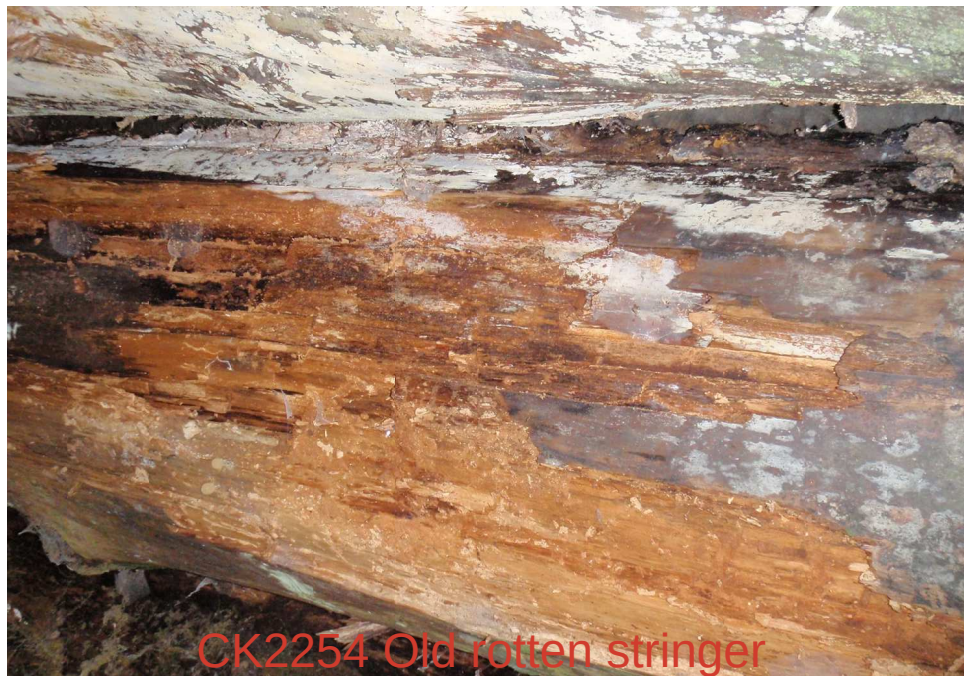
| GENERAL INFORMATION | | | | (enter either long/lat or UTM below – not both) | | | |
|---|---|---|---|---|--|--|--|
| Log/Timber Crib | E G F <u>(P)</u> N/A UR | OLD 2x ROTTEN CRIB BEING OVERSPANNED | | | | | |

CK2254 Old rotten stringer

| GENERAL INFORMATION | | | |
|---|---|---|---|
| 2 | H M <u>(L)</u> | | STRUCKERS VERY COARSE. MAY WANT THE STRUCKERS REMOVED. |
| Inspector's Comments<br>STRUCTURE SHOULD BE MONITORED ANNUALLY & IF STRUCKERS HAVE FAILED, STRUCKERS REMOVED. | | | |

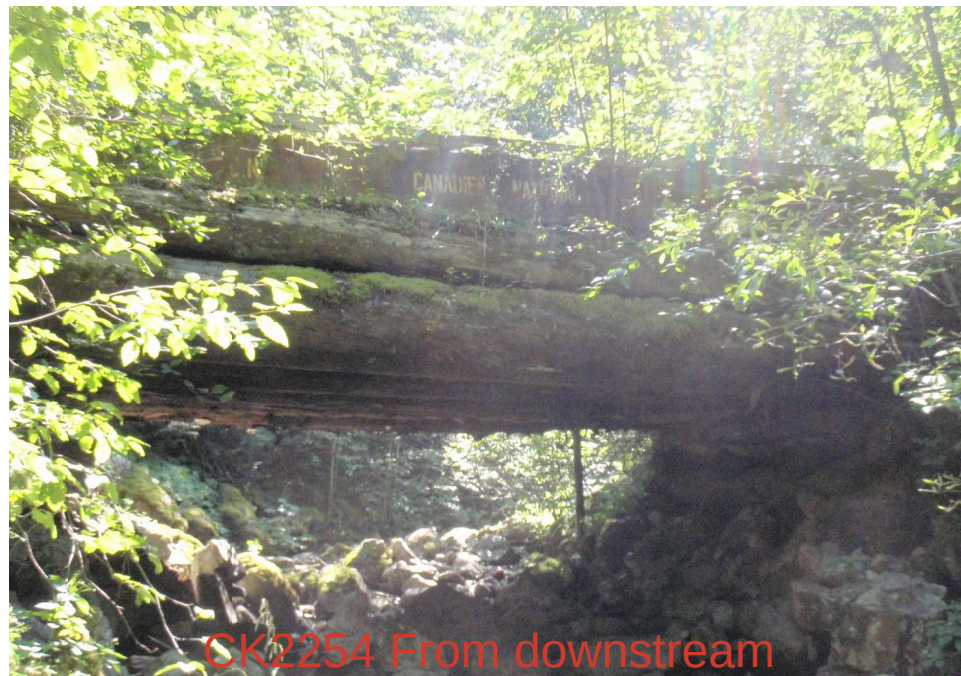
CK2254 From downstream

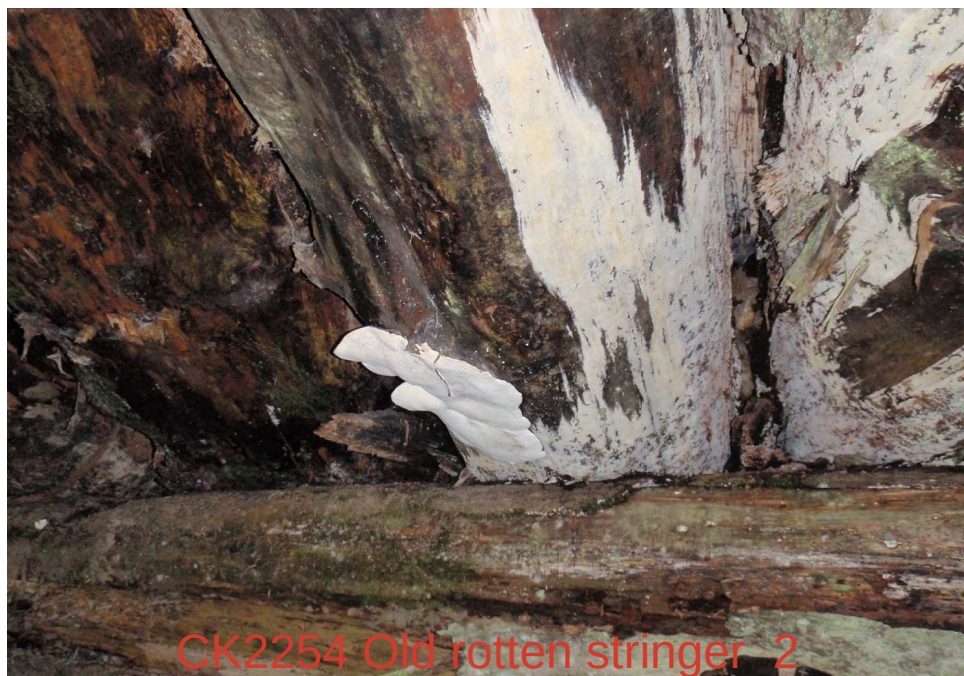
CK2254 Old rotten stringer 2

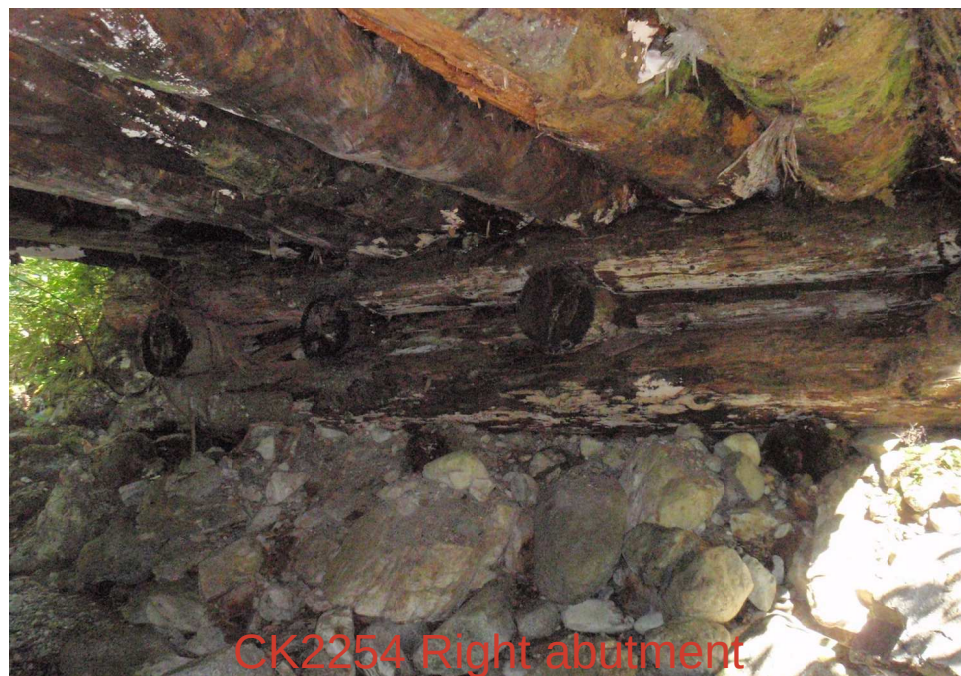
CK2254 Right abutment

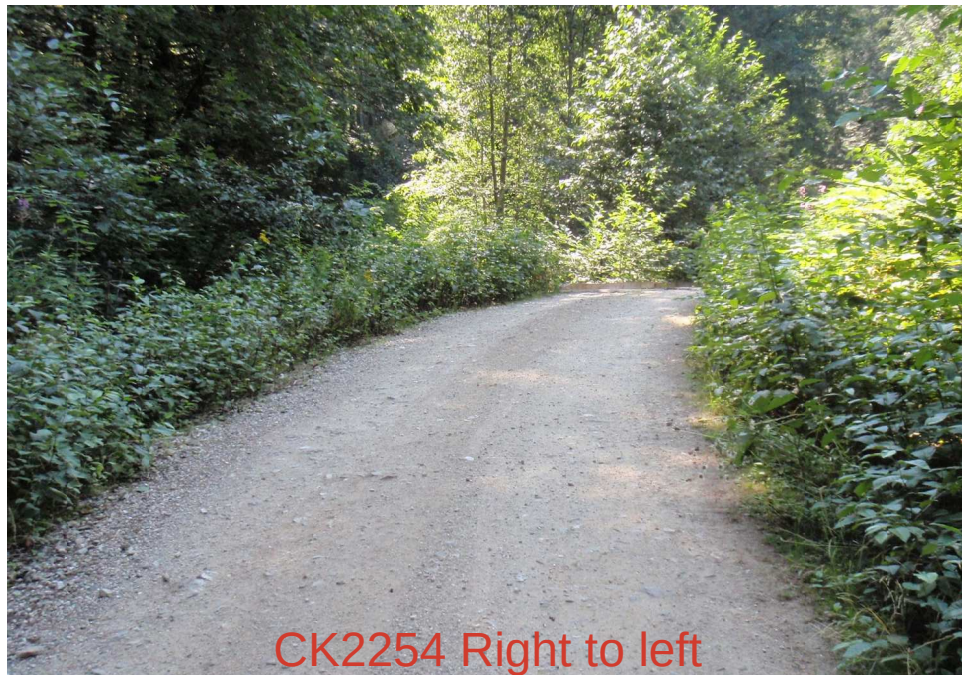
CK2254 Right to left

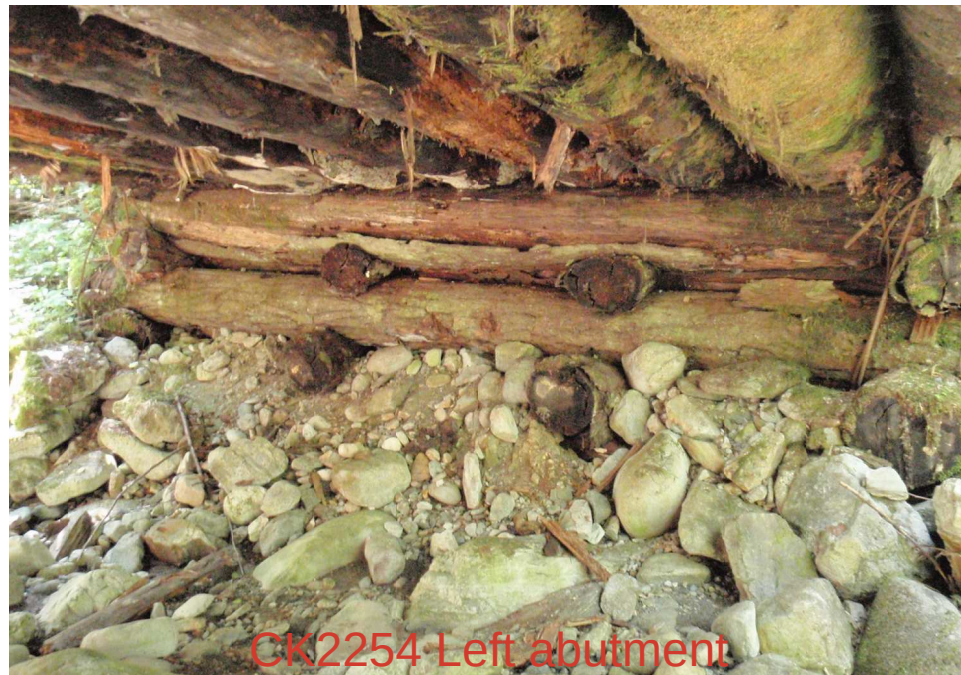
| GENERAL INFORMATION | | | | (enter either long/lat or UTM below – not both) | | | |
|---|---|---|---|---|--|--|--|
| Riprap | E G F <u>(P)</u> N/A UR | OLD CRIB HAS VERY LITTLE RIP RAP REMAINING. | | | | | |

CK2254 Left abutment

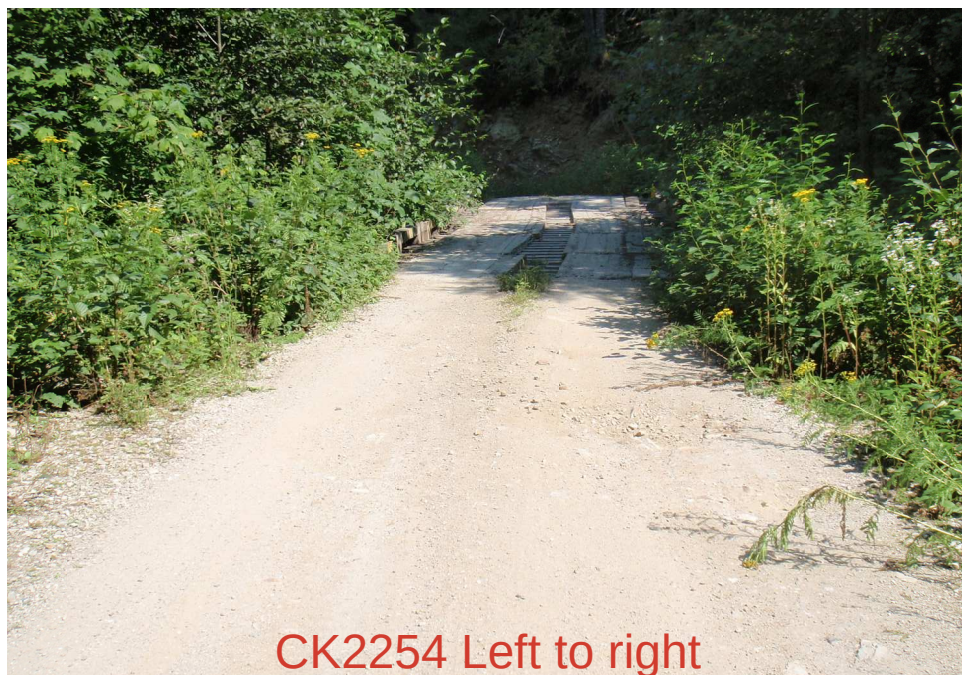
CK2254 Left to right

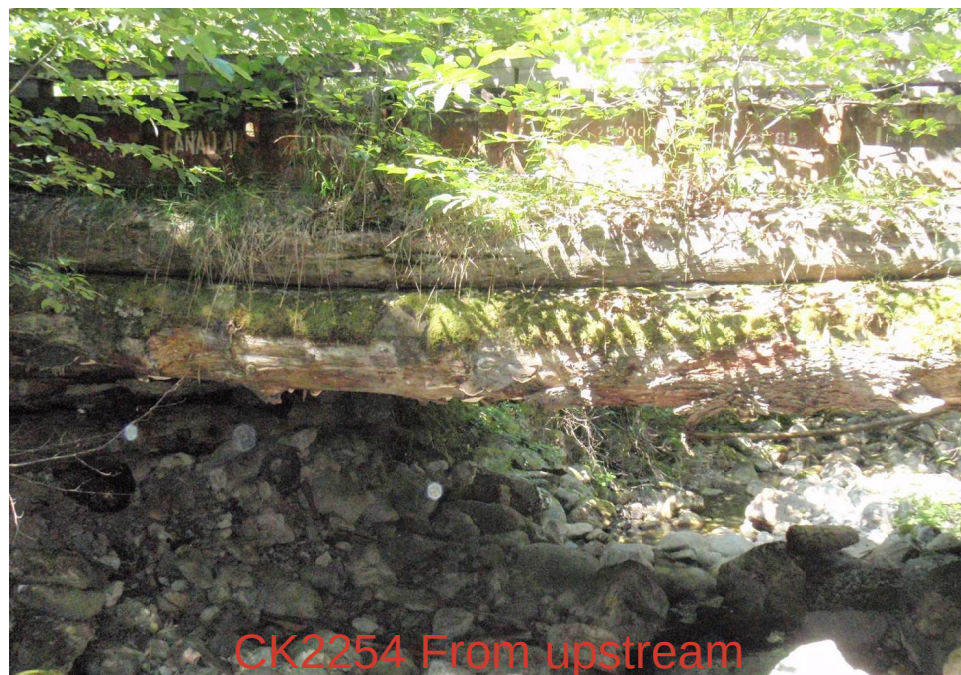
CK2254 From upstream

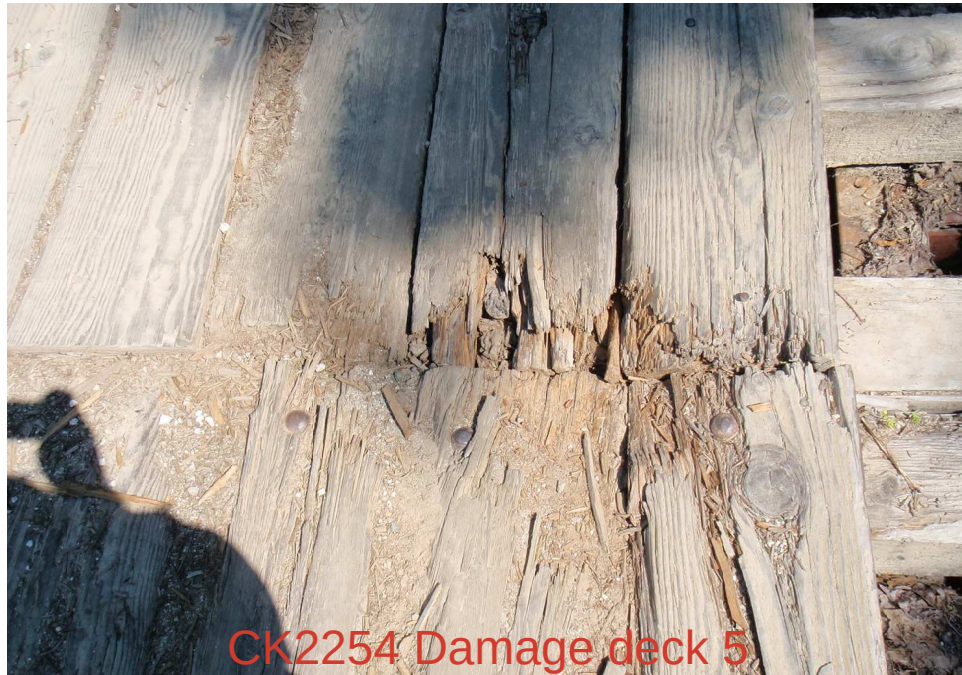
| GENERAL INFORMATION | | | | (enter either long/lat or UTM below – not both) | | | |
|---|---|---|---|---|--|--|--|
| Running Planks | E G <u>(F)</u> P N/A UR | SOME ROTTEN & BADLY DAMAGED. | | | | | |

CK2254 Damage deck 5

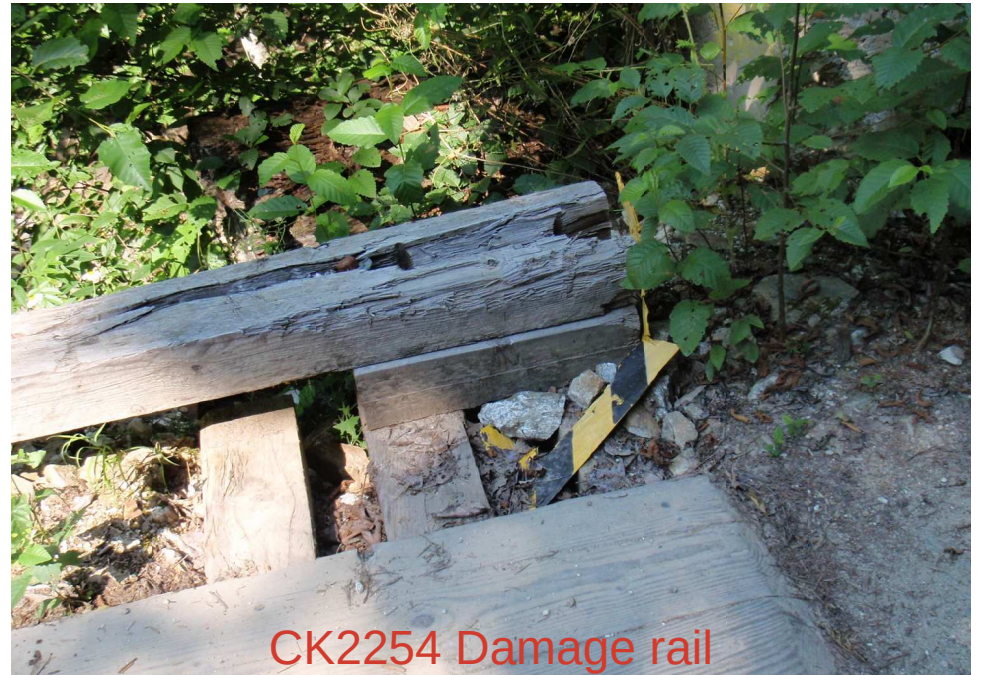
| GENERAL INFORMATION | | | | (enter either long/lat or UTM below – not both) | | | |
|---|---|---|---|---|--|--|--|
| Curb Rail/Blocks/Posts | E G F <u>(P)</u> UR | DAMAGED FROM MECHANICAL IMPACT. | | | | | |

CK2254 Damage rail

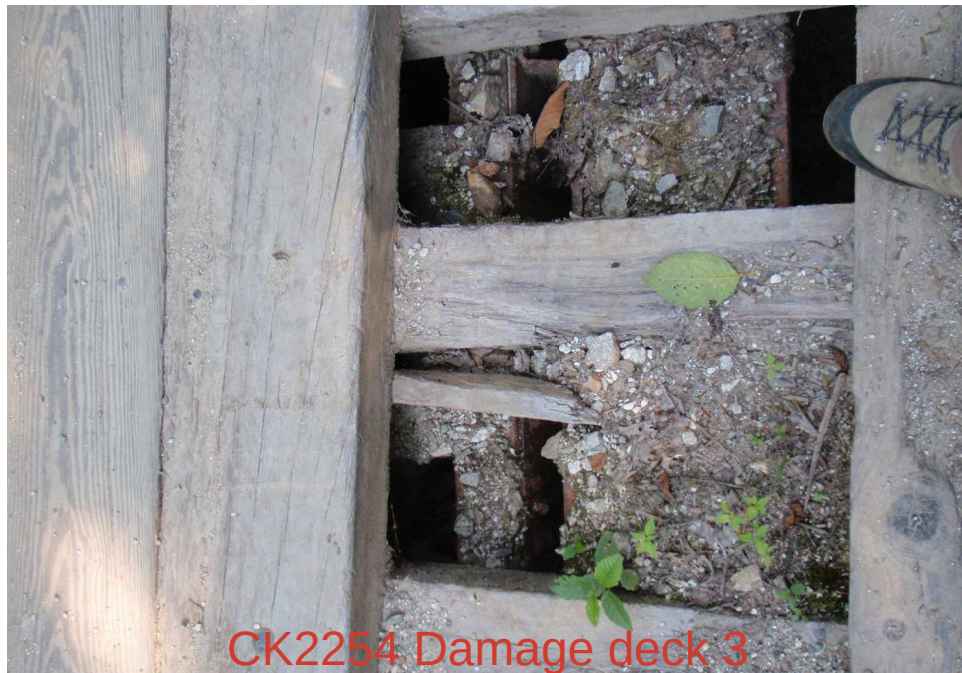
CK2254 Damage deck 3

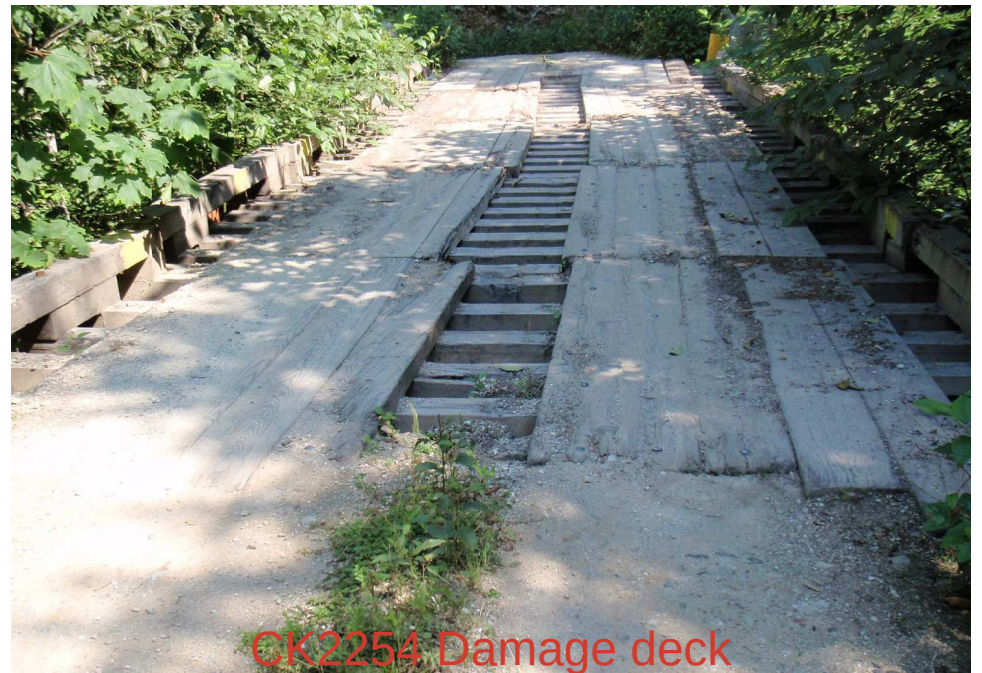
CK2254 Damage deck
