| <b>Corporate Bridge Register (CBR)</b><br><b>Structure Inventory Data Form "BRIDGES"</b> | |

**Routine Condition Bridge Inspection Form**  
(for log stringer or timber stringer bridges)

| GENERAL INFORMATION | | (enter either long/lat or UTM below – not both) | | | |
|---|---|---|---|--|--|
| *Site #: CK-2256 | *Crossing Name: | *Type/Class: <input checked="" type="checkbox"/> Major Culvert<br><input type="checkbox"/> Woodbox/Log Culvert | *Project File ID# 6092 | | |
| *FSR Name: SQUEAH | *Forest District: ChilliWack | *Kilometres: 11 | User km: 11.8 | | |

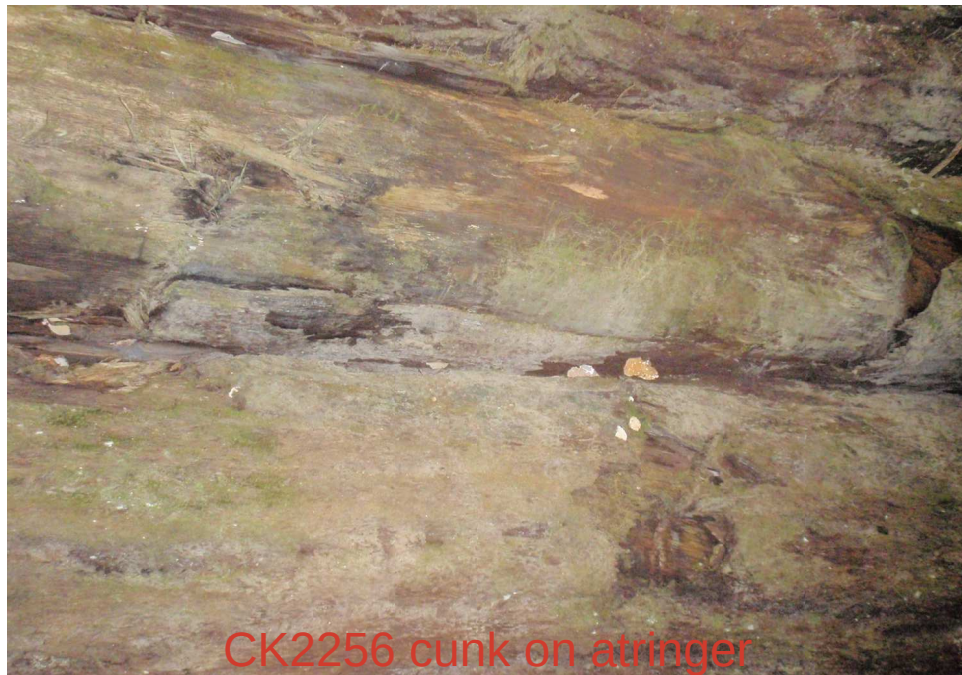
SAFELY BE  
ACCESSED. BOTH  
STRINGERS HAVE  
FRUITFUL BODY.

CK2256 cunk on atringer

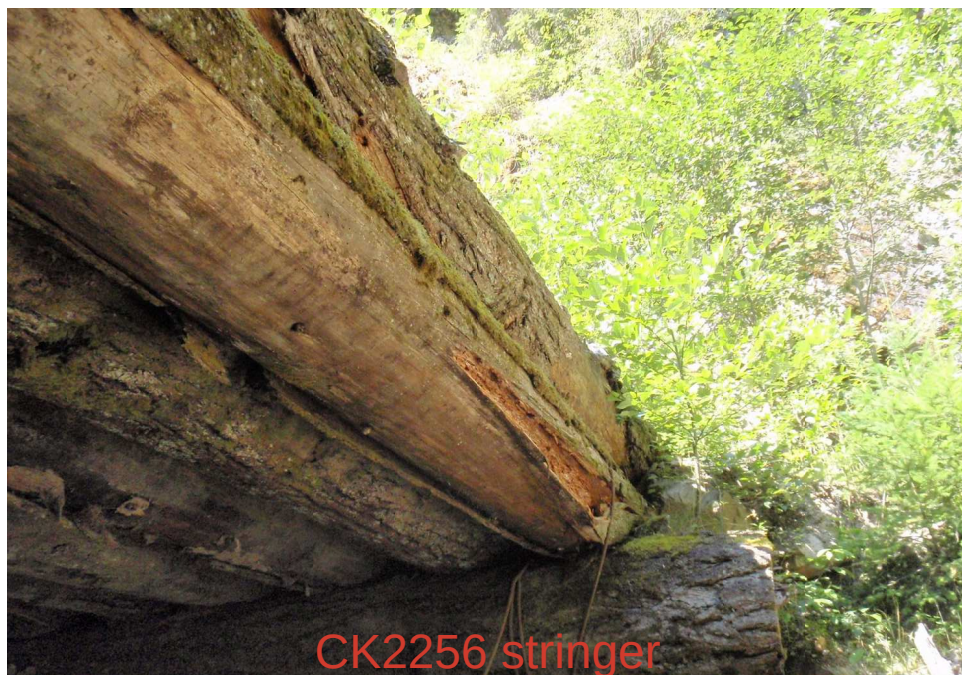
| GENERAL INFORMATION | | | | | | | |
|---|---|---|---|---|---|---|---|
| 10 | | Y N | 83 | | | | <u>ROTTEN</u> |

CK2256 stringer

| GENERAL INFORMATION | | | | | | | |
|---|---|---|---|---|---|---|---|
| P Eng Reviewer's Comments <u>Load rated for 5 tonnes. Please post. Plan to replace entire bridge due to extensive rot.</u> | | | | | | | |

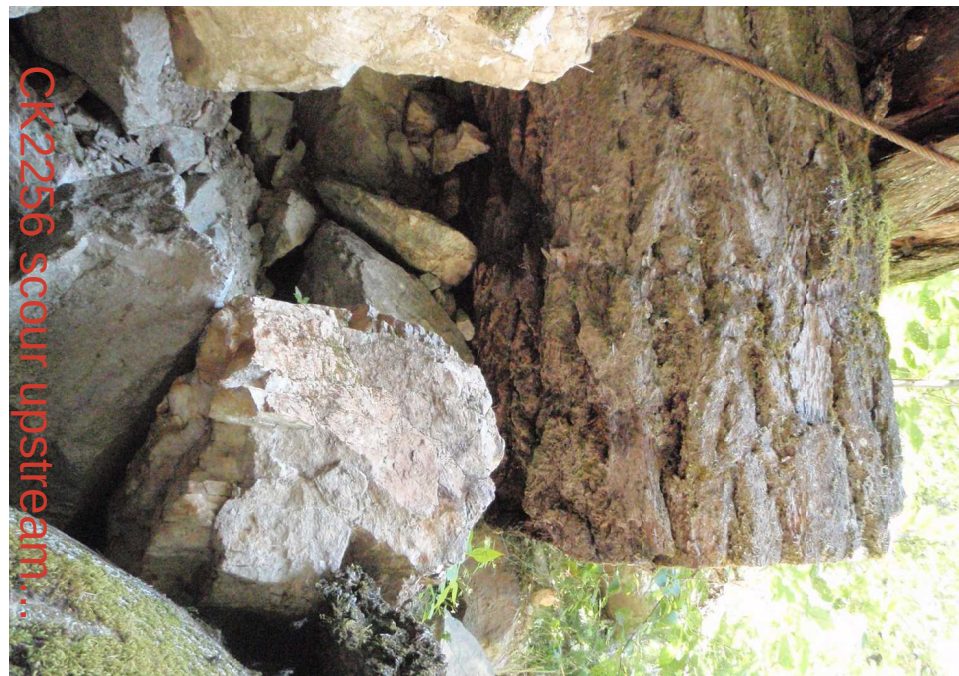
| GENERAL INFORMATION | | (enter either long/lat or UTM below – not both) | | | |
|---|---|---|---|--|--|
| Caps or Sills | E G <u>F</u> P N/A UR | UPSTREAM RIGHT ABUT. SCURED HEAVILY, DUE TO CACK OF RIP RAP. | | | |

| GENERAL INFORMATION | | | | | | | |
|---|---|---|---|---|---|---|---|
| Comments <u>MONITOR UPSTREAM CORNER, RIGHT ABUT. SCOUR.</u> | | | | | | | |

CK2256 scour upstream...

| GENERAL INFORMATION | | | | | | | |
|---|---|---|---|---|---|---|---|
| 1 | <u>RIGHT ABUT, UPSTREAM SCOUR, below SILL LOG.</u> | | | | | | |

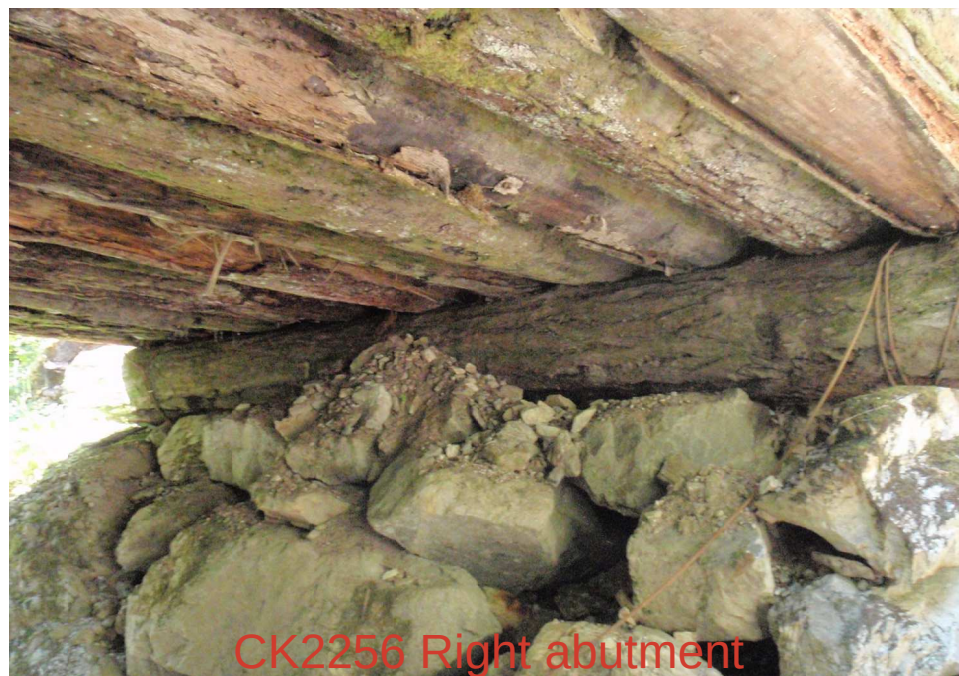
CK2256 Right abutment
