| | | Corporate Bridge Register (CBR)<br><b>Structure Inventory Data Form "BRIDGES"</b> | | Page 1 of 2 |
| *Forest Service Road: STAVE RIVER | | Kilometres: 8.5 | | |
| *Project File ID#: 8013 | | *Br. 01 | | |

# Routine Condition Bridge Inspection Form

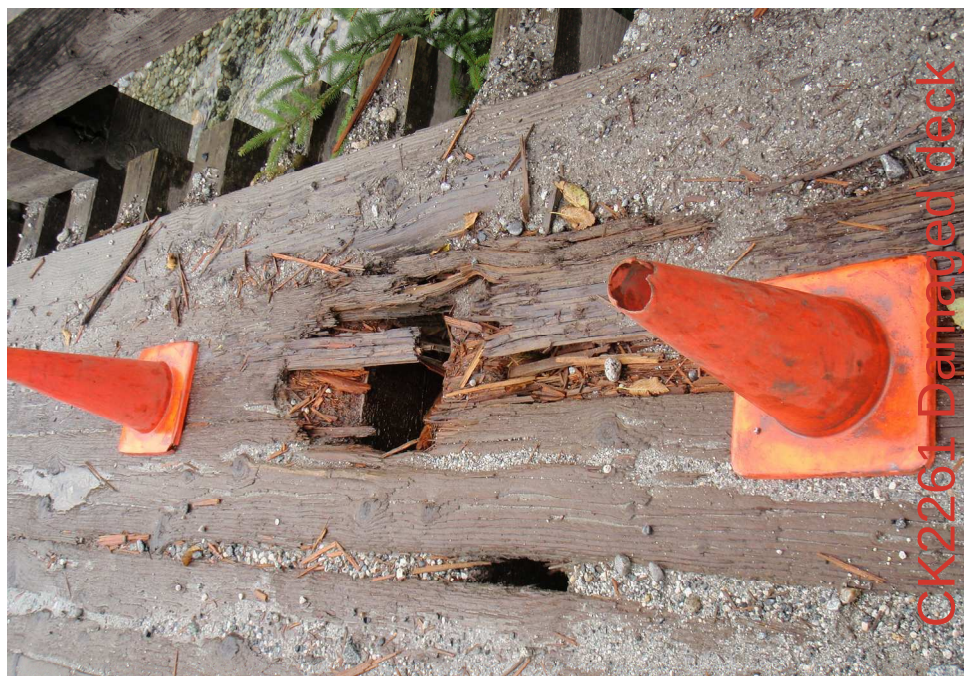
| Item | Present Condition<br>(circle) | Comments<br>(a comment is mandatory if condition "Poor" is selected) |
|---|---|---|
| Running Planks | E G <u>(F)</u> P N/A UR | <u>SOME PLANKS REQUIRE REPLACING</u> |
| Curb Rail/Blocks/Posts | E G <u>(F)</u> P UR | <u>SOME SECTIONS ROTTEN</u> |

CK2261 Damaged deck

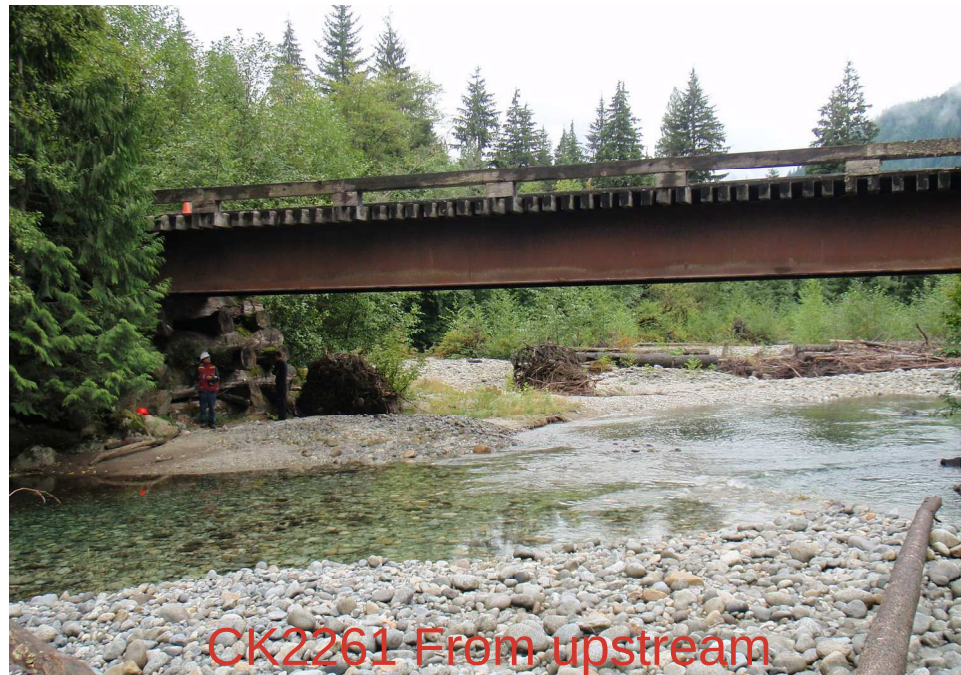
CK2261 From upstream

| GENERAL INFORMATION: | | | | | | |
|---|---|---|---|---|---|---|
| WOOD DEBRIS PILING ABOVE INLET. | | | | | | |

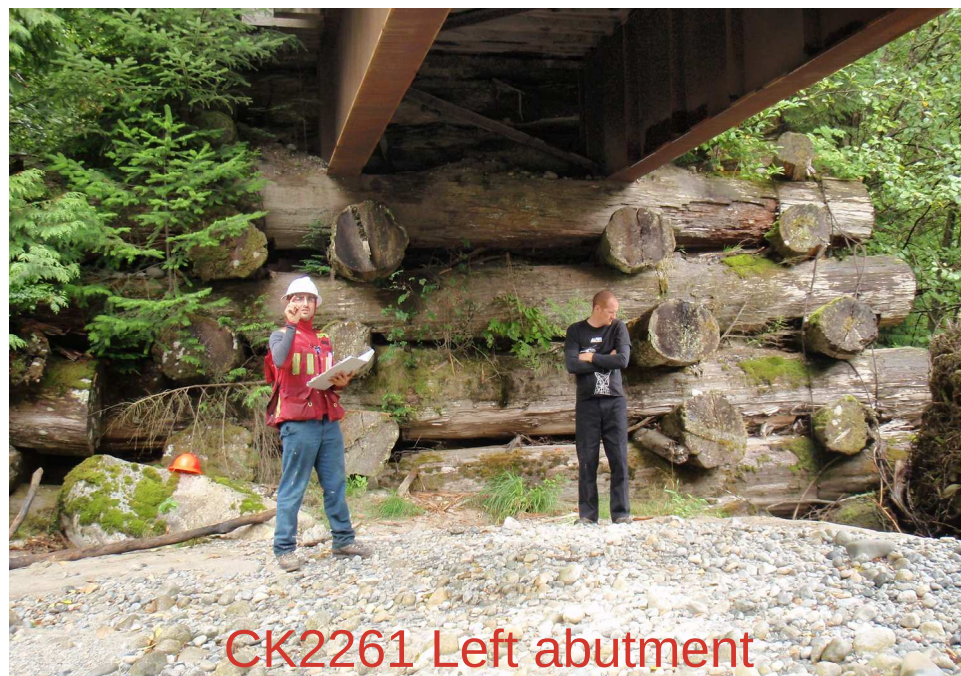
CK2261 Left abutment

| Item | Present Condition<br>(circle) | Comments<br>(a comment is mandatory if condition "Poor" is selected) |
|---|---|---|
| Log/Timber Cribbs | E G <u>(E)</u> P N/A UR | <u>4 X CLOSED FIRED LOG CRIBS ON</u> |
| Hardware | E G <u>(F)</u> P N/A UR | <u>LASHED AT CORNERS</u> |

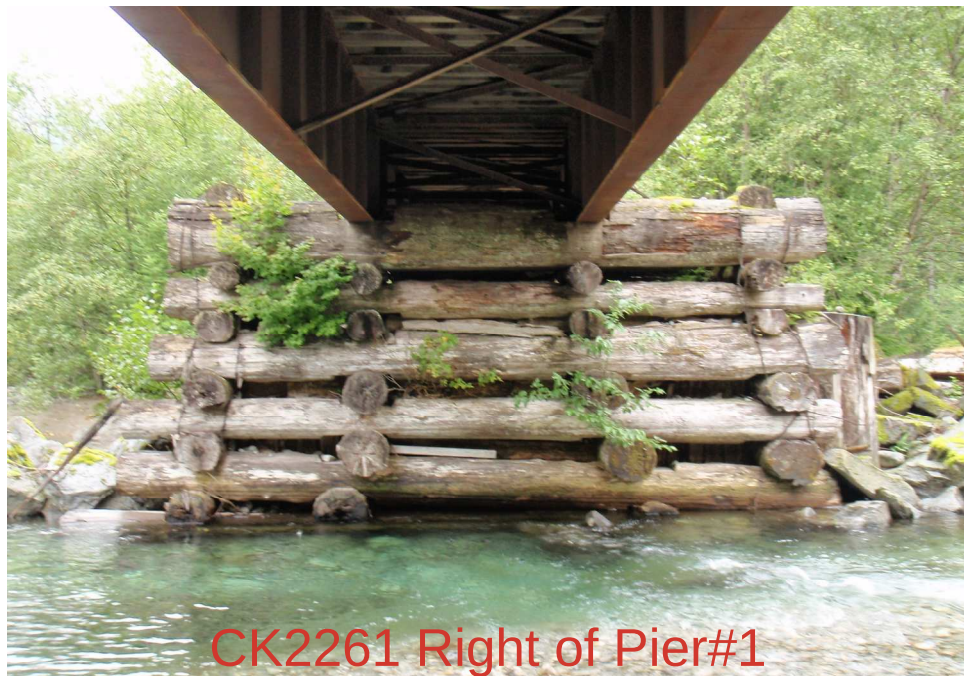
CK2261 Right of Pier#1

| Cribs | E G <u>F</u> P N/A UR | <u>5 X CRIB. OPEN FACE</u> |

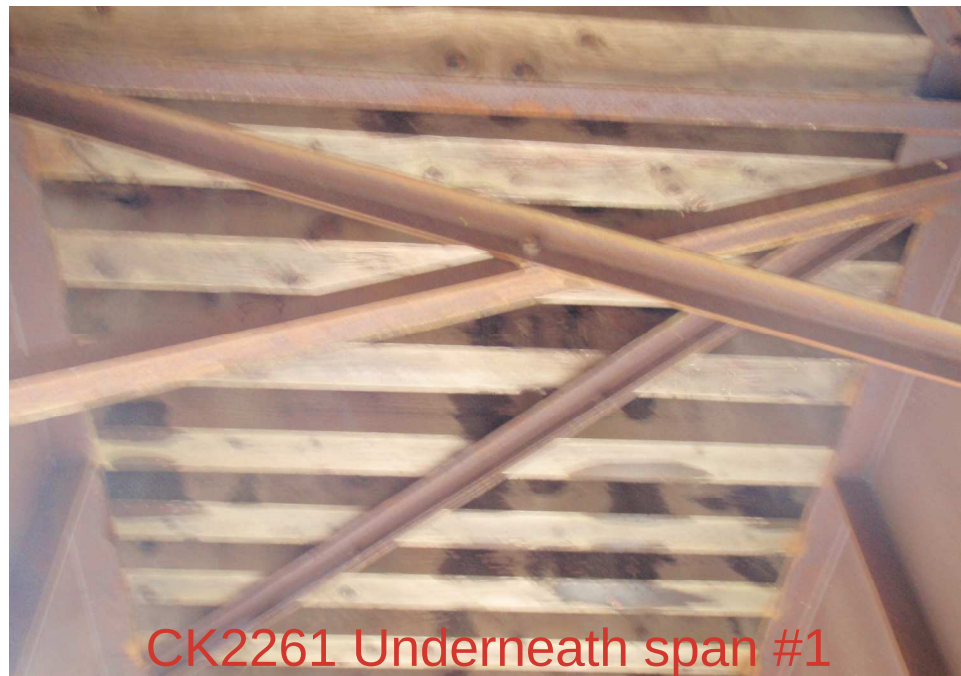
CK2261 Underneath span #1

| GENERAL INFORMATION: | | | | | | |
|---|---|---|---|---|---|---|
| Girders | E | G | F | P | UR | 2 x STEEL I-BEAM |

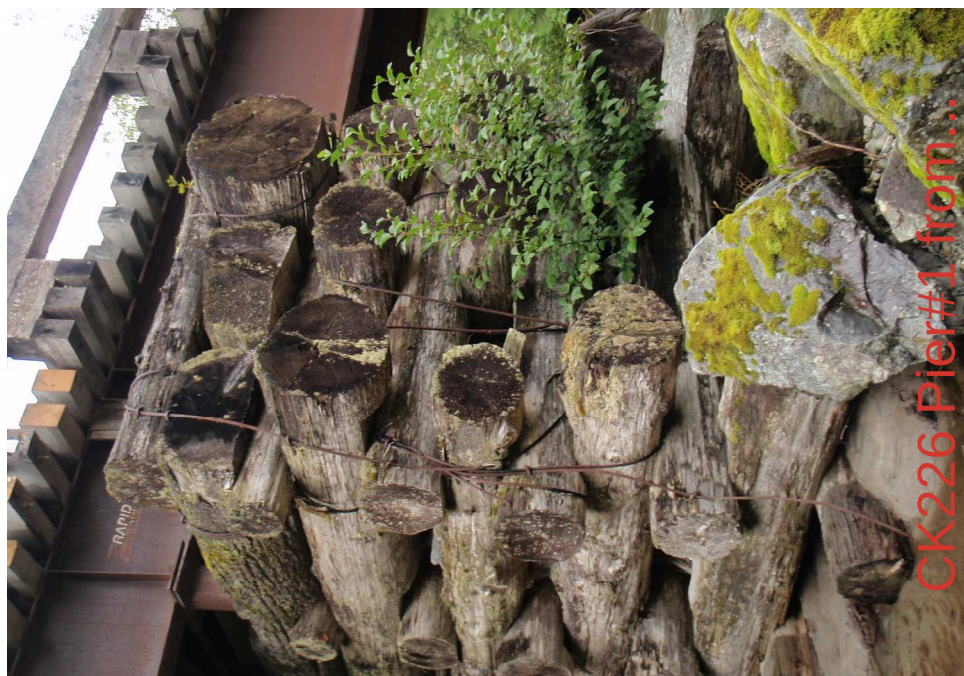
CK226 Pier#1 from...

| Caps | E G <u>F</u> P UR | <u>H-BEAM STEEL</u> |

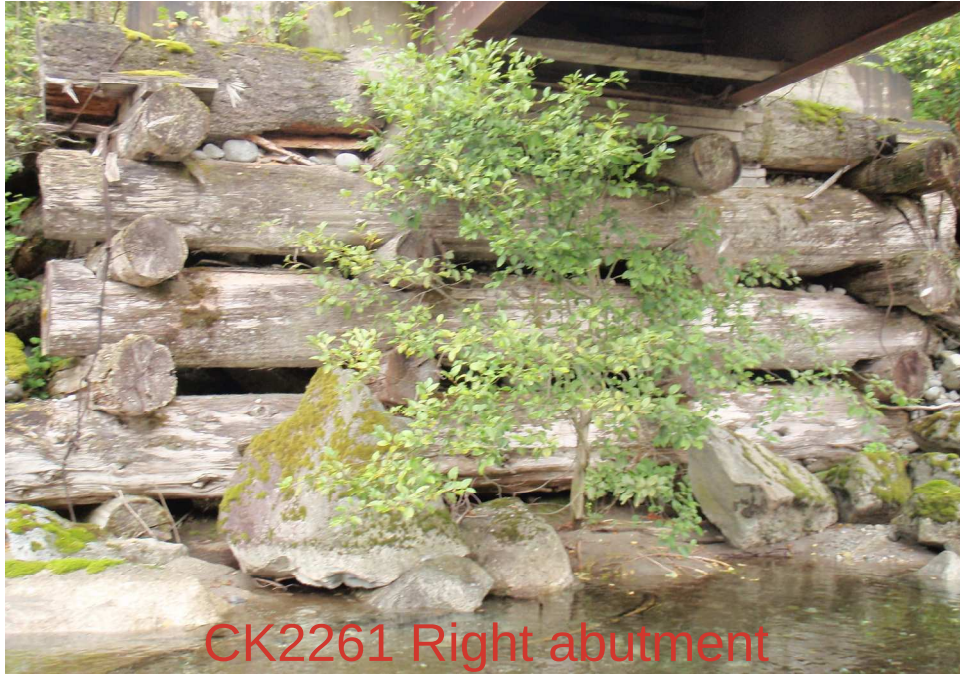
CK2261 Right abutment

| Item | Present Condition<br>(circle) | Comments<br>(a comment is mandatory if condition "Poor" is selected) |
|---|---|---|
| Tie-backs | E G <u>(F)</u> P N/A UR | <u>4 X 3 X ON RIGHT ABUT</u> |
| Riprap | E G F P <u>(N/A)</u> UR | <u>ONLY ON RIGHT CORNERS</u> |

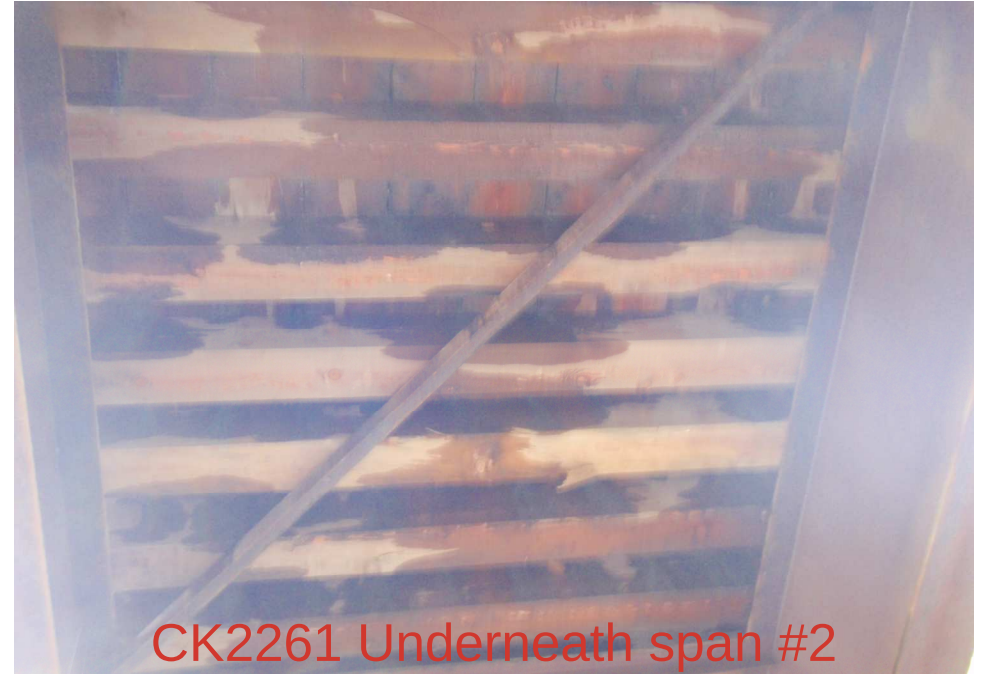
CK2261 Underneath span #2

| Girders | E G <u>F</u> P UR | <u>2 X STEEL I-BEAM</u> |
