## Corporate Bridge Register (CBR) Structure Inventory Data Form "BRIDGES"

| *Structure # <u>CK- 2278</u> | *Site #: |
| *Forest Service Road: <u>STAVE RIVER</u> | Kilometres: <u>8.8</u> |

**Routine Condition Bridge Inspection Form**  
(except for log stringer or timber stringer bridges)

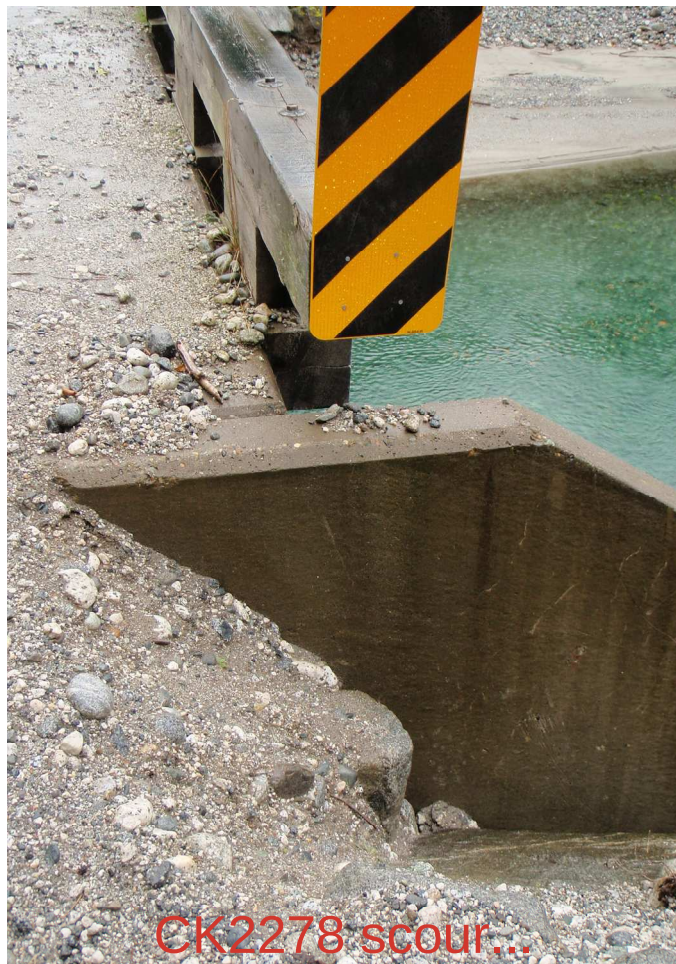
| GENERAL INFORMATION | | | | (enter either long/lat or UTM below -- not both) | | | |
|---|---|---|---|---|--|---|--|
| Piles or Posts | E G <u>(F)</u> P N/A UR | | PIPE RISERS, DOWNSTREAM RIGHT ABUT PIPE, EXPOSED AS RIP RAP IS ERODED DUE TO STREAM SPEED. | | | | |

| GENERAL INFORMATION | | | |
|---|---|---|---|
| | DOWNSTREAM EROSION | | LEFT ABUT |
| RIP RAP ON RIGHT ABUT & FILL SLOPE IS ERODING. | | | |

CK2278 scour...

| GENERAL INFORMATION | | | |
|---|---|---|---|
| 2 | <u>H</u> M L | | BARK FILL DOWNSTREAM FILL SLOPE |
| Repair fill slope failure asap. Also attend to adding riprap to exposed post on pads. | | | |

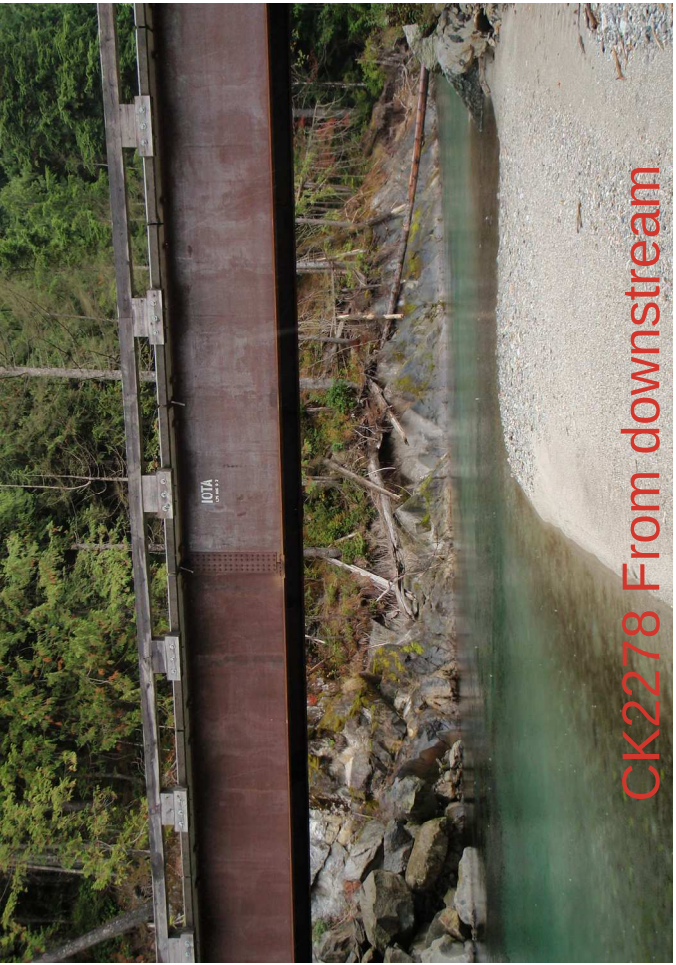
CK22278 From downstream

| GENERAL INFORMATION | | | | (enter either long/lat or UTM below -- not both) | | | |
|---|---|---|---|---|--|---|--|
| Fender Condition | E G <u>(F)</u> P None UR | | DOWN STREAM, RIGHT ABUT NO POST BARRIER NO LONGER IN PLACE DUE TO FILL SLOPE FAILURE | | | | |

| GENERAL INFORMATION | | | |
|---|---|---|---|
| 1 | <u>H</u> M L | | REINSTALL DOWNSTREAM FENDER |

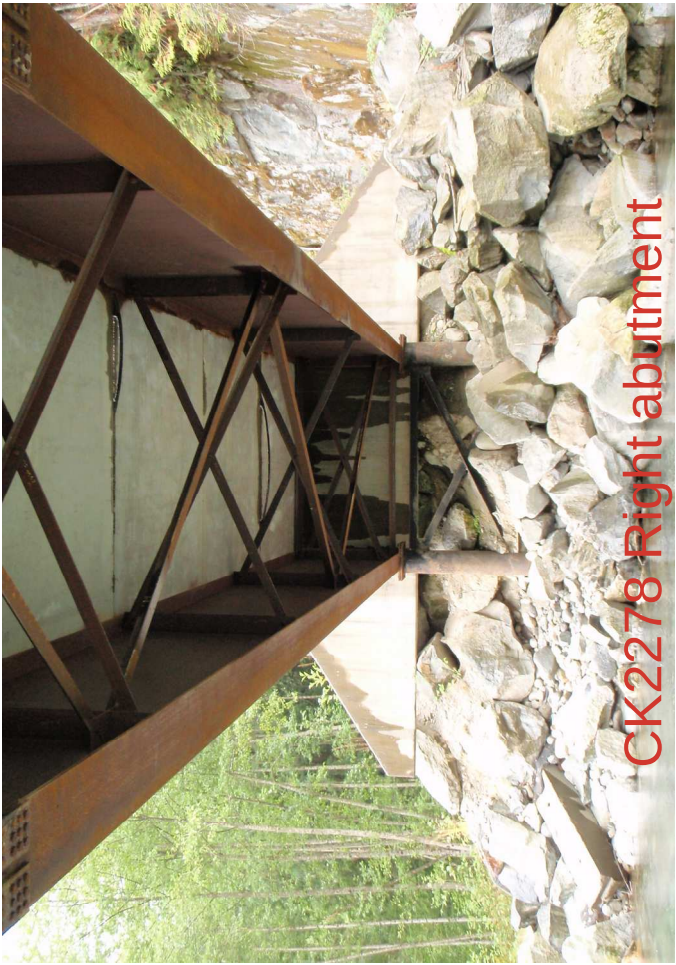
CK2278 Right abutment

| GENERAL INFORMATION | | | | (enter either long/lat or UTM below -- not both) | | | |
|---|---|---|---|---|--|---|--|
| Riprap | E G <u>(F)</u> P N/A UR | | RIP RAP ON RIGHT ABUT ERODING. | | | | |

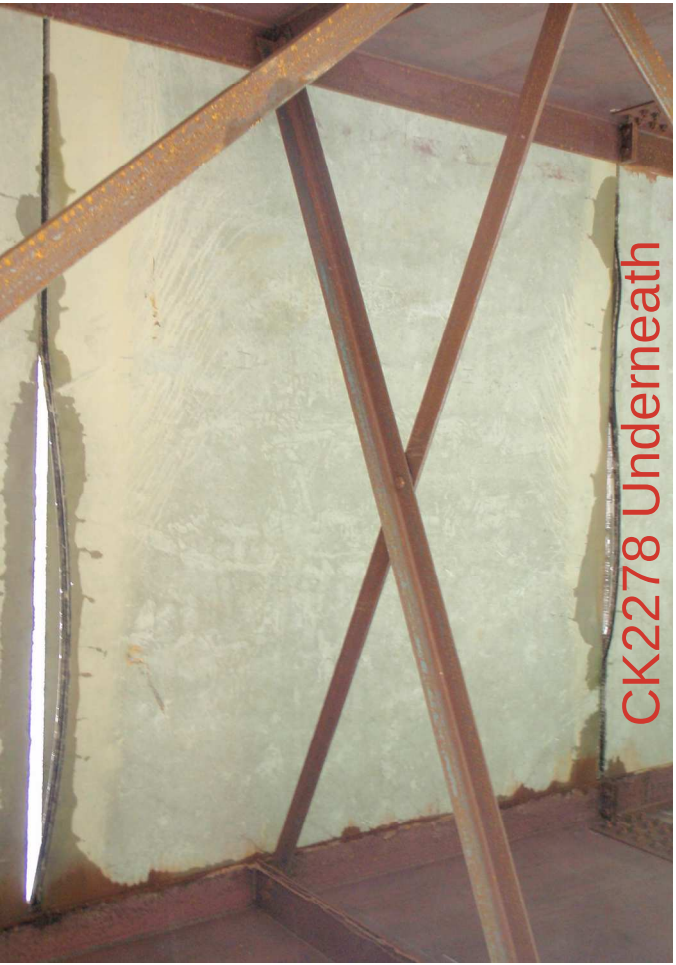
CK2278 Underneath

| GENERAL INFORMATION | | | |
|---|---|---|---|
| Girders | E G <u>F</u> P UR | 2 x STEEL - BEAM L-75 | |
