# Corporate Bridge Register (CBR) Structure Inventory Data Form "BRIDGES"

| *Structure # | *Site #: CK-2286 |
| *Forest Service Road: TSILEWIT CRK | Kilometres: 17.7 |

**Routine Condition Bridge Inspection Form**  
(except for log stringer or timber stringer bridges)

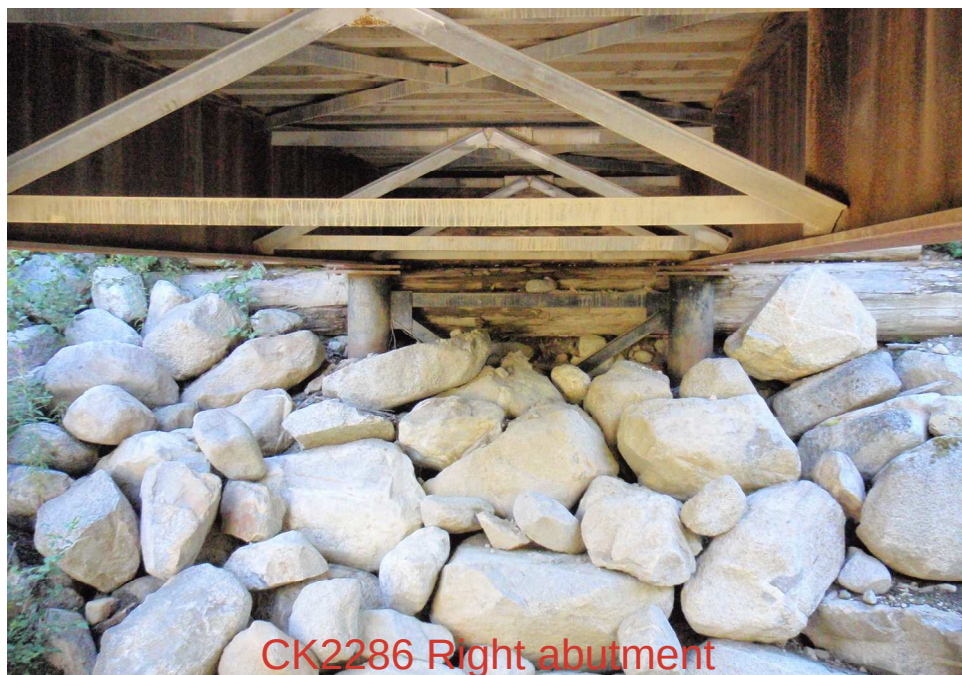
CK2286 Right abutment

| GENERAL INFORMATION | | | | (enter either long/lat or UTM below – not both) | | | |
|---|---|---|---|---|--|--|--|
| Ballast Wall | E G <u>(F)</u> P <u>(N/A)</u> UR | <u>OLD LOGS SOME ROT.</u> | | | | | |

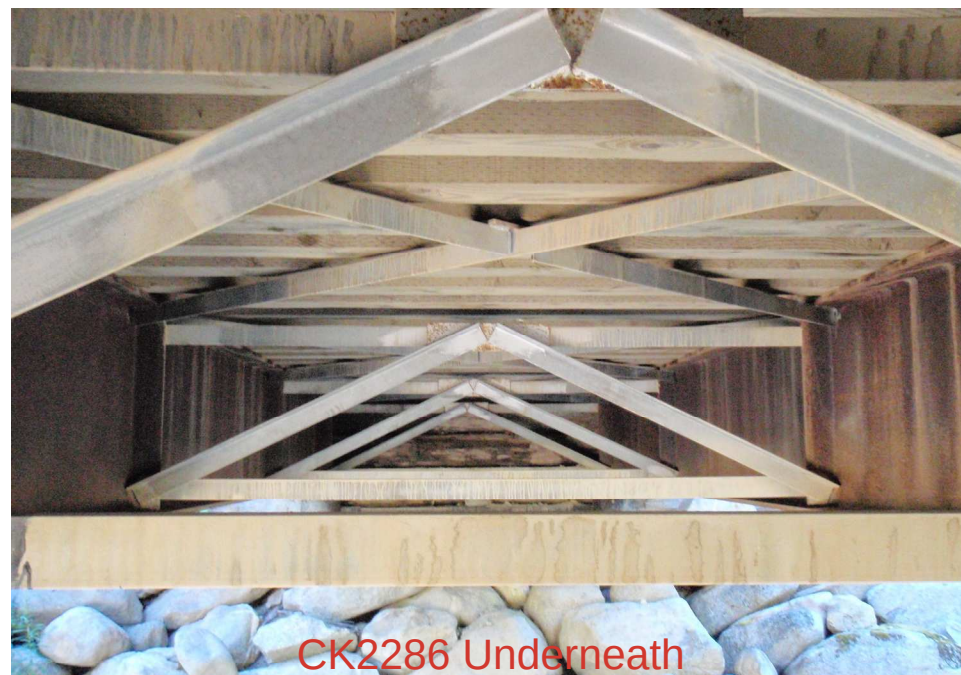
CK2286 Underneath

| GENERAL INFORMATION | | | |
|---|---|---|---|
| Girders | E (G) F P UR | 2x STEEL 1-BEAMS - WEATH STEEL | |
