# Corporate Bridge Register (CBR) Structure Inventory Data Form "BRIDGES"

**Routine Condition Bridge Inspection Form**  
(for log stringer or timber stringer bridges)

| GENERAL INFORMATION | | (enter either long/lat or UTM below - not both) | |
|---|---|---|---|
| *Site #: <u>CL-2288</u> | *Crossing Name: | *Type/Class: <input checked="" type="checkbox"/> Major Culvert<br><input type="checkbox"/> Woodbox/Log Culvert | *Project File ID# <u>7972</u> |
| *FSR Name: <u>U2TLIUS</u> | *Forest District: <u>ChilliWack</u> | *Kilometres: <u>6.4</u> | User km: |

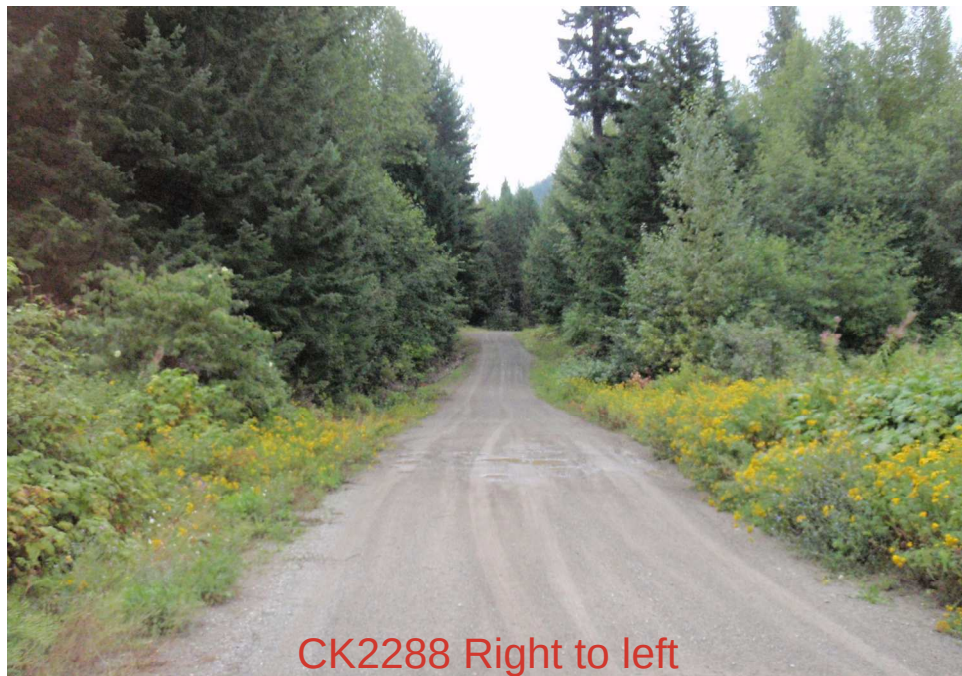
CK2288 Right to left

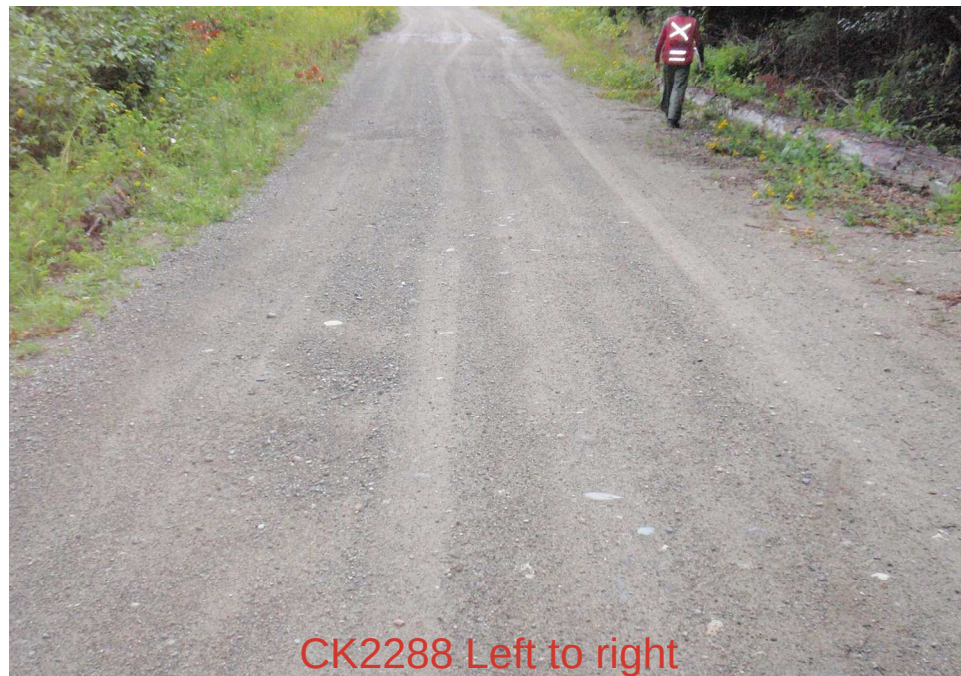
CK2288 Left to right

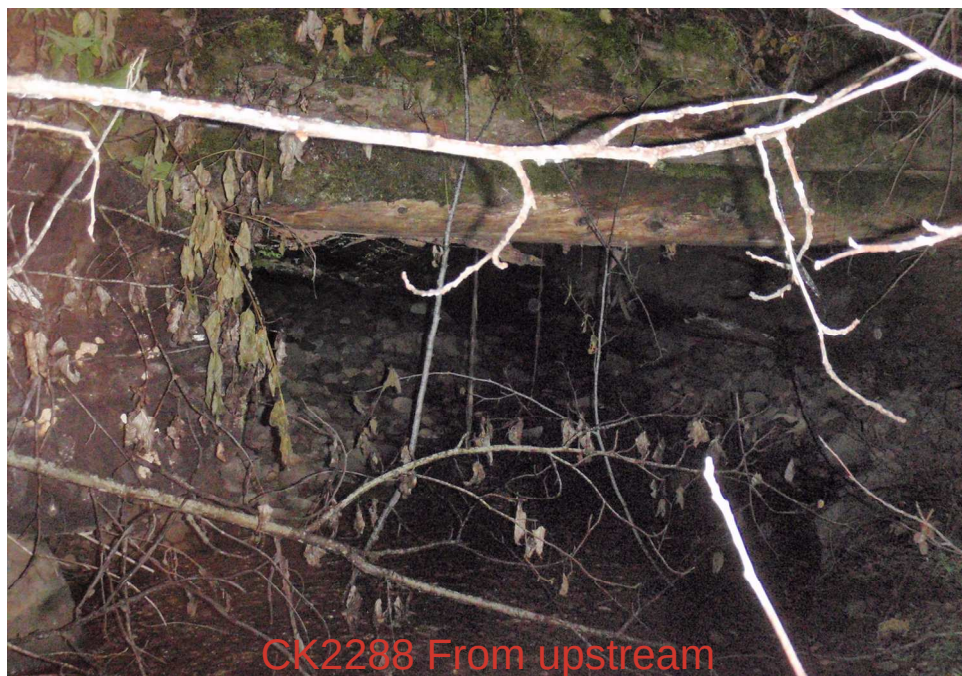
CK2288 From upstream

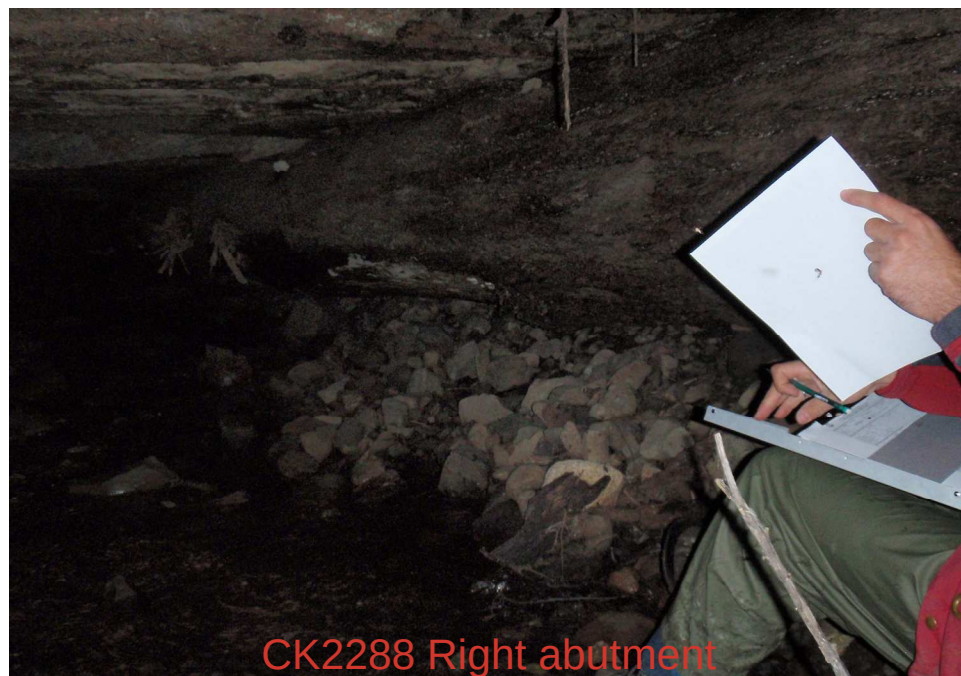
| GENERAL INFORMATION | | (enter either long/lat or UTM below - not both) | |
|---|---|---|---|
| Riprap | E G F <u>(P)</u> <u>(N/A)</u> UR | <u>LITTLE RIPRAP</u> | |

| GENERAL INFORMATION | | | | | | | | | |
|---|---|---|---|---|---|---|---|---|---|
| Comments <u>SILLS BADLY SCOUR</u> | | | | | | | | | |

CK2288 Right abutment

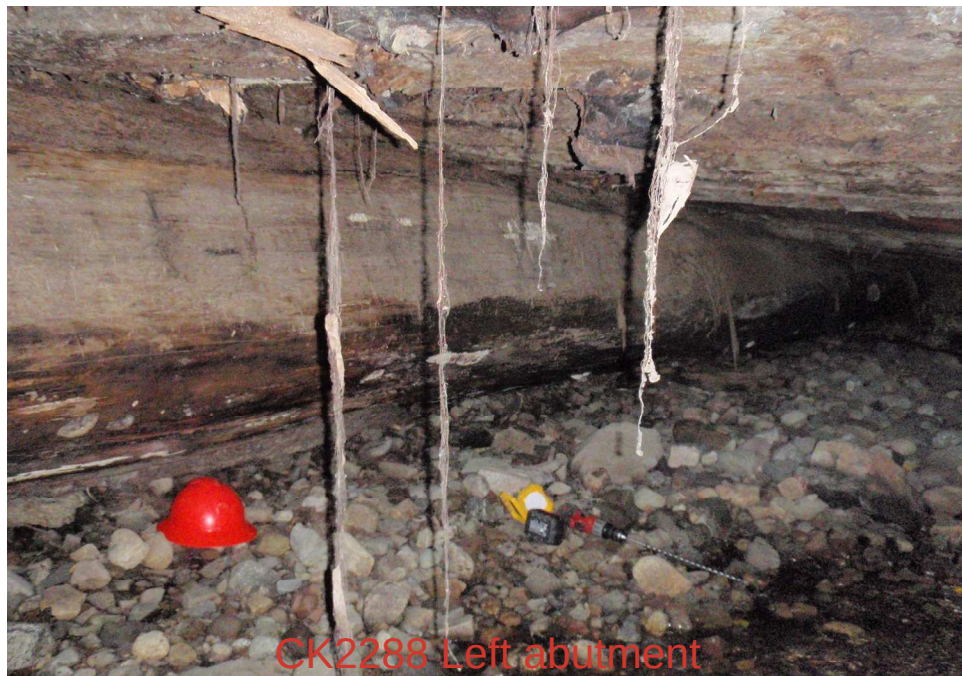
| GENERAL INFORMATION | | (enter either long/lat or UTM below - not both) | |
|---|---|---|---|
| Caps or Sills | E G <u>(F)</u> P <u>(N/A)</u> UR | <u>LEFT SILL UNDETERMINED. ? CONCRETE FROM 1960s</u> | |

| GENERAL INFORMATION | | | | | | | | | |
|---|---|---|---|---|---|---|---|---|---|
| 1 | RIGHT TO LEFT | 1 | LEFT ABUT | | | | | | |

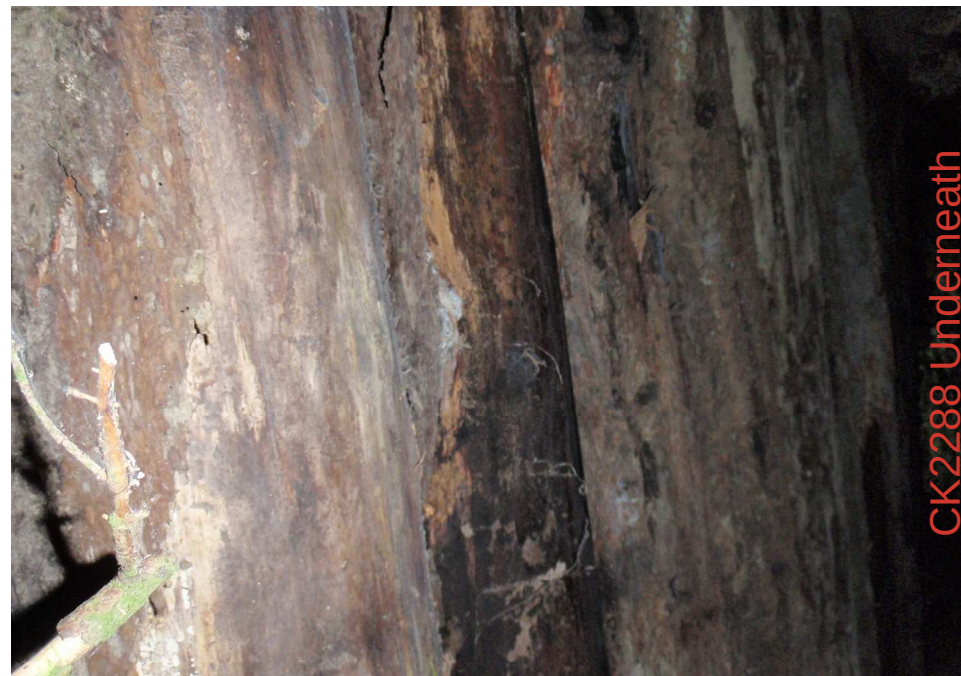
| GENERAL INFORMATION | | | | | | | | | |
|---|---|---|---|---|---|---|---|---|---|
| 2 | LEFT TO RIGHT | 2 | UNDER EARTH | | | | | | |

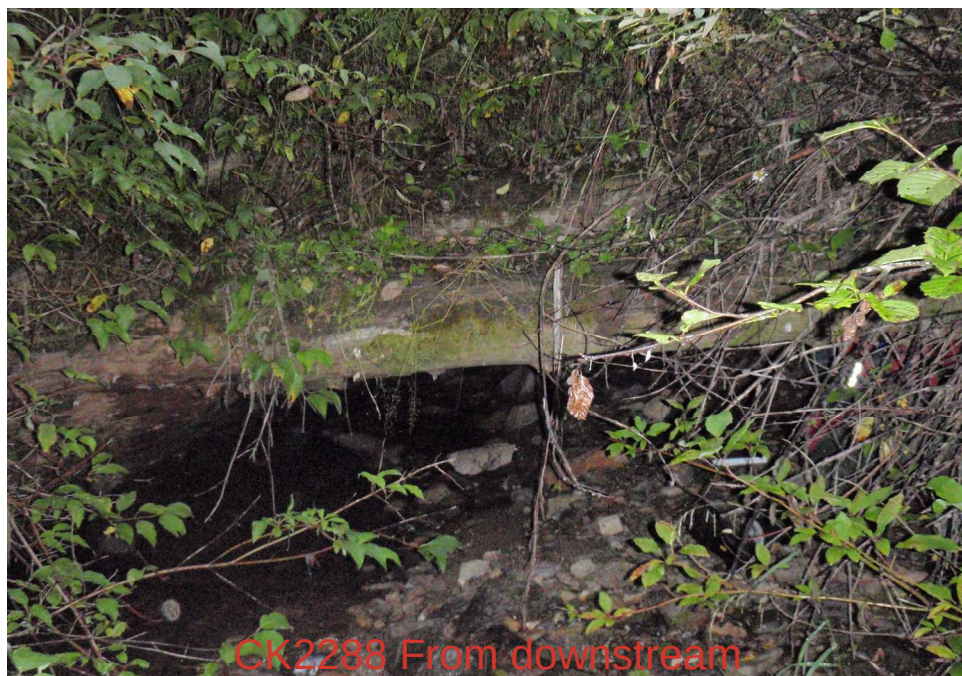
| GENERAL INFORMATION | | | | | | | | | |
|---|---|---|---|---|---|---|---|---|---|
| 3 | UPSTREAM | 3 | FROM DOWN STREAM | | | | | | |
