Corporate Bridge Register (CBR)  
Structure Inventory Data Form "BRIDGES"

| *Forest Service Road: 0710105 CRK | Kilometres: 30.8 |

CK2300

**Routine Condition Bridge Inspection Form**  
(except for log stringer or timber stringer bridges)

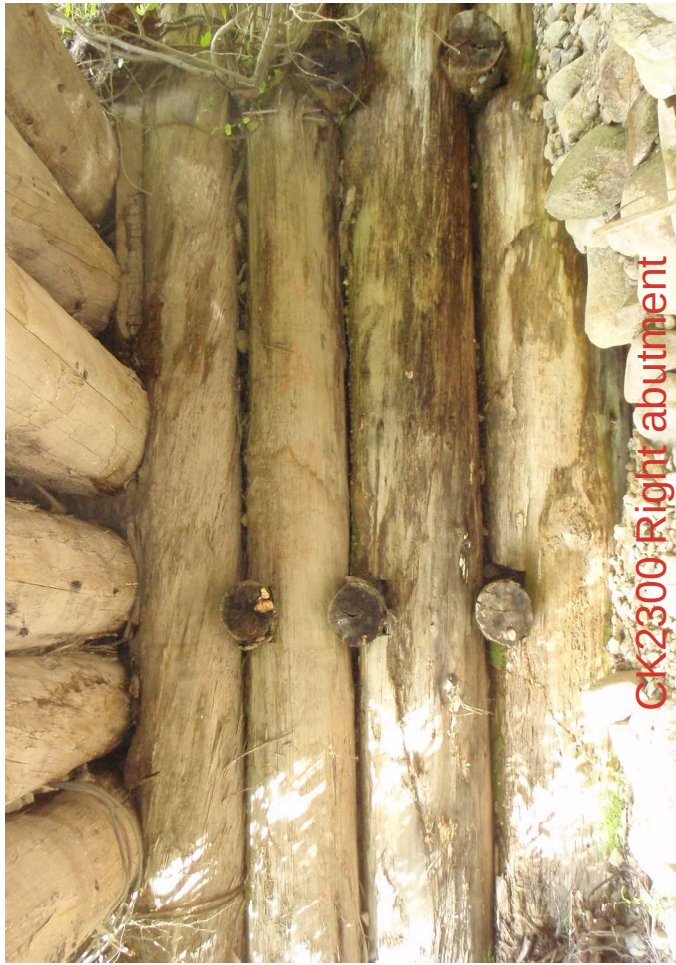
CK2300 Right abutment

| GENERAL INFORMATION | | | | (enter either long/lat or UTM below – not both) | | | |
|---|---|---|---|---|---|--|--|
| Sub-deck | E G F P <u>(N/A)</u> UR | | <u>RIGHT ABUTMENT IS LOOSE.</u> | | | | |

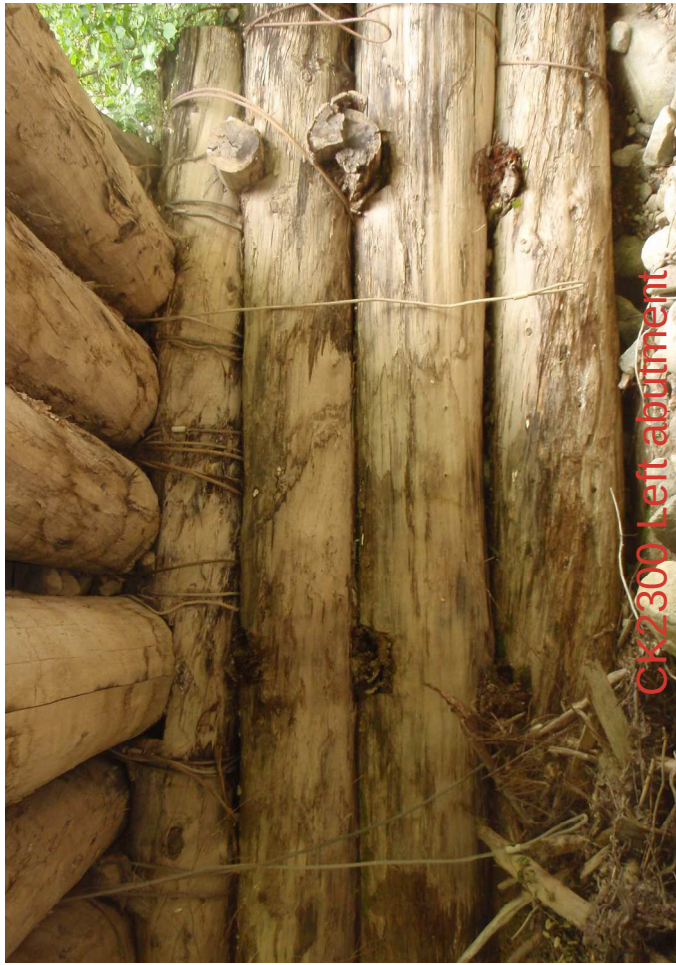
CK2300 Left abutment

CRIB NOT  
LOAD BEARING.FILL IN  
FRONT OF NEW  
SILLS. CRIB POTTED  
& LEFT CRIB, DOWN-  
STREAM IS BEING  
UNDERMINED.RIGHT ABUTMENT  
IS LOOSE.8" x 10" TIMBER. W/ 400mm C-C SPACING  
NOT VISIBLE DUE TO DEBRIS ON DECK.

| GENERAL INFORMATION | | | |
|---|---|---|---|
| 1 | MONITOR LEFT CRIB SCOUR. | | |
