# Corporate Bridge Register (CBR) Structure Inventory Data Form "BRIDGES"

**Routine Condition Bridge Inspection Form**  
(for log stringer or timber stringer bridges)

| *Site #: <u>CK-2302</u> | *Crossing Name: | *Type/Class: <input type="checkbox"/> Major Culvert<br><input checked="" type="checkbox"/> Woodbox/Log Culvert | *Project File ID# <u>7972</u> |
| *FSR Name: <u>UZZLIUS CRK</u> | *Forest District: <u>ChilliWack</u> | *Kilometres: <u>35.4</u> | User km: |

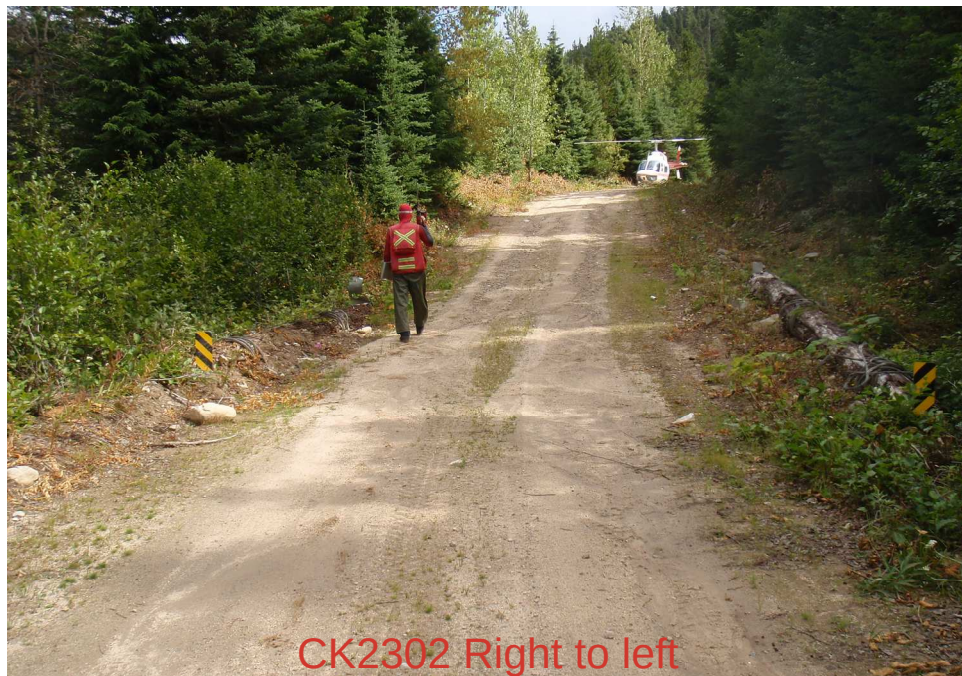
CK2302 Right to left

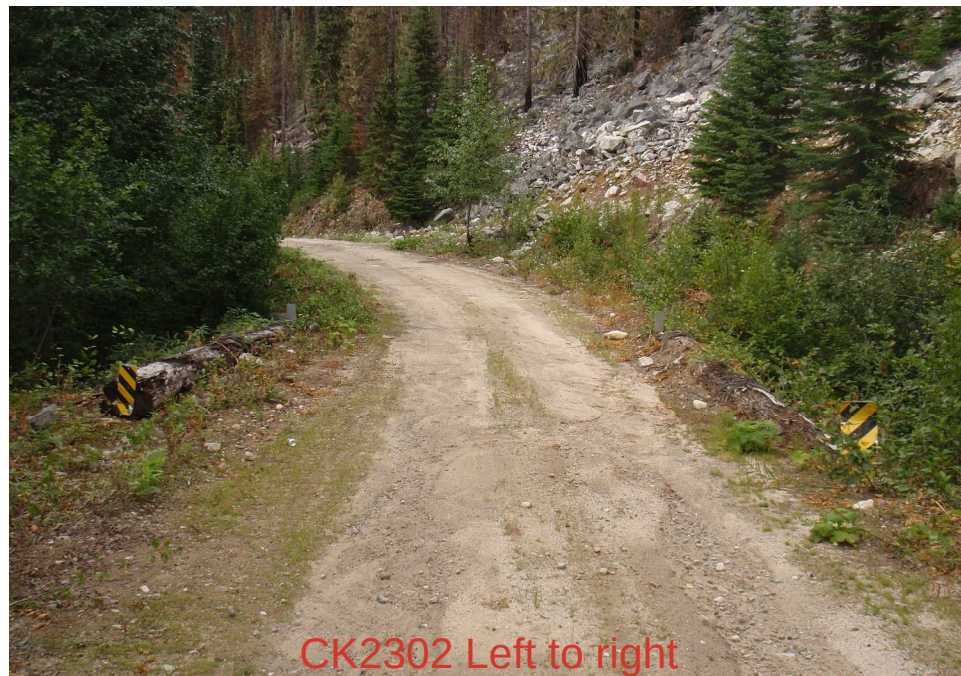
CK2302 Left to right

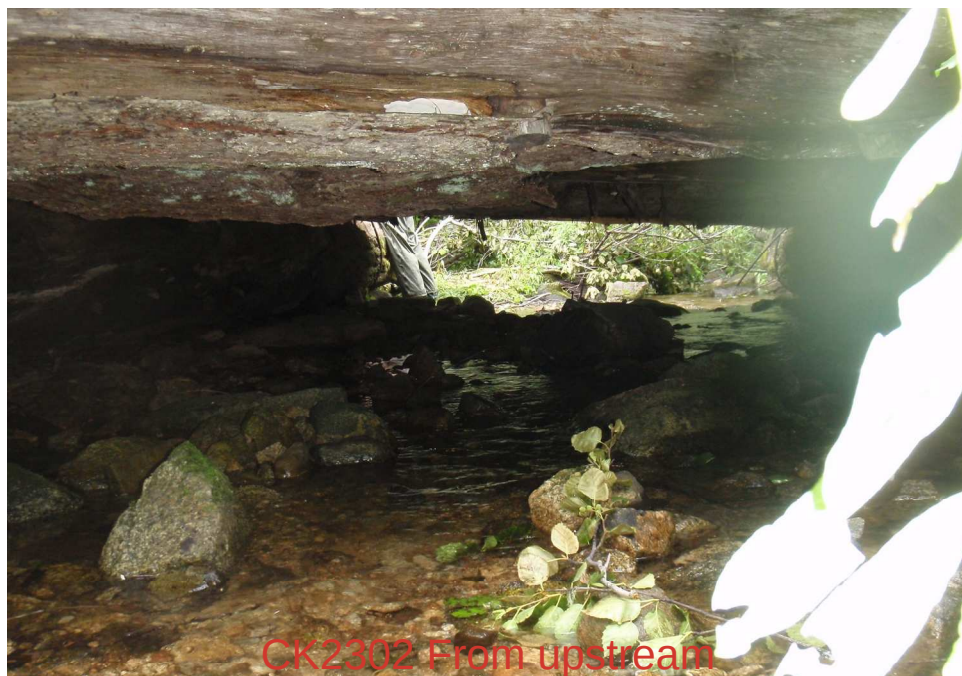
CK2302 From upstream

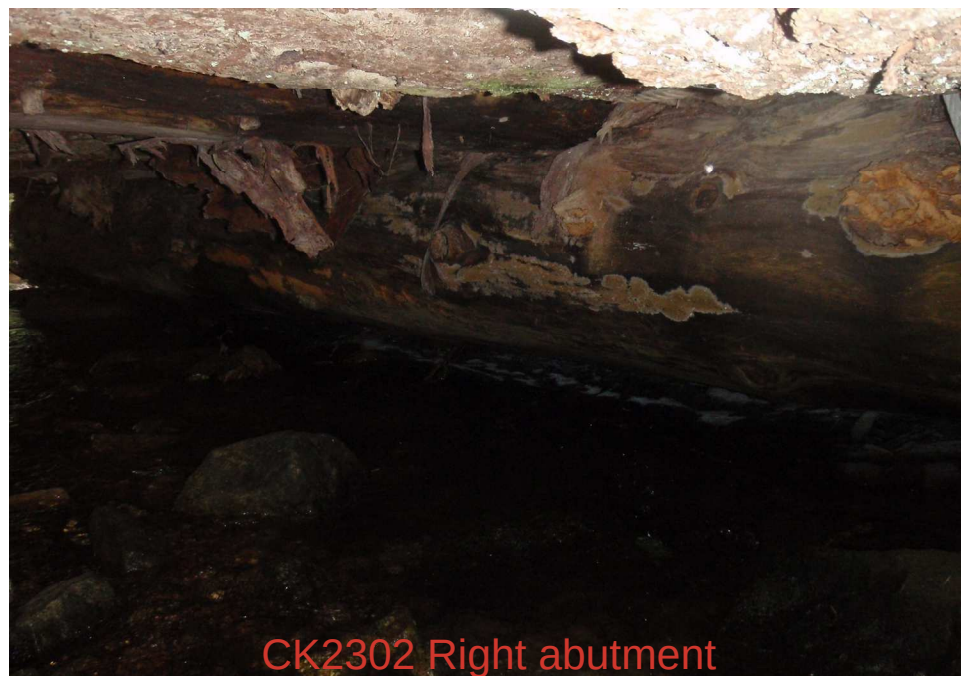
| Item | Present Condition<br>(circle) | Comments<br>(a comment is mandatory if condition "Poor" is selected) |
|---|---|---|
| Caps or Sills | E G <u>(F)</u> P <u>(N/A)</u> UR | <u>SINGLE LOG SILLS w/ 100mm OF CAP ROT.</u> |
| Fill | E G F <u>(P)</u> <u>(N/A)</u> UR | <u>VERY LITTLE FILL.</u> |

CK2302 Right abutment

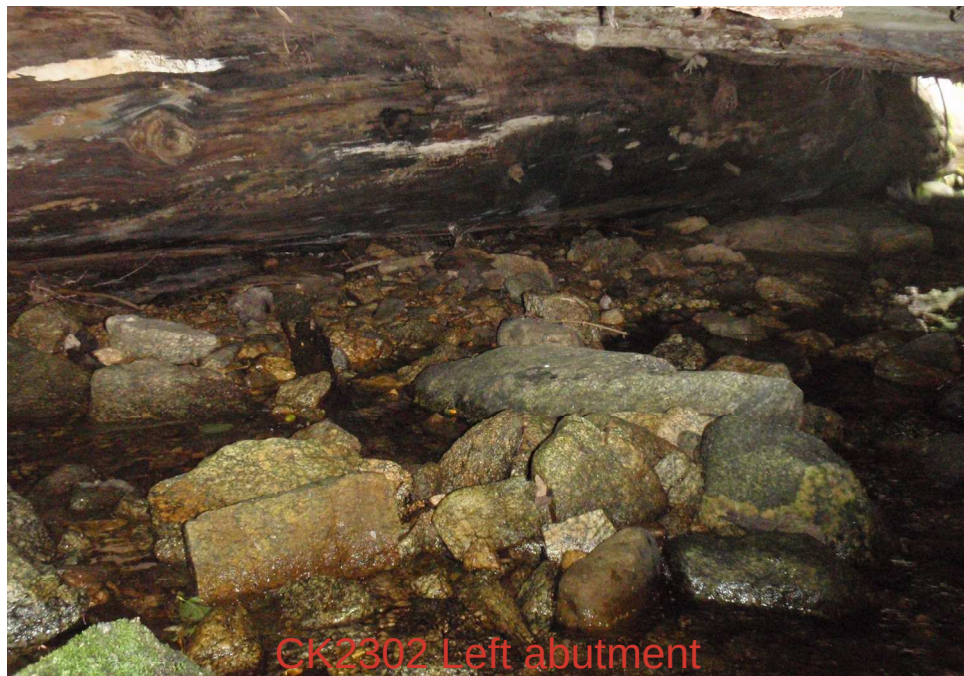
CK2302 Left abutment

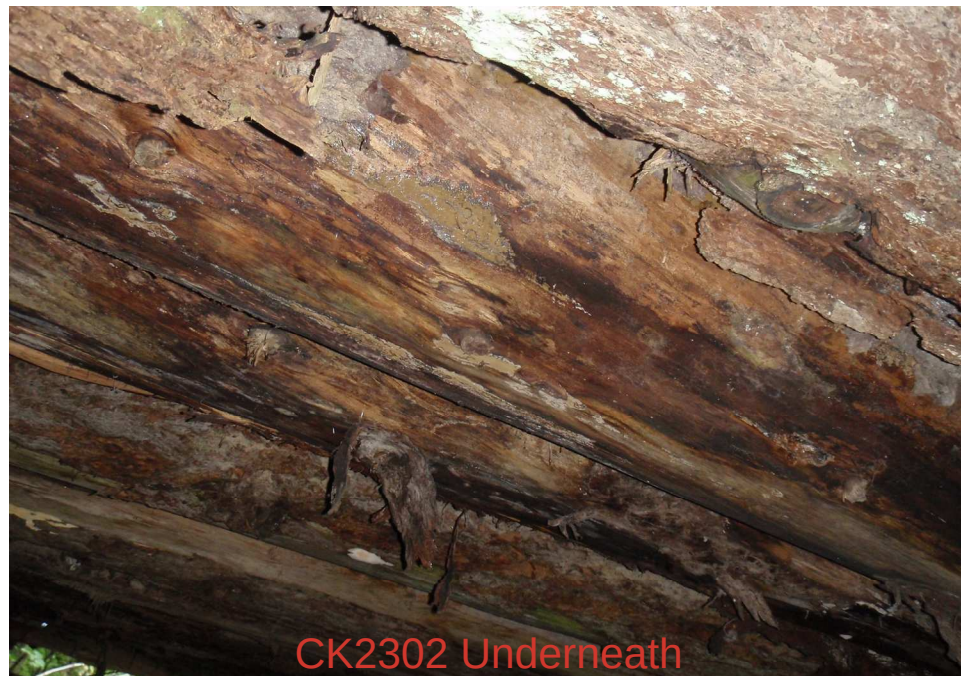
| Item | Present Condition<br>(circle) | Comments<br>(a comment is mandatory if condition "Poor" is selected) |
|---|---|---|
| Overall Deck Condition | E G F <u>(P)</u> UR | <u>DUE TO LACK OF FILL &amp; ROTTED STRINGERS</u> |

| GENERAL INFORMATION | | | | | | | | |
|---|---|---|---|---|---|---|---|---|
| Inspector's Comments<br>STRINGERS IN VERY POOR CONDITION. POST STRUCTURE LOAD LIMIT. | | | | | | | | |

CK2302 Underneath

| GENERAL INFORMATION | | | | | | | | |
|---|---|---|---|---|---|---|---|---|
| 1 | <u>H</u> M L | | REPLACE STRUCTURE | | | | | |
| 2 | <u>H</u> M L | | POST LOAD LIMIT. | | | | | |
| PEng Reviewer's Comments<br>Rotten wood box culvert. Recommend barricading, removing or replacing immediately. Remove from CBR. | | | | | | | | |

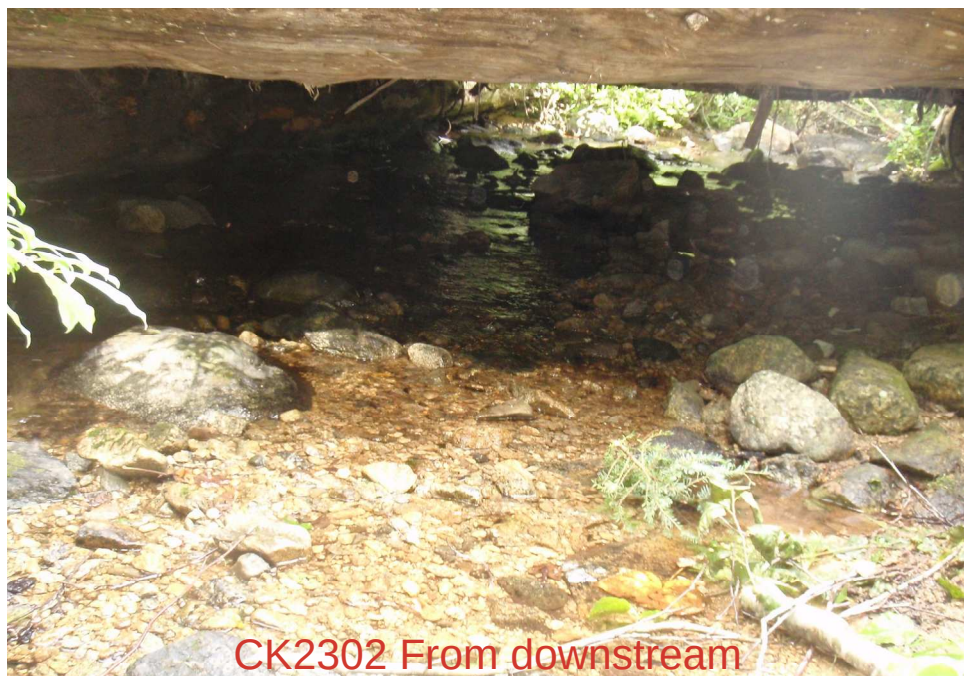
CK2302 From downstream
