# Corporate Bridge Register (CBR) Structure Inventory Data Form "BRIDGES"

**Routine Condition Bridge Inspection Form**  
(for log stringer or timber stringer bridges)

| GENERAL INFORMATION | | (enter either long/lat or UTM below – not both) | |
|---|---|---|---|
| *Site #: <u>CK-2304</u> | *Crossing Name: | *Type/Class: <input type="checkbox"/> Major Culvert<br><input type="checkbox"/> Woodbox/Log Culvert | *Project File ID# <u>7972</u> |
| *FSR Name: <u>CK-2304</u> | *Forest District: <u>ChilliWack</u> | *Kilometres: <u>6.6</u> | User km: |

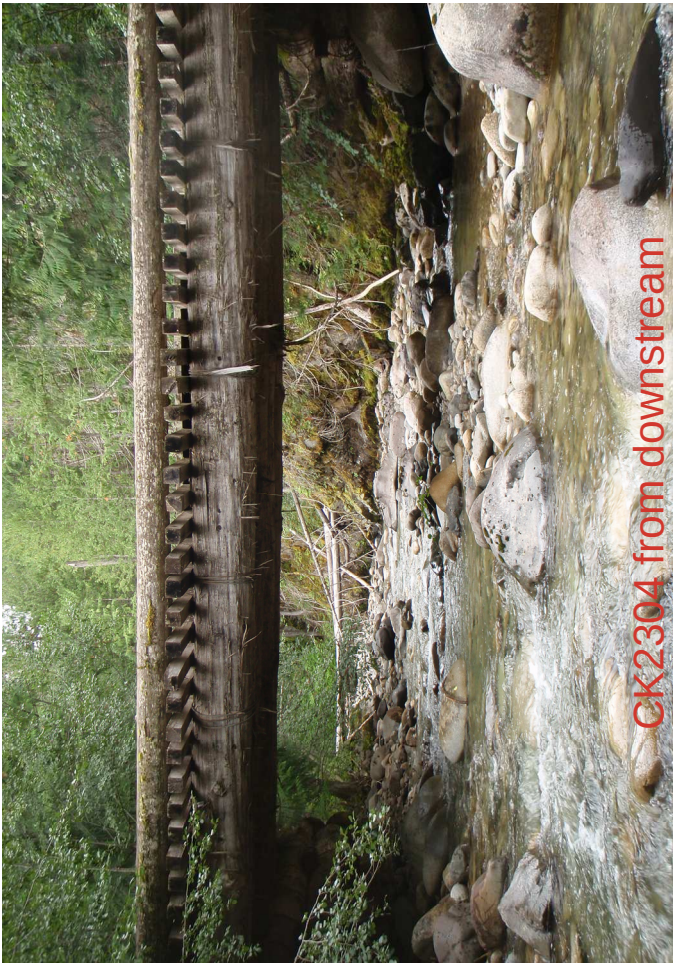
CK2304 from downstream

| GENERAL INFORMATION | | | | | | | | |
|---|---|---|---|---|---|---|---|---|
| Comments <u>DOWNSTREAM OF CRIB ABUTMENTS BEING BADLY SCOURED + UNDERMINED</u> | | | | | | | | |

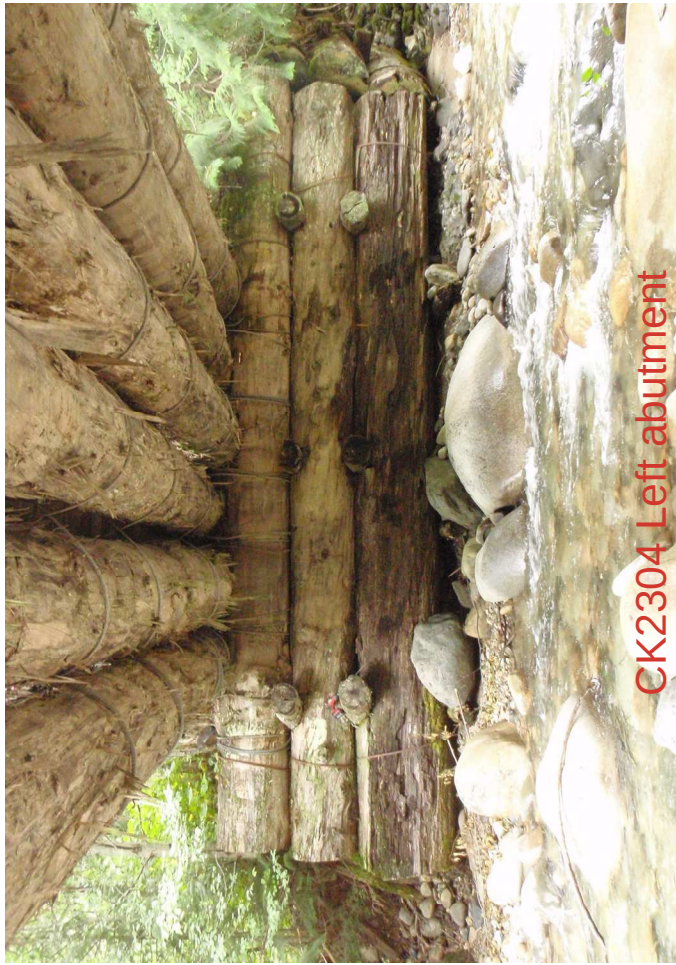
CK2304 Left abutment

| GENERAL INFORMATION | | (enter either long/lat or UTM below – not both) | |
|---|---|---|---|
| Log/Timber Crib | E G F <u>(P)</u> N/A UR | <u>ROTTEN CRIB 3X CLOSED FACE. BADLY SCOURED.</u> | |
| Tie-backs | E G F <u>(P)</u> N/A UR | <u>3X ROTTEN.</u> | |
| Riprap | E G F <u>(P)</u> N/A UR | <u>LACK OF RIPRAP HAS CAUSED SCOUR.</u> | |
