## Corporate Bridge Register (CBR) Structure Inventory Data Form "BRIDGES"

**Routine Condition Bridge Inspection Form**  
(for log stringer or timber stringer bridges)

| *Site #: CK-2321 | *Crossing Name: | *Type/Class:<br><input type="checkbox"/> Major Culvert<br><input checked="" type="checkbox"/> Woodbox/Log Culvert | *Project File ID# 5913 | | |
| *FSR Name:<br>BLUE Mtn TWO | *Forest District:<br>CHILLIWACK | *Kilometres:<br>2.2 | User km: | | |

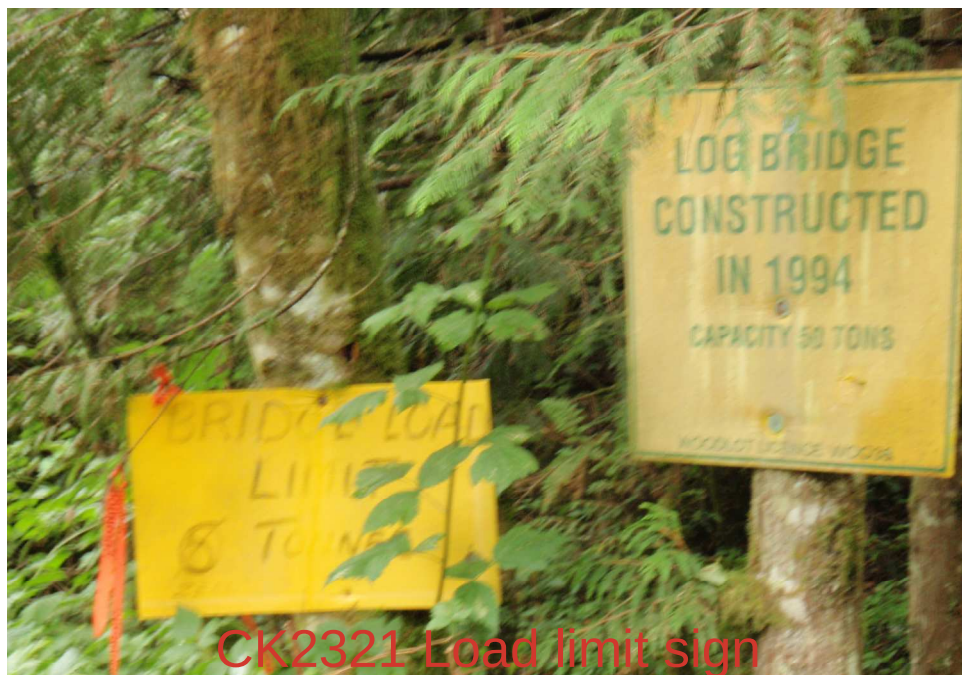
| Posted Load Rating | — (tonnes) or None | NOT ACCURATELY POSTED | | | |

CK2321 Load limit sign

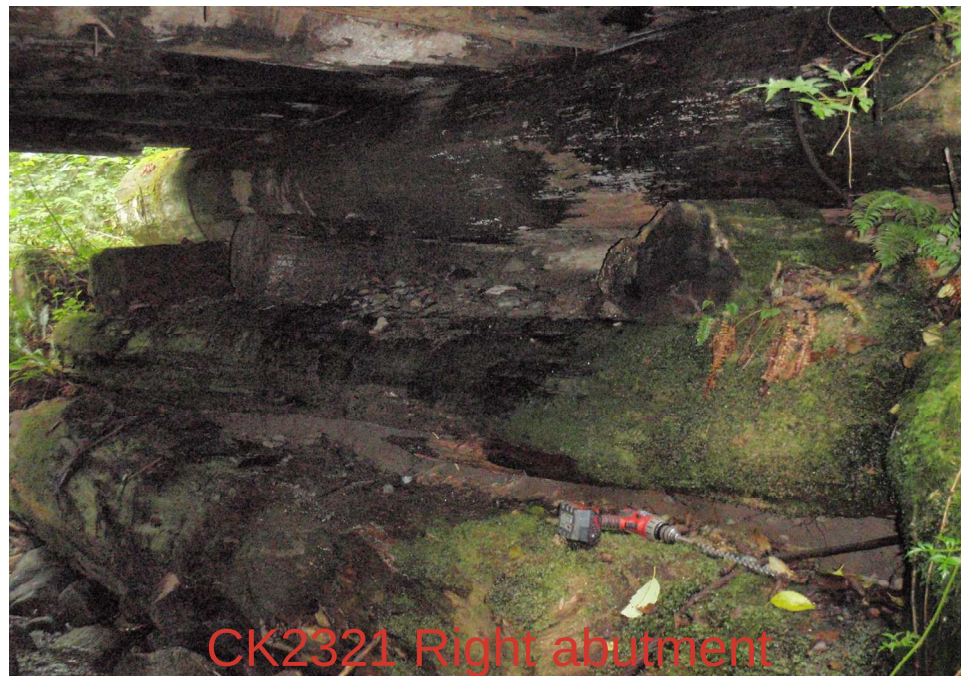
CK2321 Right abutment

| Log/Timber Crib | E G <b>(F)</b> <b>(P)</b> N/A UR | 3x CRIBS IN POOR CONDITION - FD CRIBS | | | |
| Riprap | E G <b>(F)</b> <b>(P)</b> N/A UR | CRIBS BEING UNDERMINED DUE TO INADEQUATE RIP RAP | | | |

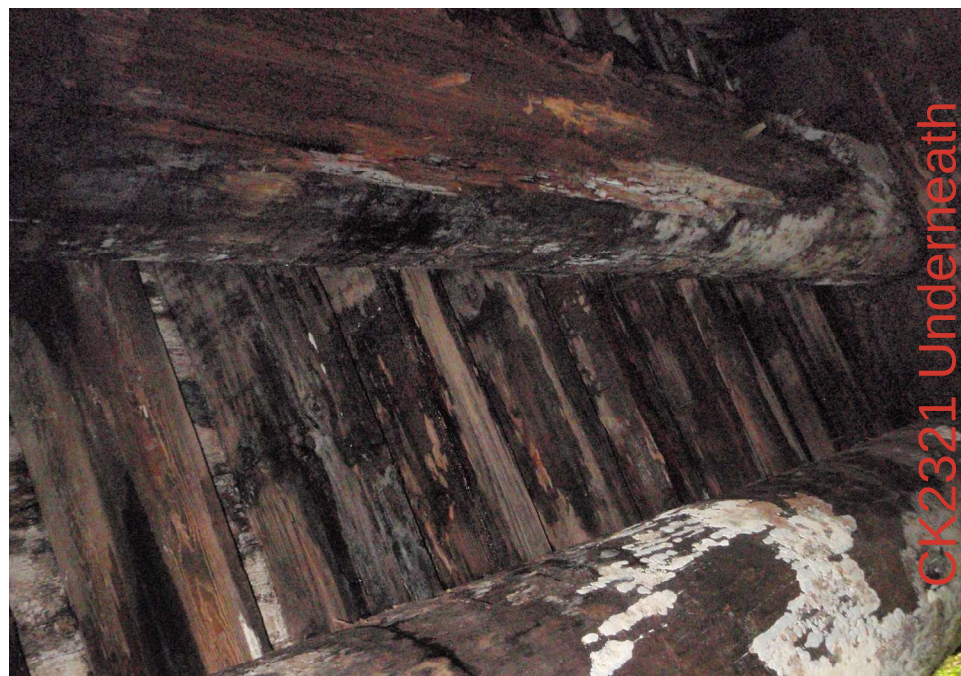
CK2321 Underneath

| 1 | FA | N | 630 | | | | ROTEN | | | | |
| 2 | " | N | 590 | 100 | | | ROTEN | | | | |
| 3 | " | N | 560 | | | | ROTEN | | | | |
| 4 | " | Y | 580 | | | | ROTEN | | | | |
| 5 | " | Y | 530 | | | | ROTEN | | | | |

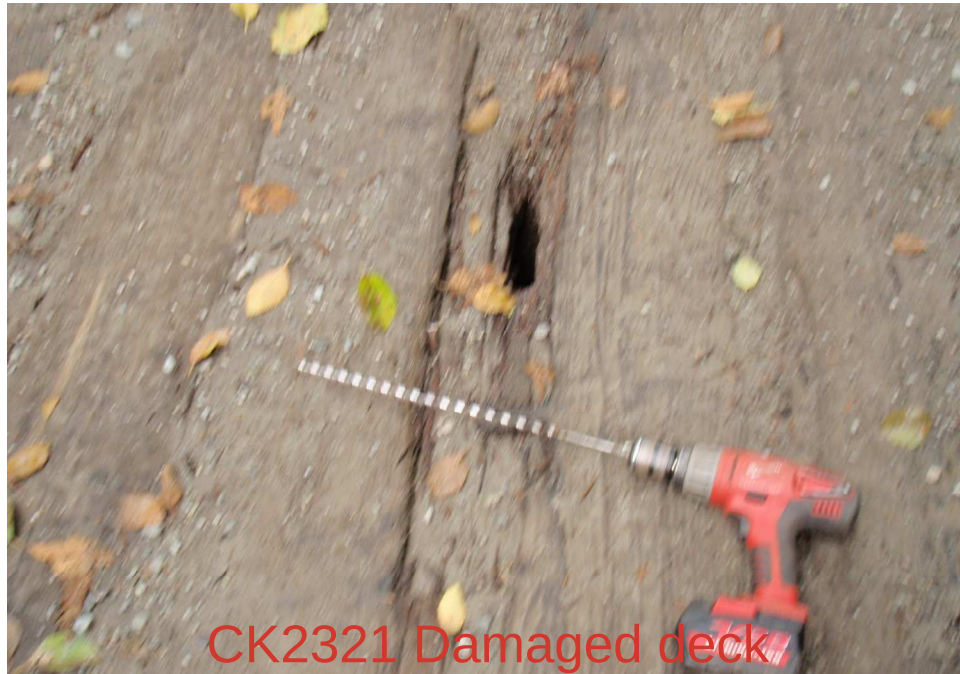
| Running Planks | E G F <b>(P)</b> N/A UR | 6" ROTTEN TIMBER | | | |
| Ties | E G F <b>(P)</b> N/A UR | 8" x 2" ROTTEN TIMBER | | | |
| Curb Rail/Blocks/Posts | E G F <b>(P)</b> UR | ROTTEN TIMBER RAIL | | | |
| Hardware | E G F <b>(P)</b> N/A UR | LOOSE | | | |
| Overall Deck Condition | E G F <b>(P)</b> UR | | | | |

CK2321 Damaged deck

| P Eng Reviewer's Comments | | Bridge condemned. Remove bridge or barricade road completely. | | | | | | | | | |

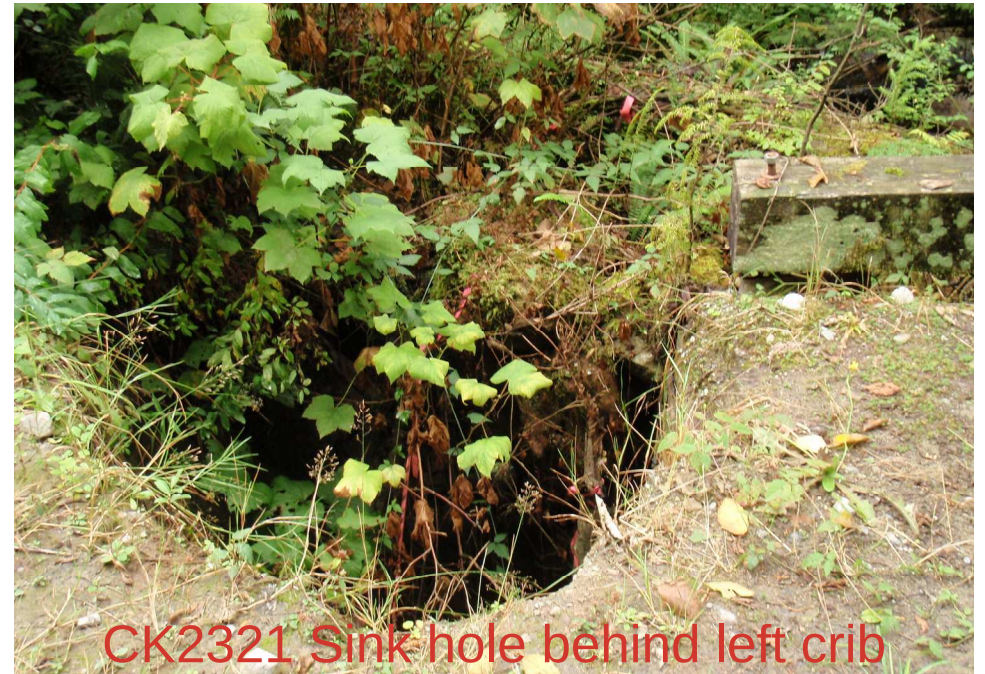
| Pill | E G F <b>(P)</b> N/A UR | DOWN STREAM LEFT ABUT: LARGE SINKHOLE BEHIND BRIDGE | | | |

CK2321 Sink hole behind left crib
