## Corporate Bridge Register (CBR) Structure Inventory Data Form "BRIDGES"

CK-2330

**Routine Condition Bridge Inspection Form**  
(except for log stringer or timber stringer bridges)

| GENERAL INFORMATION | | | | (enter either long/lat or UTM - not both) | | | | | |
|---|---|--|--|---|---|---|---|---|---|
| FSR Name | LOST-BLACK LOCK | | | User km | 1.3 | Project File ID | 8466 | Branch | 11 |

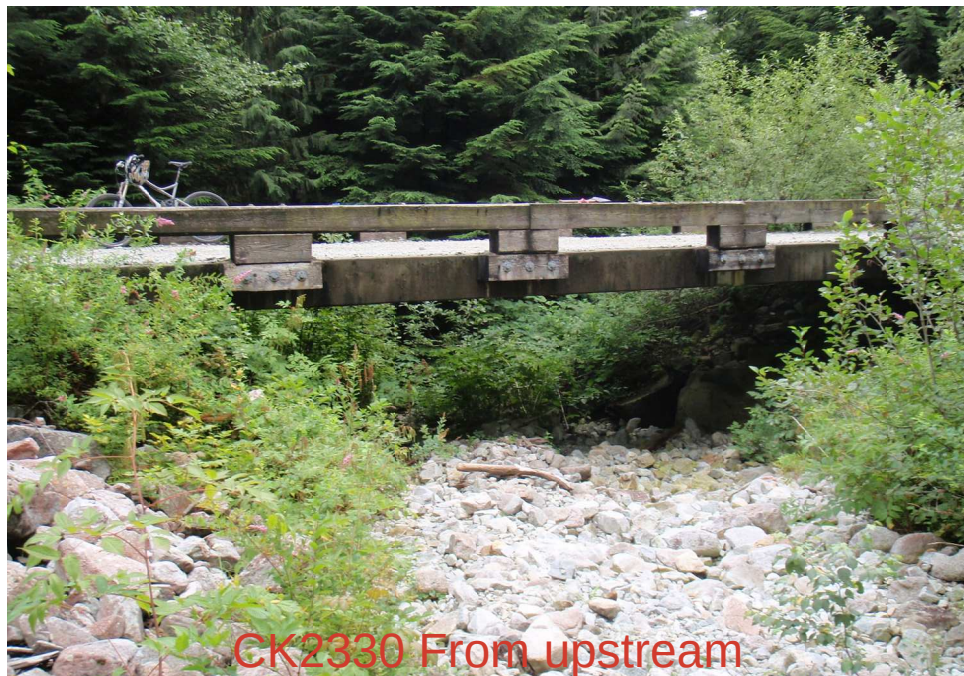
CK2330 From upstream

| GENERAL INFORMATION | | | |
|---|---|---|---|
| Comments <u>ACTIVE CHANNEL WITH LARGE AMOUNT OF BEDROCK</u> | | | |

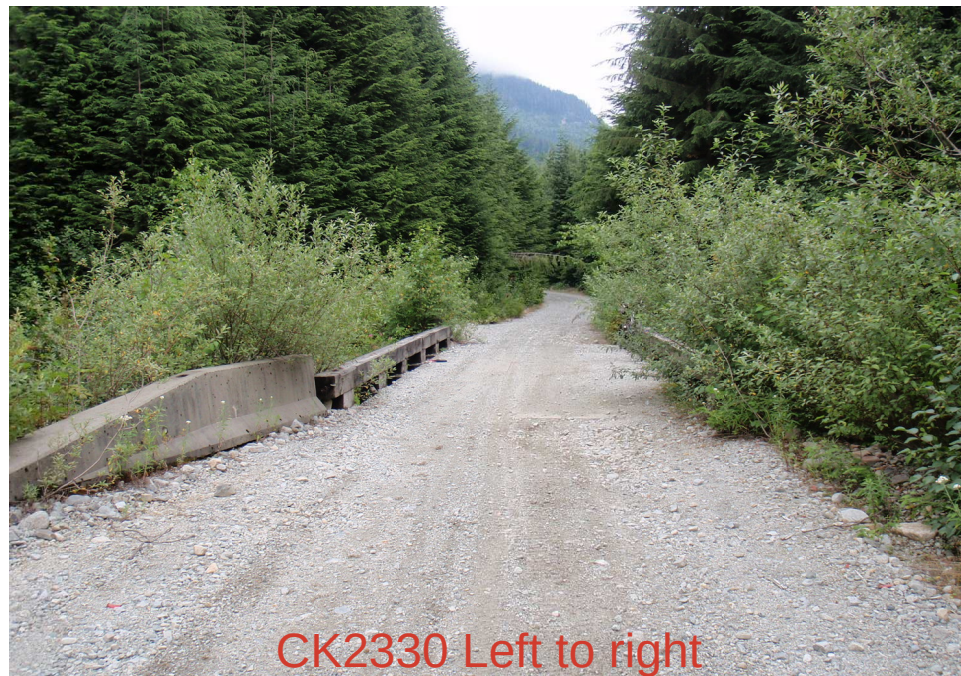
CK2330 Left to right

| GENERAL INFORMATION | | | | (enter either long/lat or UTM - not both) | | | | | |
|---|---|--|--|---|---|---|---|---|---|
| Running Surface | E G (F) P | | | DEBRIS SCATTERED ACROSS DECK. | | | | | |

| GENERAL INFORMATION | | | |
|---|---|---|---|
| 2 | H M (L) | | CLEAN DEBRIS OFF DECK. |

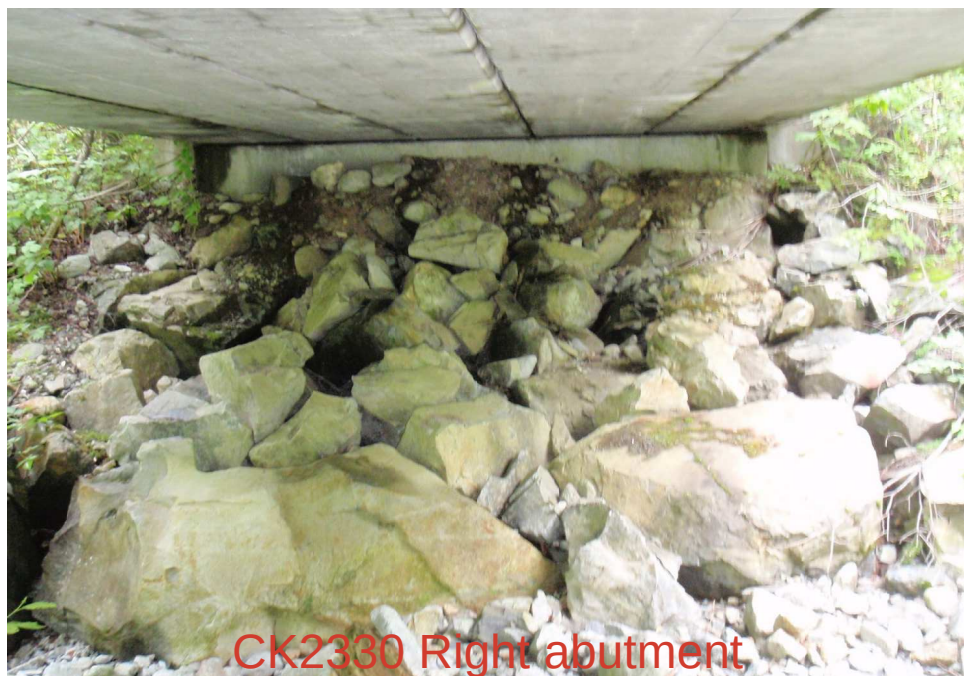
CK2330 Right abutment

| GENERAL INFORMATION | | | | (enter either long/lat or UTM - not both) | | | | | |
|---|---|--|--|---|---|---|---|---|---|
| Precast Concrete | E (G) F P N/A | | | PRECAST CONCR. CAPS + BALLAST WALL COMBO | | | | | |
