| <br>BC Ministry of<br>Forests and Range | | <b>Corporate Bridge Register (CBR)</b><br><b>Structure Inventory Data Form "BRIDGES"</b> | | Page 1 of 2 |

# Routine Condition Bridge Inspection Form

| *Site #: <u>CK-2346</u> | *Crossing Name: | *Type/Class: <input type="checkbox"/> Major Culvert<br><input checked="" type="checkbox"/> Woodbox/Log Culvert | (enter either long/lat or UTM below - not both) | |

| *Date of Inspection (yyyy/mm/dd) | 2010-09-09 | *Inspection Company Name | Dnsi Engineering Ltd. | *Inspector's Name (print) | Ali Sadique | Inspector's Signature | | | |

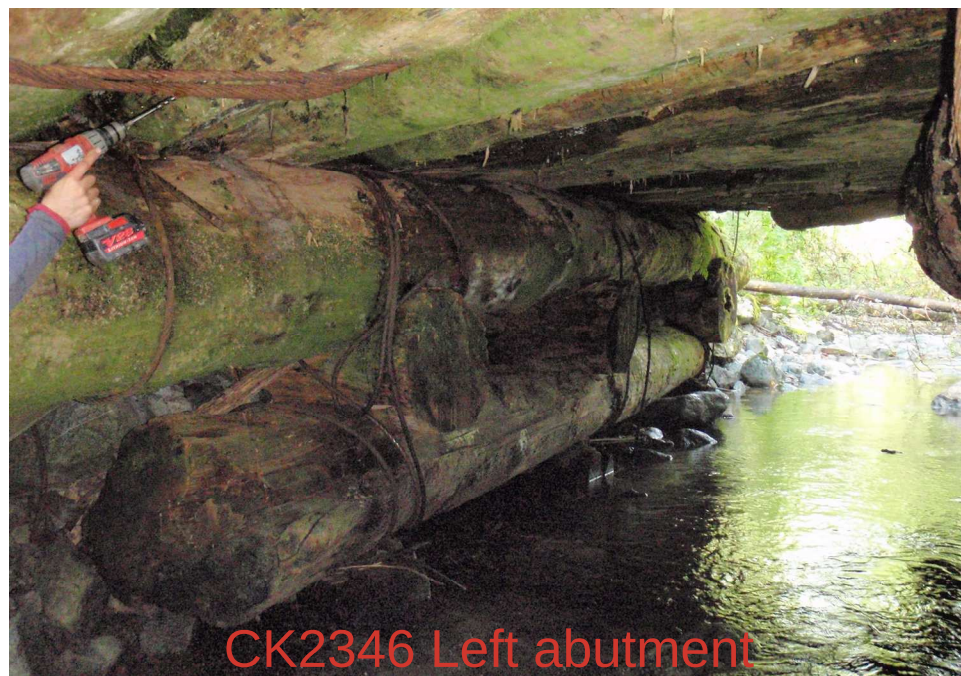
CK2346 Left abutment

| Item | Present Condition<br>(circle) | Comments<br>(a comment is mandatory if condition "Poor" is selected) |
|---|---|---|
| Log/Timber Girds | E G F <u>(P)</u> N/A UR | <u>3x OPEN TIED CUB. POOL BEARING ON UPSTREAM LEFT</u> |
| Bearings | E G F <u>(P)</u> N/A UR | <u>FIRST 3-STRINGERS FROM UPSTREAM BEAR ON THE TOP LOG CUB WITH NO SUPPORT.</u> |

| Inspector's Comments | | POOR BEARING ON LEFT ABUT. UPSTREAM CORALERS. 3 STRINGERS HAVE VERN POLE SUPPORT. PLEASE TO REVIEW | | | | | | | |

| P Eng Reviewer's Comments Downrate to 5 tonnes. Please post. Recommend bridge replacement. | | | | | | | | | |

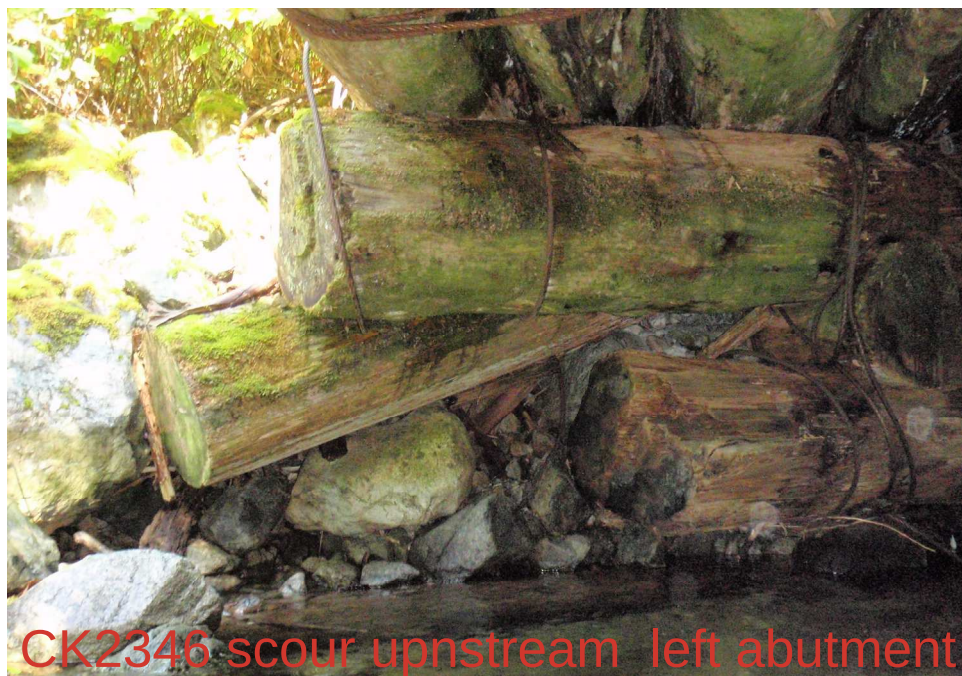
| Comments LEFT ABUT, DOWNSTREAM ALREADY SAVED. | | | | | | | | | |

CK2346 scour upstream left abutment
