**BC Ministry of  
Forests and Range**

| *Structure #: | Ck2349 | *Site #: | | | |
| *Forest Service Road: | STAVE RIVER | Kilometres: | 5.2 | | |

Routine Condition Culvert Inspection Form

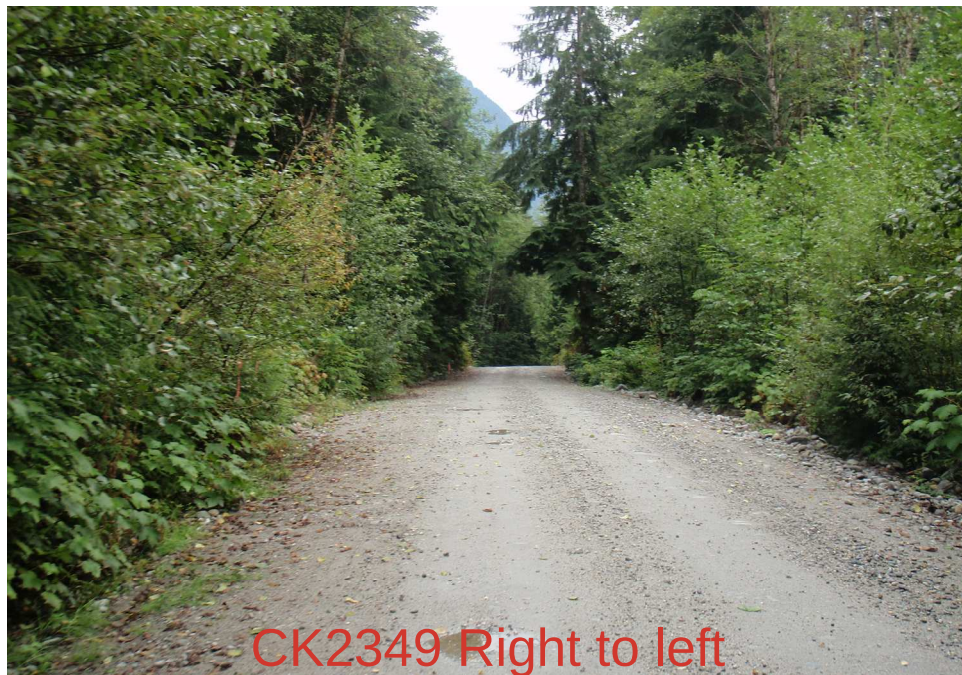
CK2349 Right to left

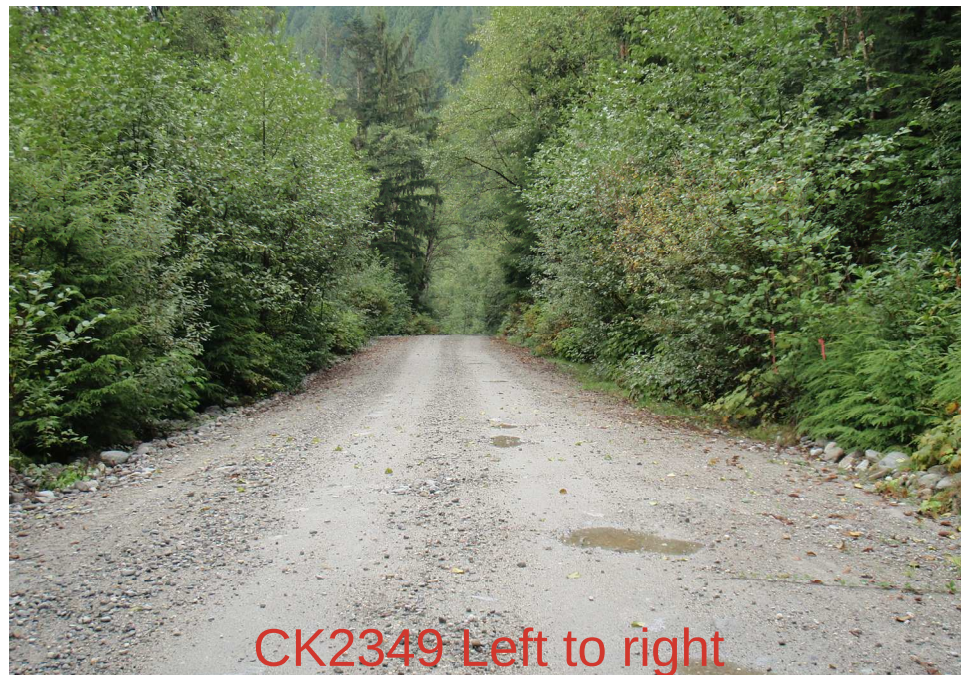
CK2349 Left to right

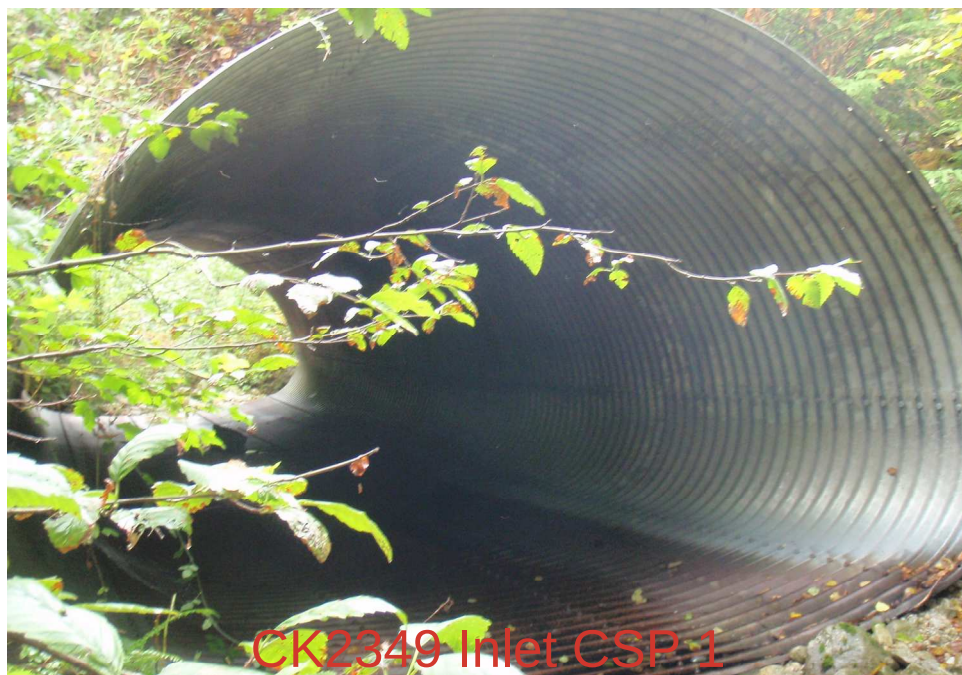
CK2349 Inlet CSP 1

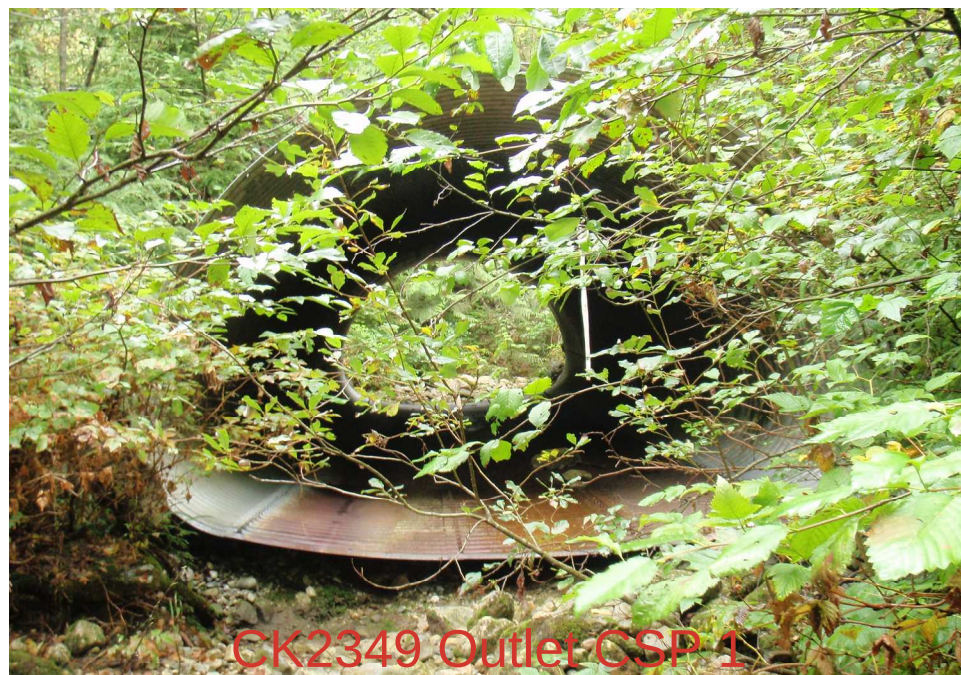
CK2349 Outlet CSP 1

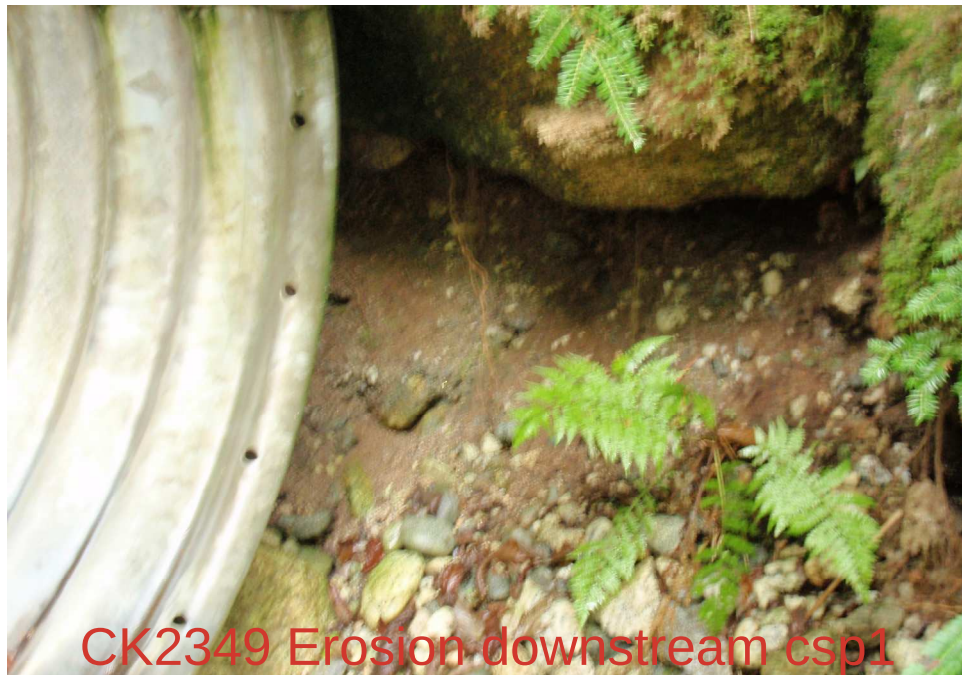
Erosion on downstream left corner (p.d)

emission valve in downstream left corner allowing exposed soil

CK2349 Erosion downstream csp1

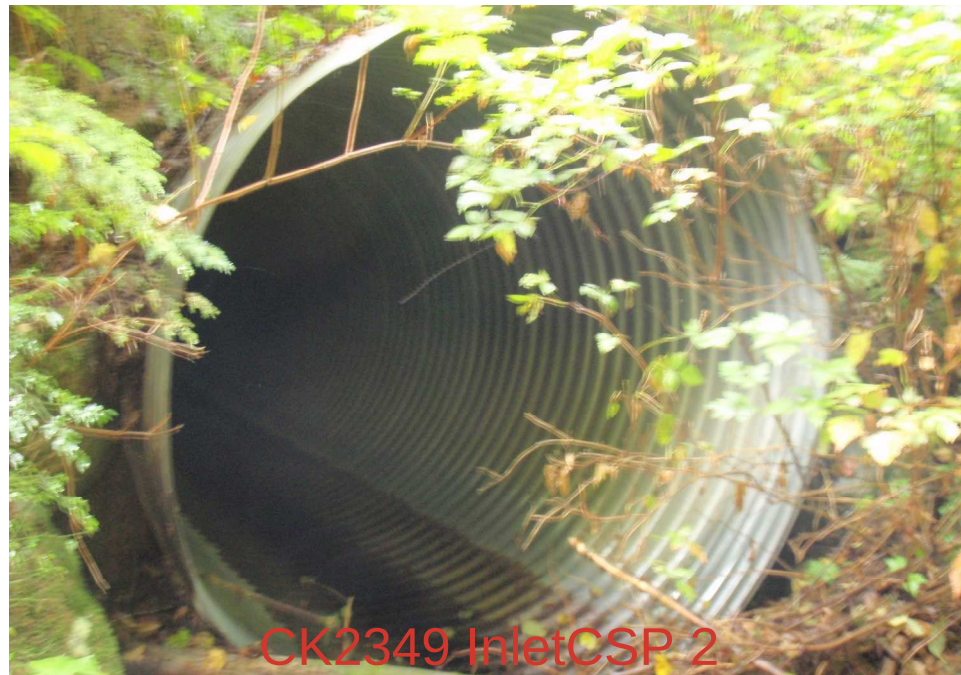
CK2349 InletCSP 2

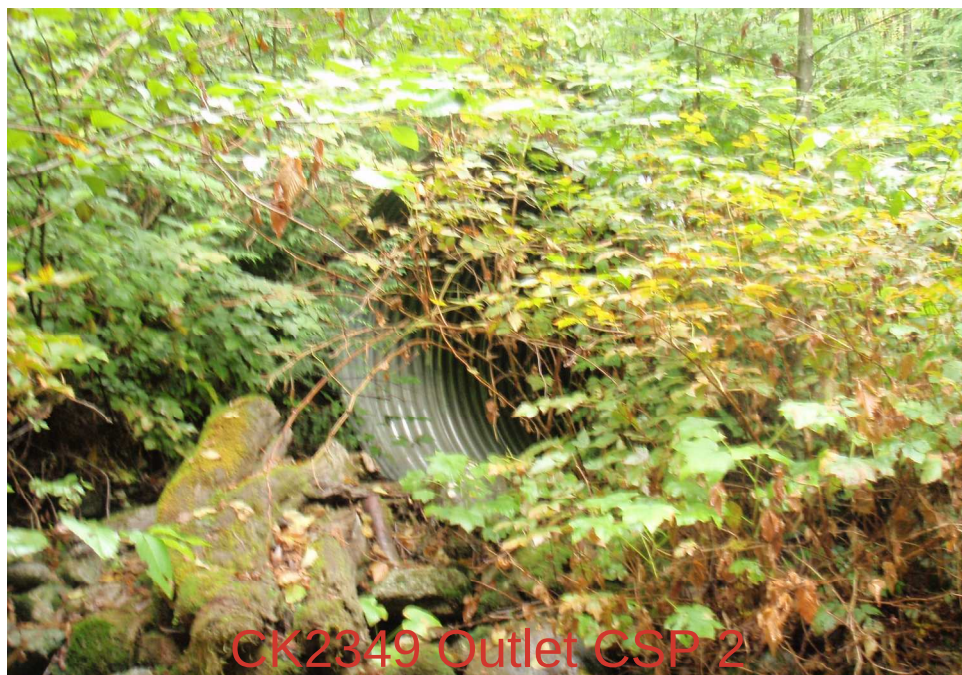
CK2349 Outlet CSP 2
