# Corporate Bridge Register (CBR) Structure Inventory Data Form "BRIDGES"

| *Structure # <u>CK-2353</u> | *Site #: <u>CK-2353</u> |
| *Forest Service Road: <u>Stave-Winslow</u> | Kilometres: <u>1.8</u> |

**Routine Condition Bridge Inspection Form**  
(except for log stringer or timber stringer bridges)

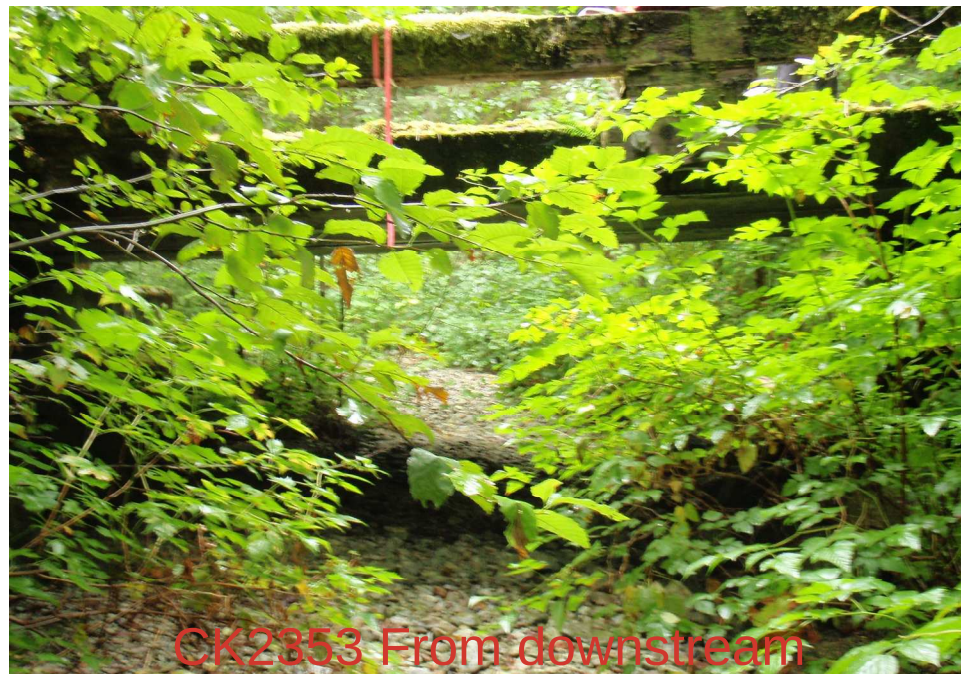
CK2353 From downstream

| GENERAL INFORMATION | | | | (enter either long/lat or UTM below - not both) | | | |
|---|---|---|---|---|---|--|--|
| Fender Condition | E G <u>(F)</u> P None UR | DOWNSTREAM - RIGHT APPROACH HAS BEEN HIT & NOW IT'S IN THE DITCH | | | | | |

| GENERAL INFORMATION | | | | | | | | | | | | | | | | | | | |
|---|---|---|---|---|---|---|---|---|---|---|---|---|---|---|---|--|--|--|--|
| 1 | (H) | M | L | | | REPLACE FENCE - 1 INDUSTRIAL ACTIVITY | | | | | | | | | | | | | |

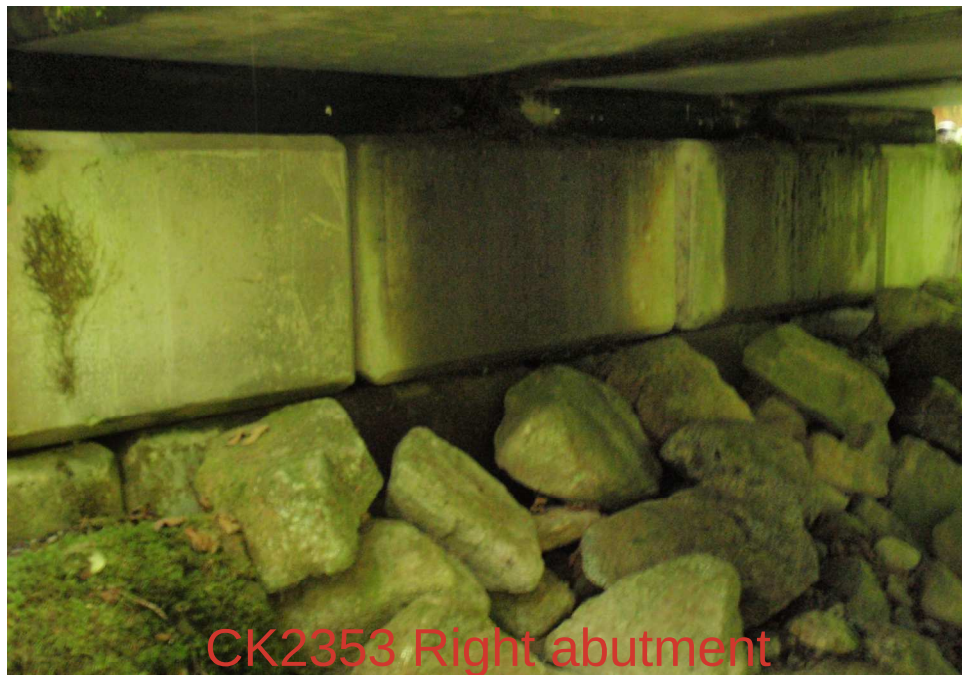
CK2353 Right abutment

| GENERAL INFORMATION | | | | (enter either long/lat or UTM below - not both) | | | |
|---|---|---|---|---|---|--|--|
| Concrete (cast in place, lock blocks, precast) | E G <u>(F)</u> P N/A UR | 2X LOCK BLOCKS w/ GEOTRIP | | | | | |

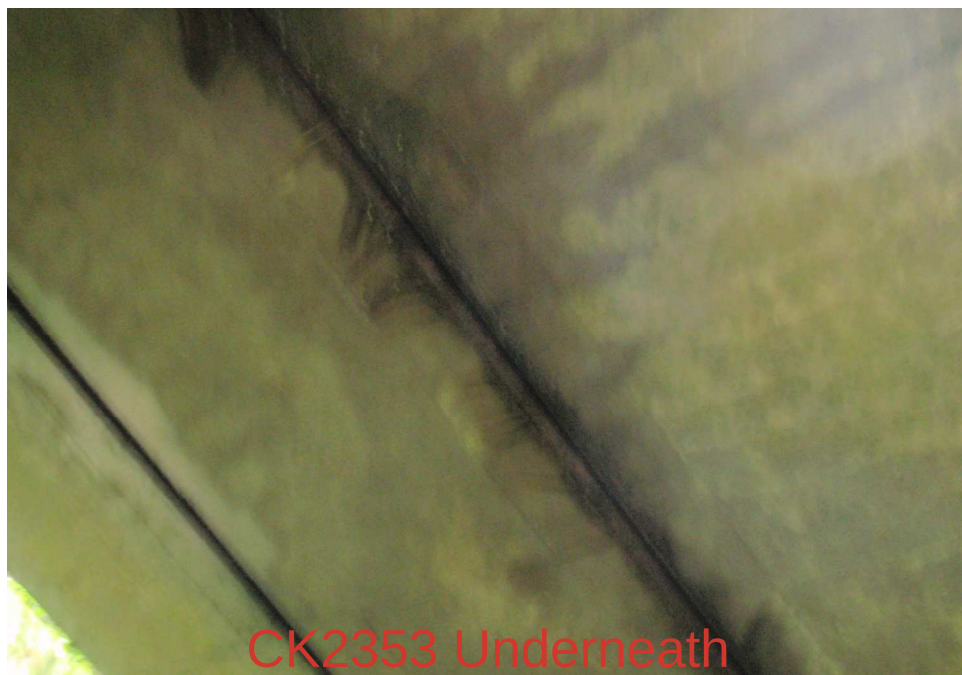
CK2353 Underneath

| GENERAL INFORMATION | | | | (enter either long/lat or UTM below - not both) | | | |
|---|---|---|---|---|---|--|--|
| Bearings | E G <u>(F)</u> P N/A UR | RUBBER PADS | | | | | |

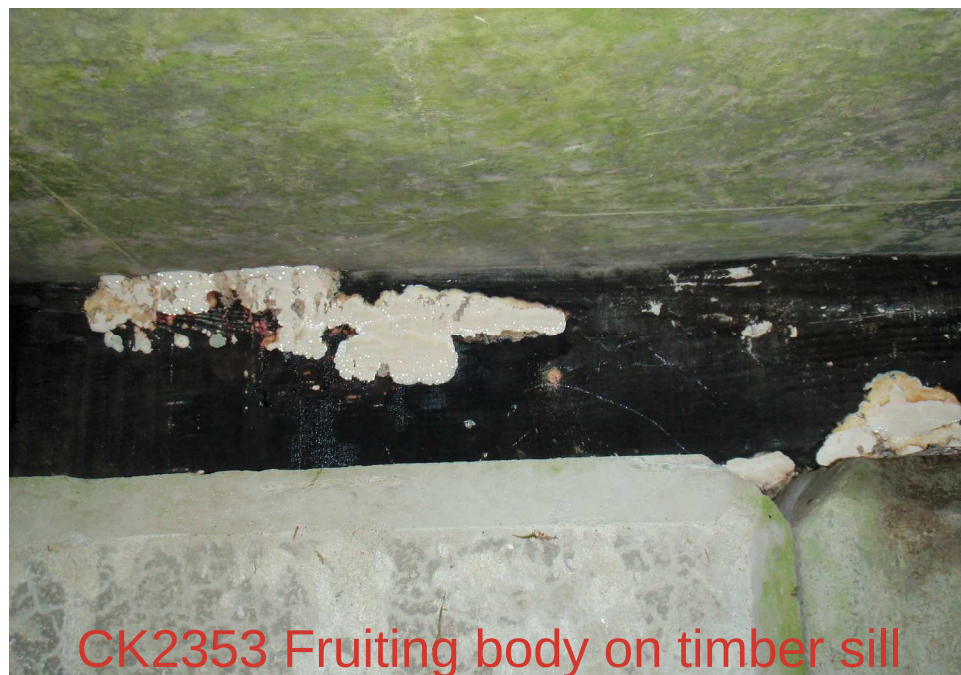
| GENERAL INFORMATION | | | | (enter either long/lat or UTM below - not both) | | | |
|---|---|---|---|---|---|--|--|
| Caps or Sills | E G <u>(F)</u> P N/A UR | 8" x 8" TIMBER, SOME FRUITING BODY GROWING ON THEM. | | | | | |

CK2353 Fruiting body on timber sill

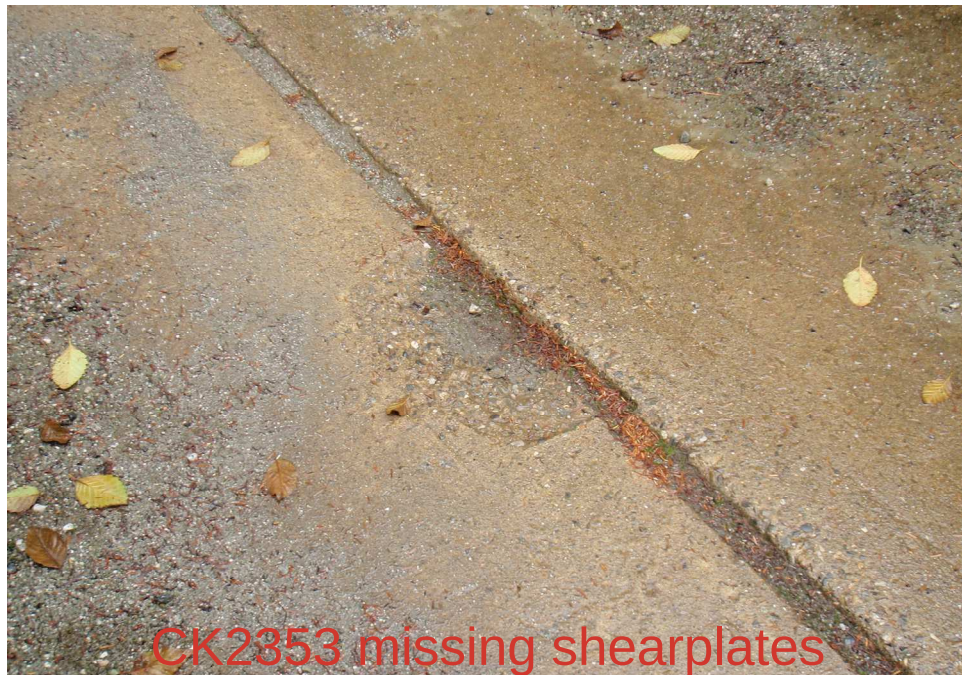
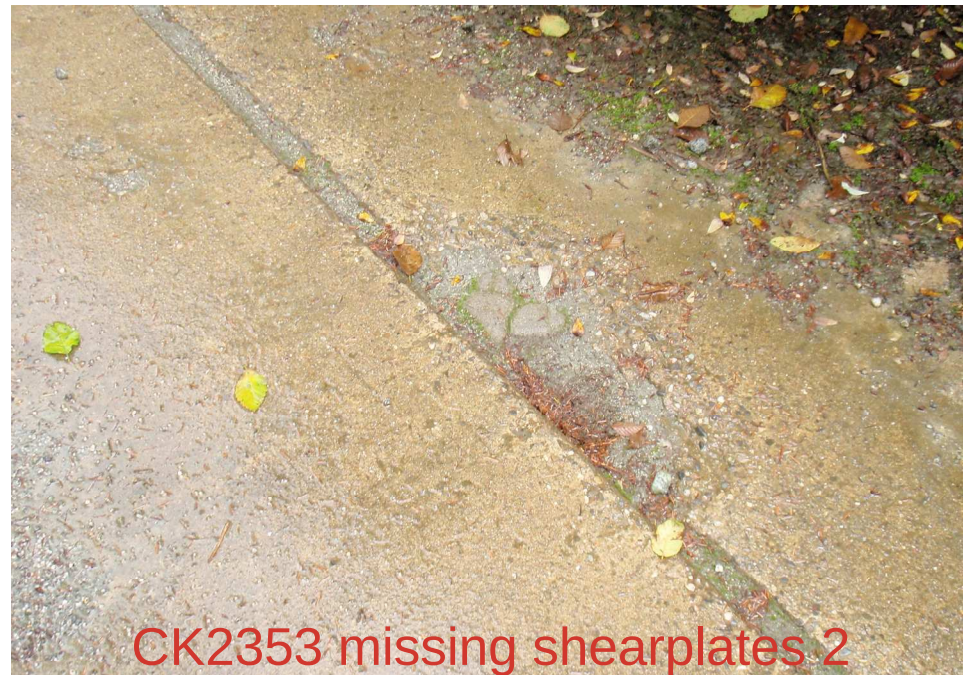
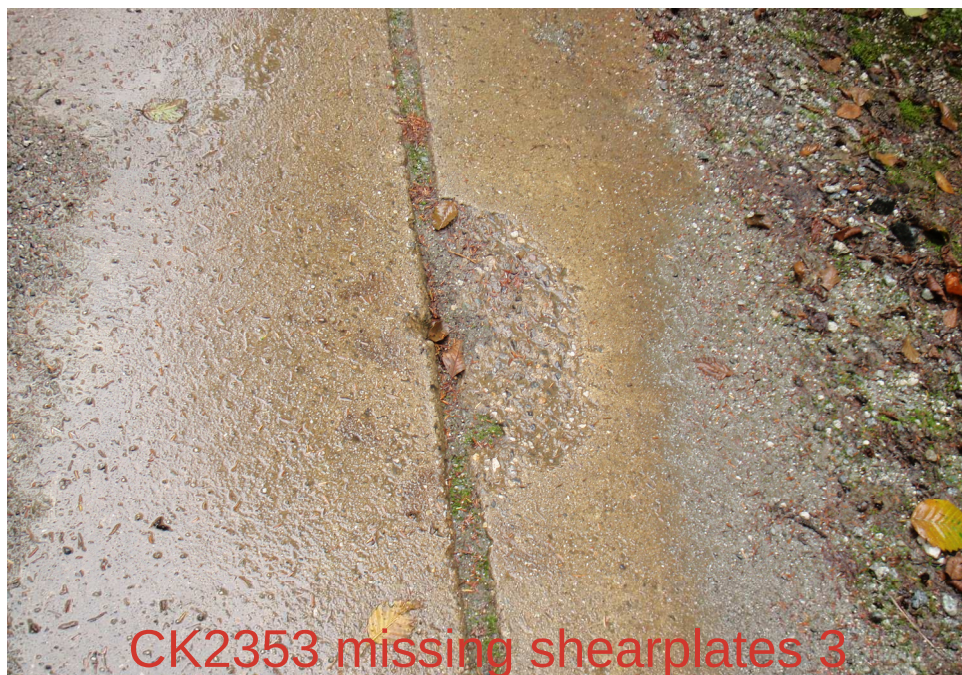
| GENERAL INFORMATION | | | | | | | | | | | | | | | | | | | |
|---|---|---|---|---|---|---|---|---|---|---|---|---|---|---|---|--|--|--|--|
| Welded / Grouted Shear Connectors | E | G | F | P | (N/A) | UR | WOODEN PLATES ??? | | | | | | | | | | | | |

CK2353 missing shearplates

CK2353 missing shearplates 2

CK2353 missing shearplates 3
