**Routine Condition Bridge Inspection Form**  
(except for log stringer or timber stringer bridges)**GENERAL INFORMATION**

| *Site #: <u>CL-2011</u> | *Crossing Name: <u>Cooper Creek</u> | *Type/Class: <input type="checkbox"/> Temporary bridge<br><input checked="" type="checkbox"/> Permanent bridge | *Project File ID# <u>5913</u> |
| *FSR Name: <u>BLUE MTN</u> | *Forest District: <u>CL</u> | *Kilometres: _____ | User km: <u>01</u> |

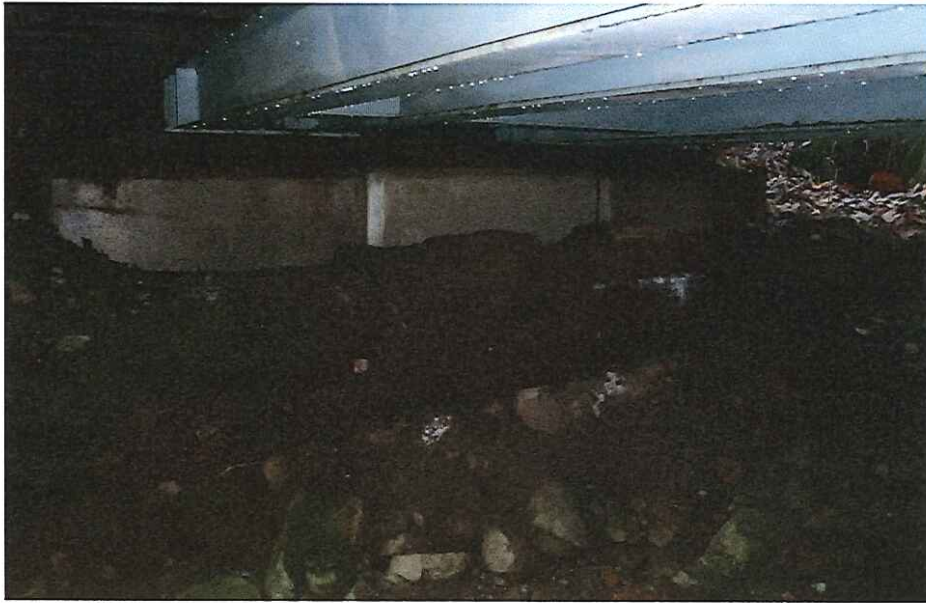
CK2011 Right Abutment

| Item | Present Condition<br>(circle) | Comments<br>(a comment is mandatory if condition "Poor" is selected) |
|---|---|---|
| Log/Timber Cribs | E G F <u>P</u> N/A UR | <u>OLD LOG SILLS IN FRONT OF LOCK BLOCKS</u> |
| Concrete (cast in place; lock blocks, precast) | E <u>G</u> F P N/A UR | <u>Lock blocks behind old crib</u> |

| Monitor Item # | *Monitor Description |
|---|---|
| 1 | MONITOR SCOUR OF AND CRIBS |

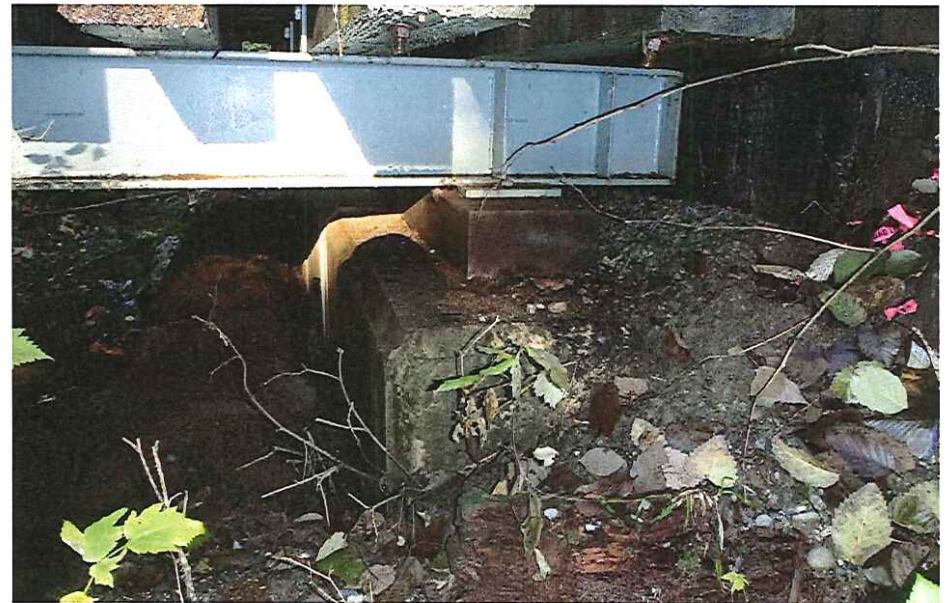
CK2011 Left Abutment bearing

| Item | Present Condition<br>(circle) | Comments<br>(a comment is mandatory if condition "Poor" is selected) |
|---|---|---|
| Bearings | E <u>G</u> F P N/A UR | |

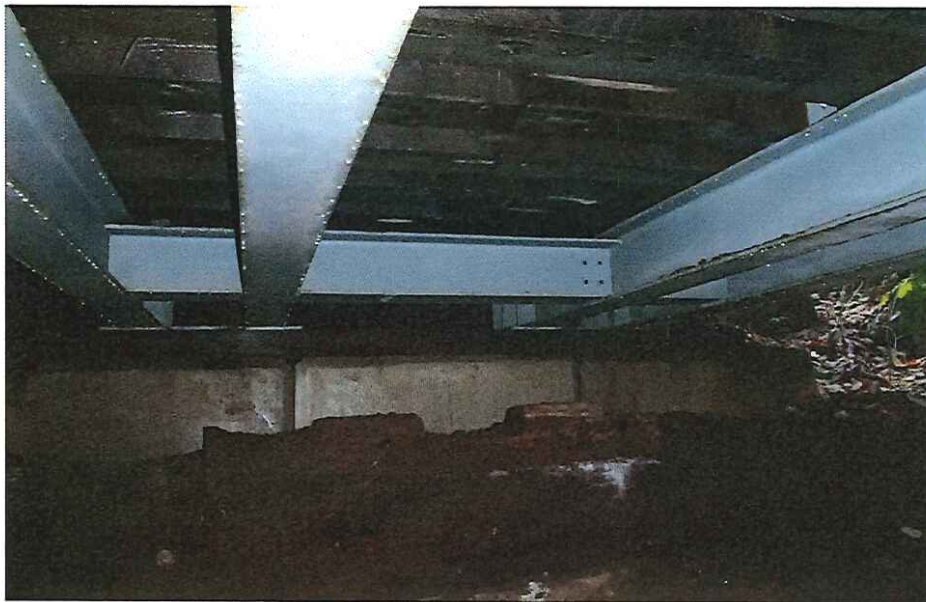
CK2011 Girders

| Item | Present Condition (circle) | Comments<br>(a comment is mandatory if condition "Poor" is selected) |
|---|---|---|
| Girders | E (G) F P UR | 4 I-beams painted - small rusted sections |
