**Routine Condition Bridge Inspection Form**  
(except for log stringer or timber stringer bridges)**GENERAL INFORMATION**

| *Site #: <u>CLC-2012</u> | *Crossing Name: | *Type/Class: <input checked="" type="checkbox"/> Temporary bridge<br><input type="checkbox"/> Permanent bridge | *Project File ID# <u>5713</u> |
| *FSR Name: <u>Blue Mountain</u> | *Forest District: <u>CLC</u> | *Kilometres: | User km: <u>0.8</u> |

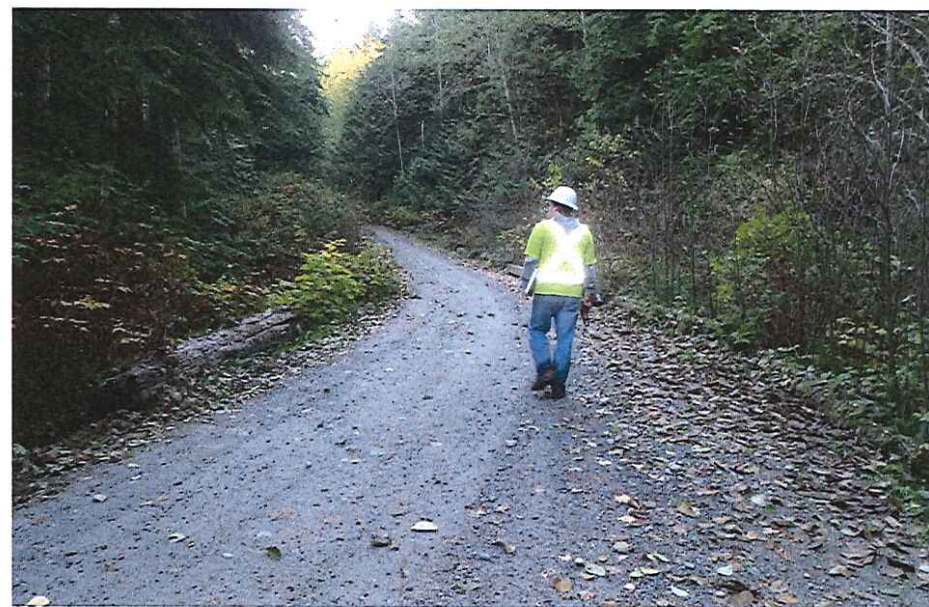
CK2012 Left to Right Approach

| Item | Present Condition (circle or fill-in) | Comments (a comment is mandatory if condition "Poor" is selected) |
|---|---|---|
| Alignment | E G <u>(P)</u> UR | Corners on each side |

Post bridge ahead signs. Present load rating of L75 or 68 tonnes to continue.

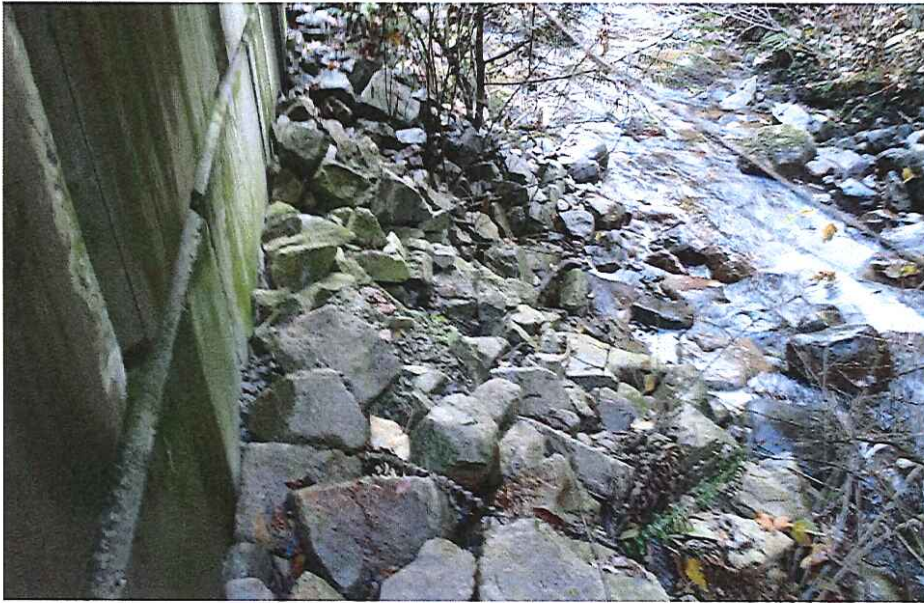
CK2012 Left Abutment rip rap

| Item | Present Condition (circle) | Comments (a comment is mandatory if condition "Poor" is selected) |
|---|---|---|
| Riprap | E G <u>(P)</u> P N/A UR | Right side inadequate |

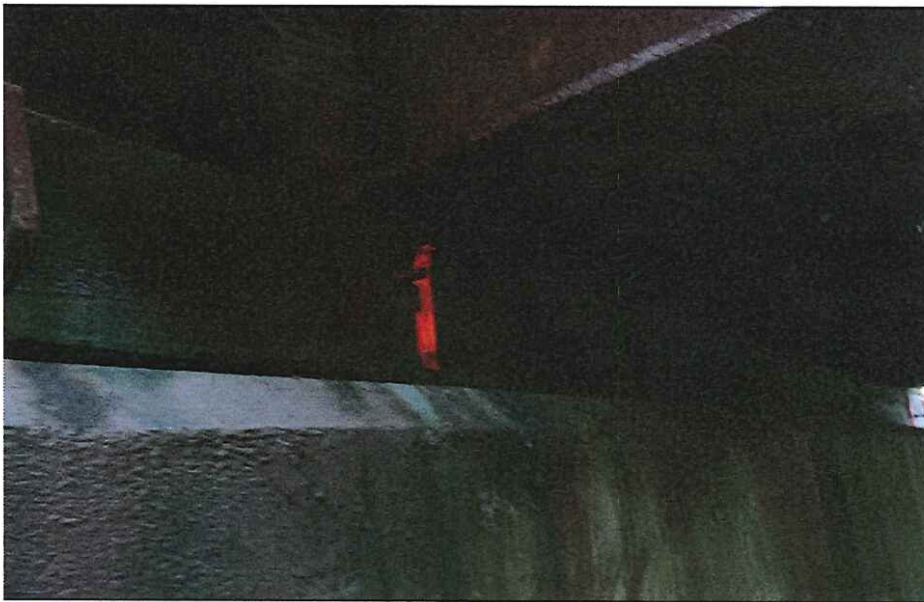
CK2012 Left Abutment bearing

| Item | Present Condition (circle) | Comments (a comment is mandatory if condition "Poor" is selected) |
|---|---|---|
| Bearings | E <u>(G)</u> F P N/A UR | |

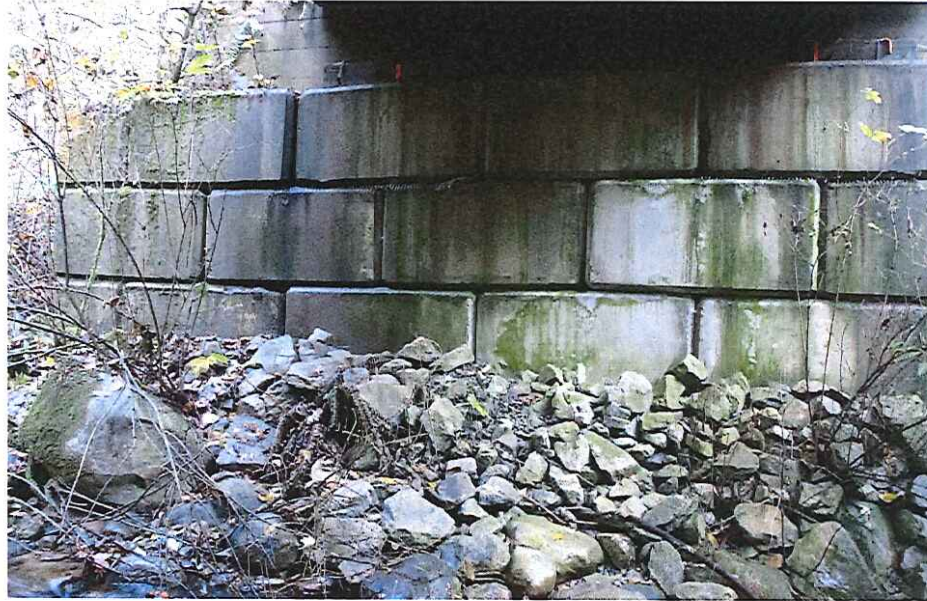
CK2012 Left Abutment

| Item | Present Condition (circle) | Comments (a comment is mandatory if condition "Poor" is selected) |
|---|---|---|
| Concrete (cast in place; lock blocks, precast) | E <u>(G)</u> F P N/A UR | Lock blocks (3 high w/ gravel) |

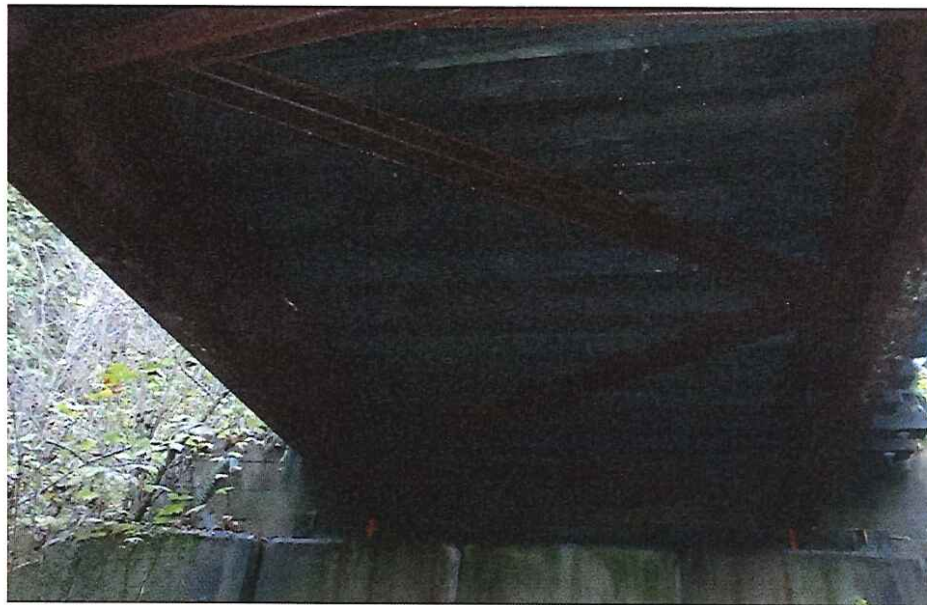
CK2012 Girders

| GENERAL INFORMATION | | | |
|---|---|---|---|
| Girders | E <u>(G)</u> F P UR | Weathering steel (MBS) | |
