**Routine Condition Bridge Inspection Form**  
(except for log stringer or timber stringer bridges)**GENERAL INFORMATION**

| *Site #: <u>CX 2018</u> | *Crossing Name: <u>Cantelon Crk</u> | *Type/Class: <input type="checkbox"/> Temporary bridge<br><input checked="" type="checkbox"/> Permanent bridge | *Project File ID# <u>2124</u> |
| *FSR Name: <u>Cantelon</u> | *Forest District: <u>22</u> | *Kilometres: <u>0.4</u> | User km: <u>0.4</u> |

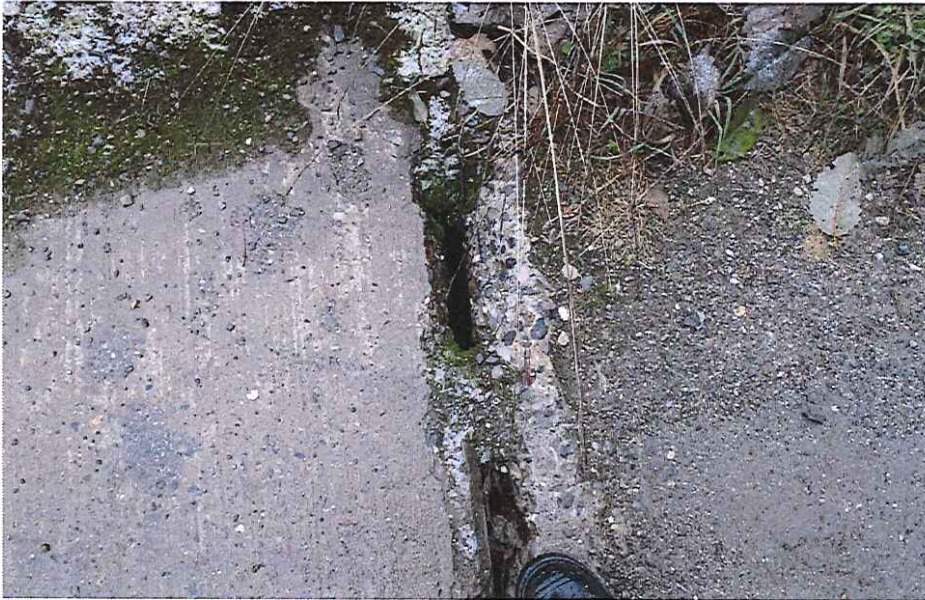
| Item | Present Condition (circle) | Comments (a comment is mandatory if condition "Poor" is selected) |
|---|---|---|
| Ballast Wall | E (G) F P N/A UR | <u>BUT REBAR EXPOSED ON LEFT TOP - FIX</u> |

CK2018 Left ballast wall rebar exposed

| GENERAL INFORMATION | | | |
|---|---|---|---|
| 1 | (H) M L | | TOP OF LEFT BALLAST WALL |

Replace missing delineators and patch left ballast wall. Present load rating of L75 or 68 tonnes to continue.
