**Routine Condition Bridge Inspection Form**  
(except for log stringer or timber stringer bridges)

| GENERAL INFORMATION | | (enter either long/lat or UTM below - not both) | |
|---|---|---|---|
| *Site #: <u>CK 2021</u> | *Crossing Name: <u>Boulder Crk</u> | *Type/Class: <input checked="" type="checkbox"/> Temporary bridge<br><input checked="" type="checkbox"/> Permanent bridge | *Project File ID# <u>8241</u> |
| *Structure #: <u>CK2021</u> | *Forest District: <u>chehalis</u> | *Kilometres: <u>10.6</u> | *Br. <u>01</u> |

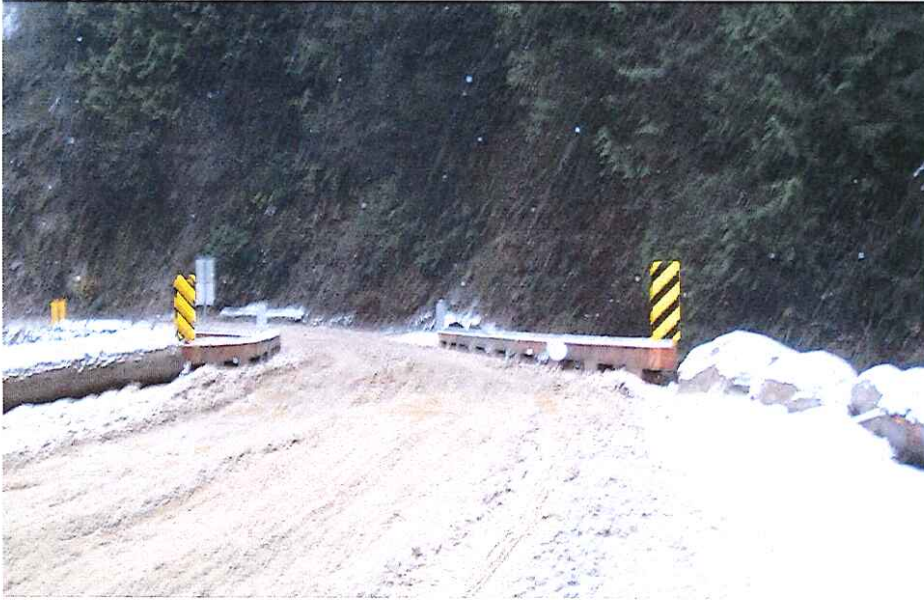
CK-2021 Approach Left Bank

| GENERAL INFORMATION | | (enter either long/lat or UTM below - not both) | |
|---|---|---|---|
| Road Surface | E G F <u>(P)</u> UR | <u>Grading / Patching at approaches</u> | |

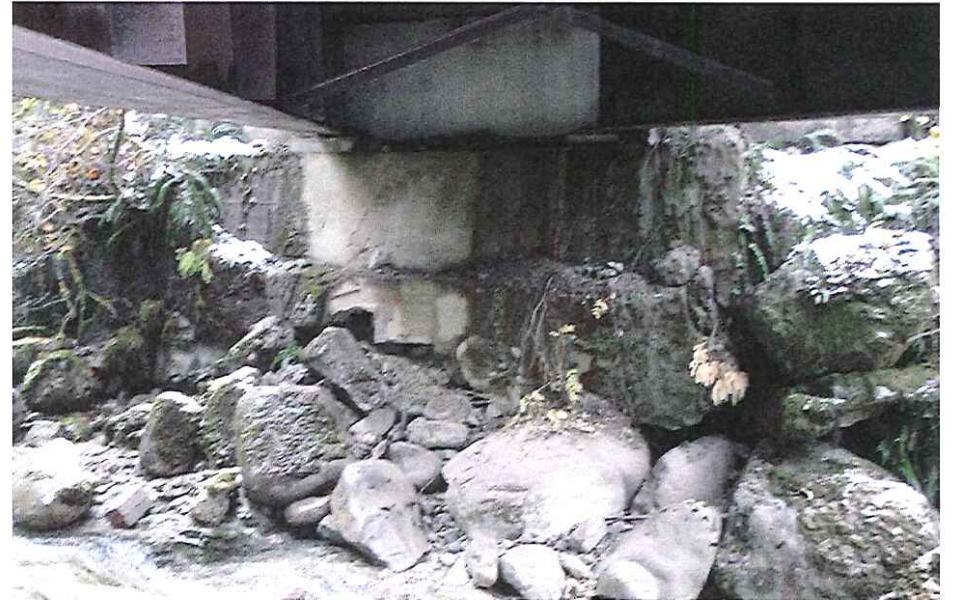
CK-2021 Abutment Left Bank

| GENERAL INFORMATION | | | |
|---|---|---|---|
| 1 | Left bank cast in place abutment front | | |
| 2 | face of footing has pieces breaking off | | |
| P Eng Reviewer's Comments<br><u>Monitor left abutment.</u> | | | |
