**Routine Condition Bridge Inspection Form**  
(except for log stringer or timber stringer bridges)**GENERAL INFORMATION**

| *Site #: <u>CK 2023</u> | *Crossing Name: <u>Upper Bentley</u> | *Type/Class: <input type="checkbox"/> Temporary bridge<br><input checked="" type="checkbox"/> Permanent bridge | *Project File ID# <u>E241</u> |
| *Structure #: <u>CK 2023</u> | *Forest District: <u>Chilliwack</u> | *Kilometres: <u>21.8</u> | *Br. <u>01</u> |
| *FSR Name: <u>Chelalis</u> | *User km: | | |

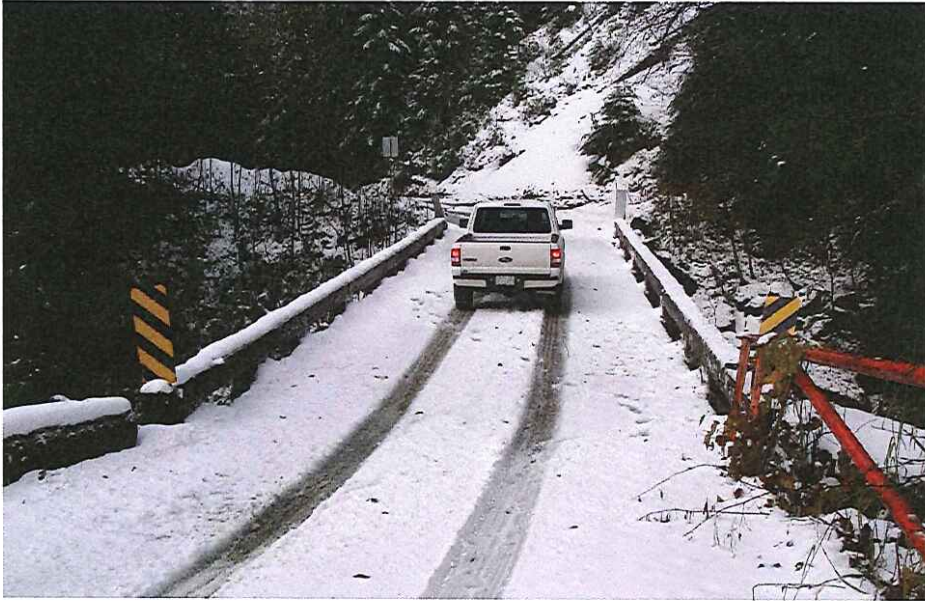
CK-2023Approach Left Bank

| Item | Present Condition<br>(circle or fill-in) | Comments<br>(a comment is mandatory if condition "Poor" is selected) |
|---|---|---|
| Alignment | E G <u>(F)</u> P UR | <u>On a curve</u> |
| Fender Condition | E G <u>(F)</u> P None UR | |
