**Routine Condition Bridge Inspection Form**  
(except for log stringer or timber stringer bridges)

| GENERAL INFORMATION | | (enter either long/lat or UTM below - not both) | | | |
|---|---|---|---|--|--|
| *Site #: <u>CK2025</u> | *Crossing Name: <u>Second Crk</u> | *Type/Class: <input type="checkbox"/> Temporary bridge<br><input checked="" type="checkbox"/> Permanent bridge | *Project File ID# <u>8241</u> | | |
| *Structure #: <u>CK2025</u> | *Forest District: <u>Chilliwack</u> | *Kilometres: <u>26.4</u> | *Br. <u>CL</u> | | |
| *FSR Name: <u>Chelalis</u> | *Forest District: <u>Chilliwack</u> | *User km: | | | |

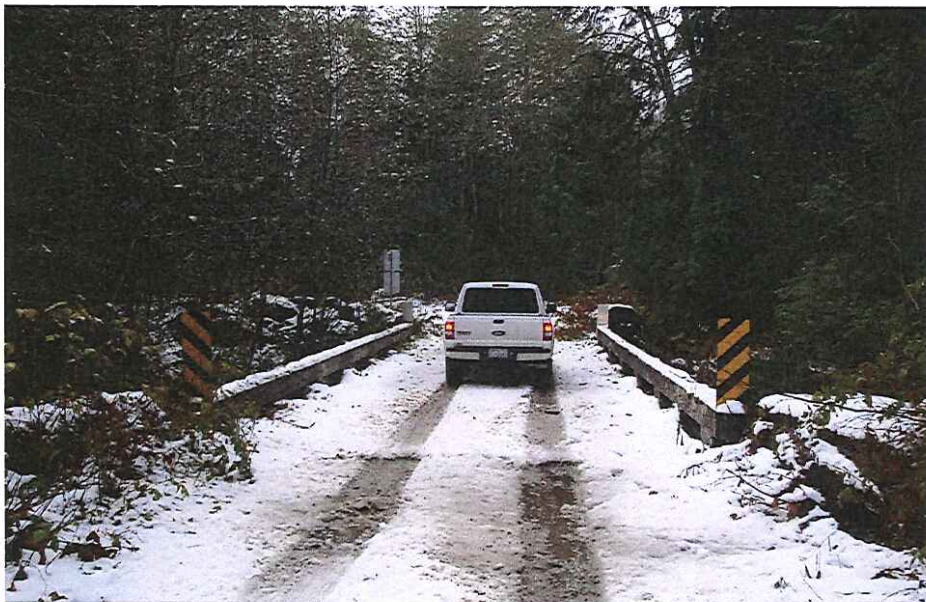
CK-2025 Approach Left Bank

| GENERAL INFORMATION | | (enter either long/lat or UTM below - not both) | | | |
|---|---|---|---|--|--|
| Road Surface | E <u>G</u> F P UR | <u>Approaches need grading</u> | | | |

| GENERAL INFORMATION | | | |
|---|---|---|---|
| 1 | H <u>M</u> L | | Grading / Patching of approaches |

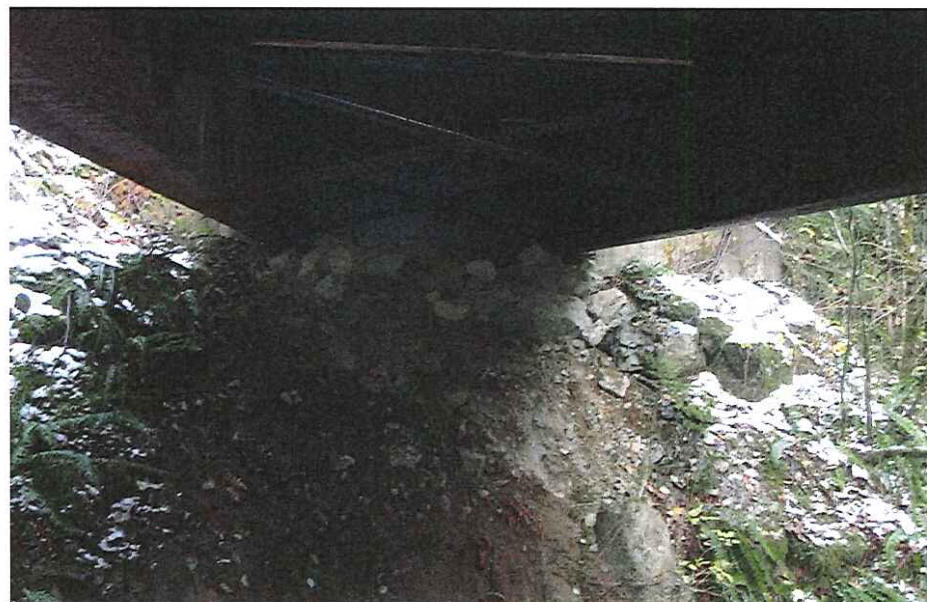
CK-2025 Abutment Left Bank

| GENERAL INFORMATION | | (enter either long/lat or UTM below - not both) | | | |
|---|---|---|---|--|--|
| Bearings | E <u>G</u> F P <u>N/A</u> UR | <u>Bulldging out</u> | | | |

| GENERAL INFORMATION | | | |
|---|---|---|---|
| 1 | Check bearing pads next inspection | | |
