**Routine Condition Bridge Inspection Form**  
(except for log stringer or timber stringer bridges)**GENERAL INFORMATION**

| *Site #: <u>CL 7031</u> | *Crossing Name: <u>Statlu</u> | *Type/Class: <input checked="" type="checkbox"/> Temporary bridge<br><input checked="" type="checkbox"/> Permanent bridge | *Project File ID# <u>8241</u> |
| *FSR Name: <u>Chehalis Statlu</u> | *Forest District: <u>Chilliwack</u> | *Kilometres: <u>1.8</u> | Usor km: |

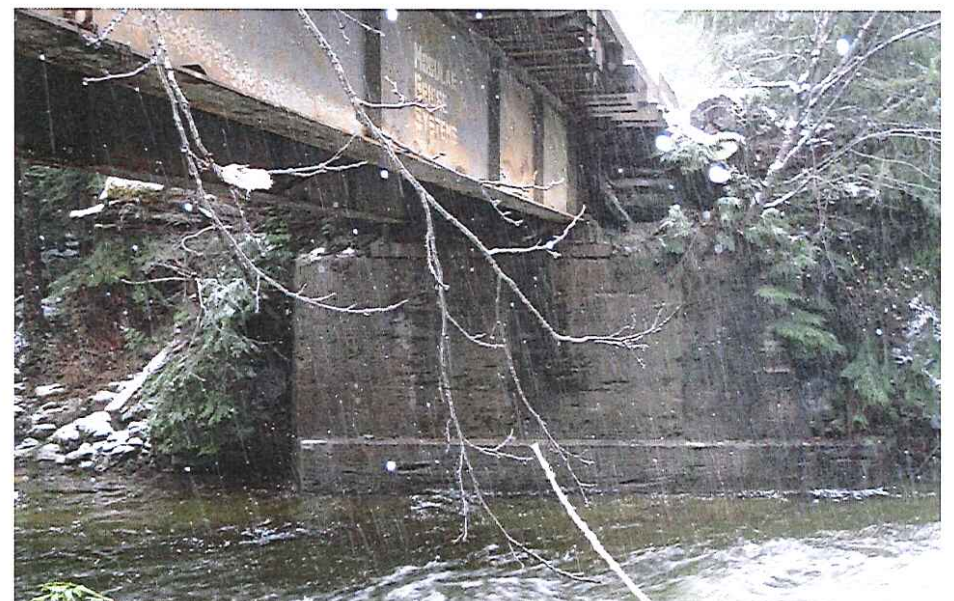
CK-2031 Abutment Right Bank

| GENERAL INFORMATION | | | |
|---|---|---|---|
| 1 | Previous inspection note scour under right abutment | | |
