**Routine Condition Bridge Inspection Form**  
(for log stringer or timber stringer bridges)**GENERAL INFORMATION**

| *Site #: <u>CK-2066</u> | *Crossing Name: <u>Stapley Crk</u> | *Type/Class: <input type="checkbox"/> Major Culvert<br><input type="checkbox"/> Woodbox/Log Culvert | *Project File ID# <u>5127</u> |
| *FSR Name: <u>Chilliwack - Tamihi</u> | *Forest District: <u>CK</u> | *Kilometres: <u>10.3km</u> | User km: _____ |

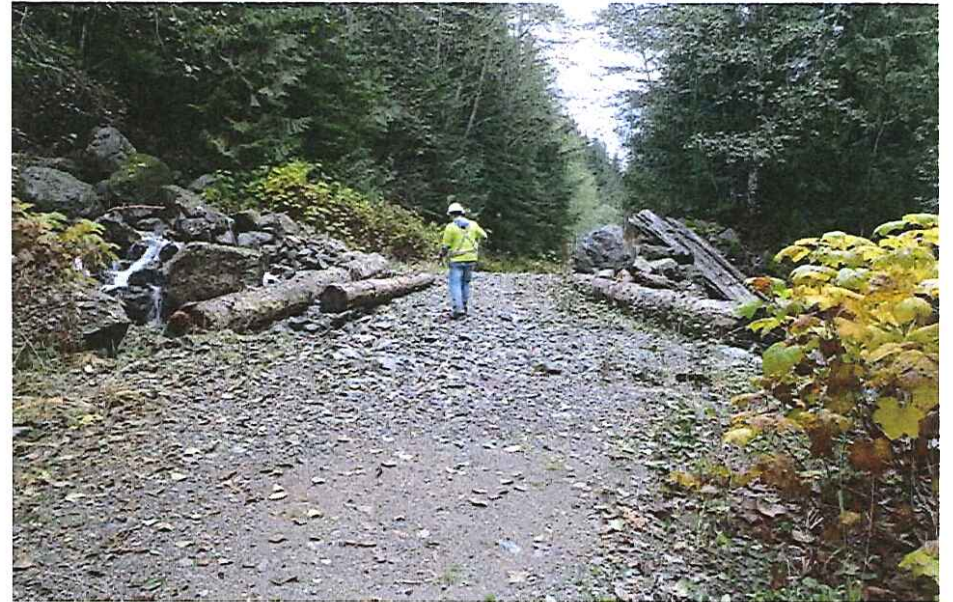
CK2066 Right to Left Approach

| Item | Present Condition<br>(circle or fill-in) | Comments<br>(a comment is mandatory if condition "Poor" is selected) |
|---|---|---|
| Road Surface | E G F <u>(F)</u> UR | <u>very bony surface</u> |

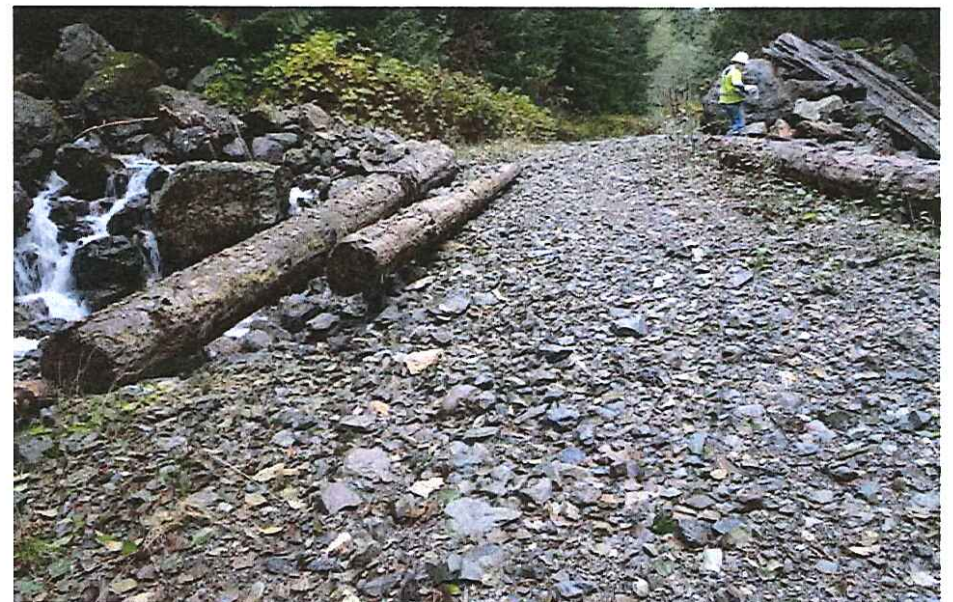
CK2066 Deck

| Item | Present Condition<br>(circle) | Comments<br>(a comment is mandatory if condition "Poor" is selected) |
|---|---|---|
| Curb Rail/Blocks/Posts | E G F <u>(P)</u> UR | <u>loose w/ gravel deck foiling under</u> |
| Hardware | E G F <u>(F)</u> N/A UR | <u>Loose lashing</u> |

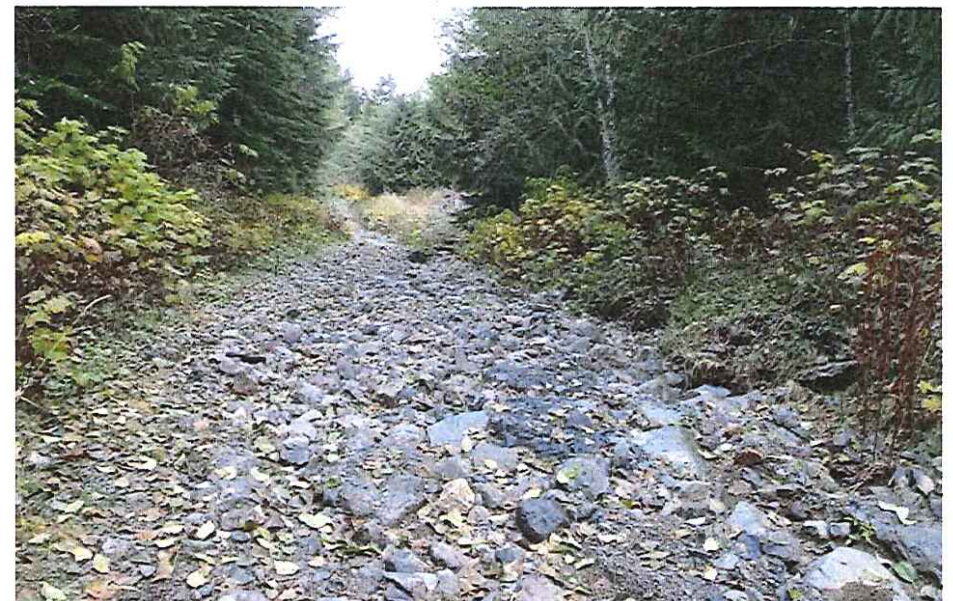
However, the the structure is undersized and is diverting high flows down the road; remove or replace.

CK2066 Left Approach scour from diverted water

| Repair Item # | *Priority (circle) | *Estimate (\$) | *Repair Description |
|---|---|---|---|
| 1 | <u>H</u> M L | | REMOVE ASAP - DIVERTING FLOW DOWN ROAD |
