**Routine Condition Bridge Inspection Form**  
(except for log stringer or timber stringer bridges)**GENERAL INFORMATION**

| *Site #: <u>067087</u> | *Crossing Name: <u>Cedarflat Crk</u> | *Type/Class: <input checked="" type="checkbox"/> Temporary bridge<br><input type="checkbox"/> Permanent bridge | *Project File ID# <u>7995</u> |
| *FSR Name: <u>DEWNEY</u> | *Forest District: <u>CK</u> | *Kilometres: | User km: <u>5.4</u> |

| GENERAL INFORMATION | | | |
|---|---|---|---|
| *Date of Inspection (yyyy/mm/dd)<br><u>2011/11/12</u> | *Inspection Company Name<br><u>GWS ENGINE LTD</u> | *Inspector's Name (print)<br><u>J. C. P. ARAKI</u> | Inspector's Signature<br> |

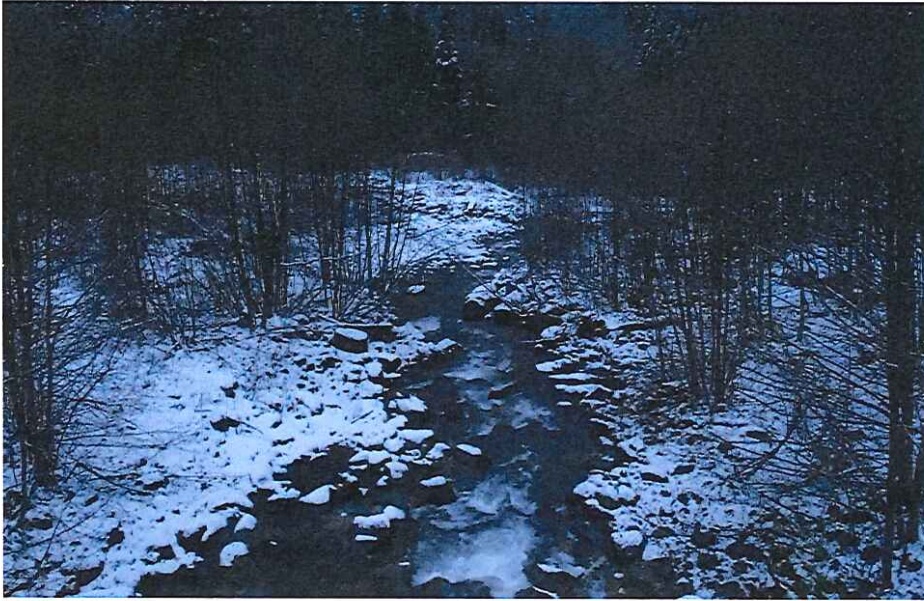
CK2087 Downstream

| GENERAL INFORMATION | | | |
|---|---|---|---|
| Comments: <u>VERY ACTIVE CHANNEL</u> | | | |

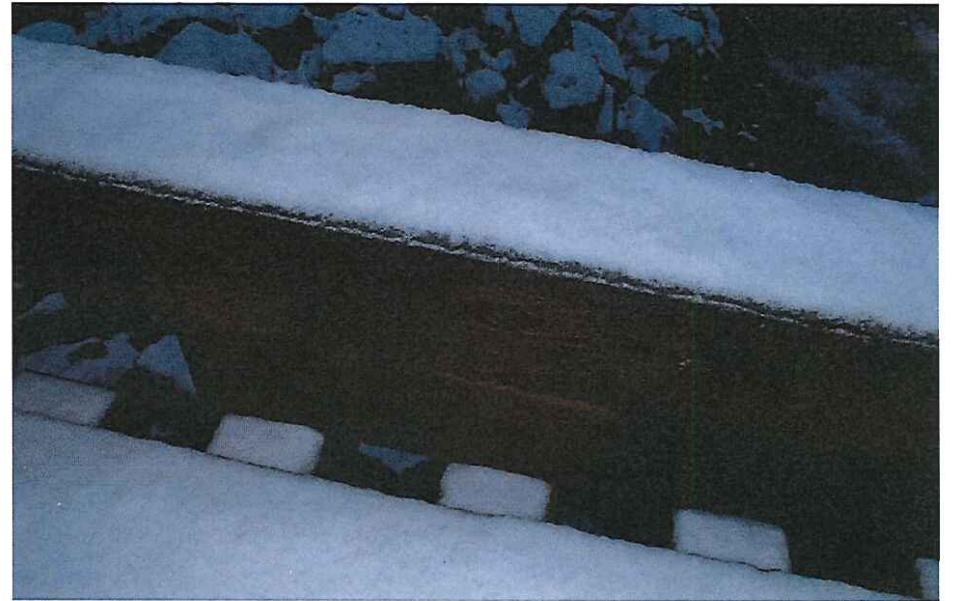
CK2087 Guard Rails

| Item | Present Condition (circle) | Comments (a comment is mandatory if condition "Poor" is selected) |
|---|---|---|
| Curb Rail/Blocks/Posts | <u>(E)</u> G F P UR | <u>NEW</u> |

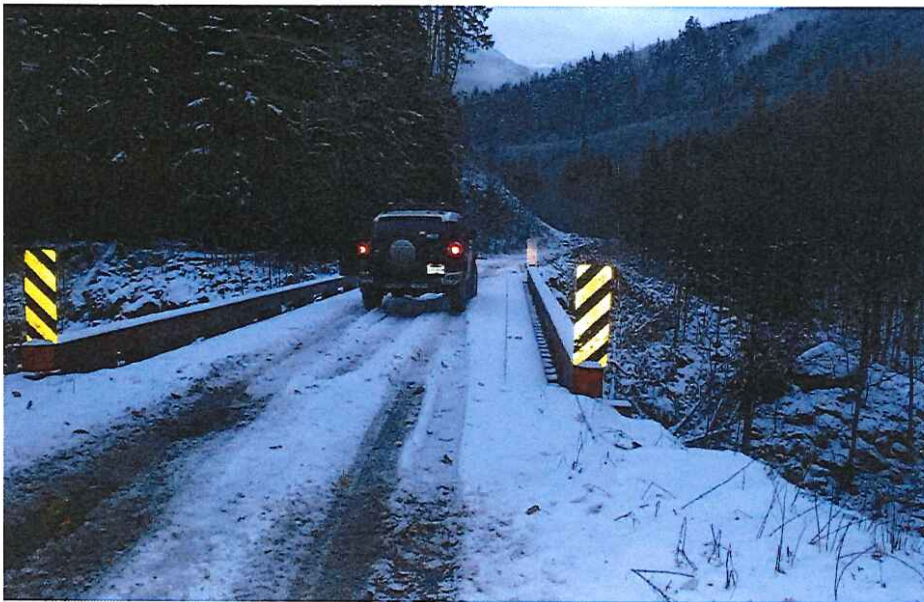
CK2087 Right to Left Approach

| Item | Present Condition (circle or fill-in) | Comments (a comment is mandatory if condition "Poor" is selected) |
|---|---|---|
| Road Surface | E G <u>(F)</u> P UR | <u>BIG POTHOLES</u> |

| GENERAL INFORMATION | | | |
|---|---|---|---|
| P Eng Reviewer's Comments<br><u>Post bridge ahead signs.</u> | | | |

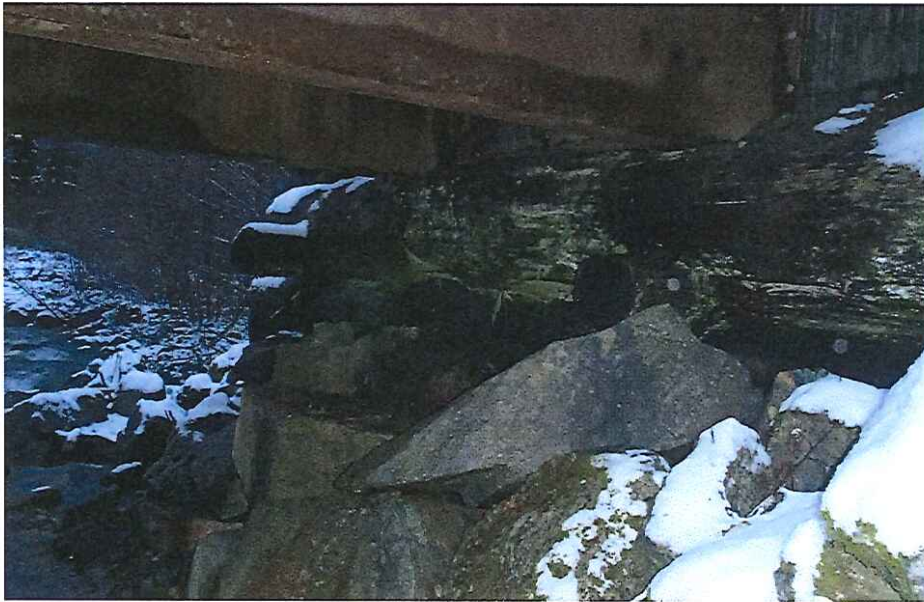
CK2087 Right Abutment

| Item | Present Condition (circle) | Comments (a comment is mandatory if condition "Poor" is selected) |
|---|---|---|
| Log/Timber Cribs | E G <u>(F)</u> P N/A UR | <u>CRIBS w/ SOME ROT BUT GENERALLY GOOD</u> |
| Tie-backs | E G <u>(F)</u> P N/A UR | <u>42 NOT CRUSHING</u> |

| GENERAL INFORMATION | | | |
|---|---|---|---|
| 1 | cribs | | |

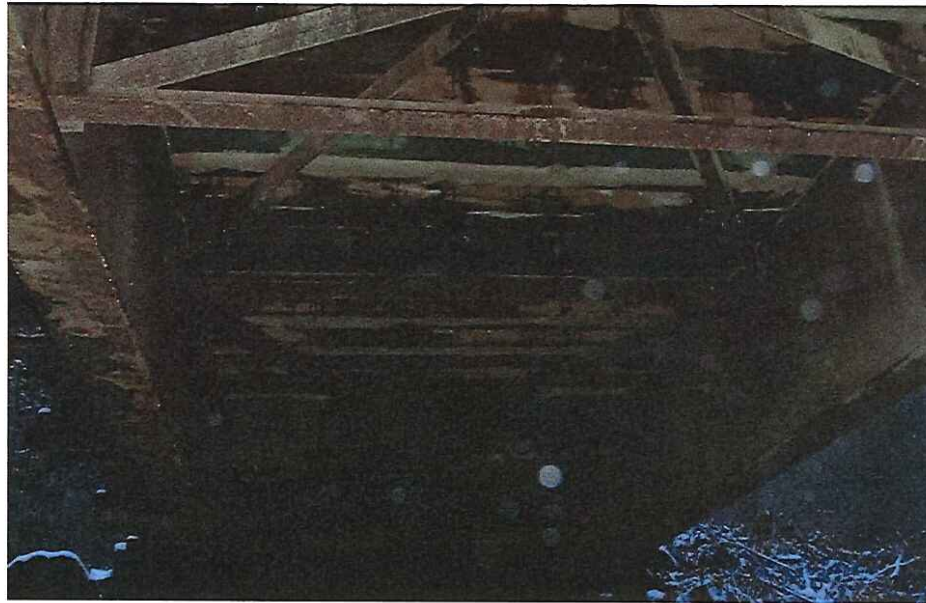
CK2087 Girders

| GENERAL INFORMATION | | | |
|---|---|---|---|
| Girders | E <u>G</u> F P UR | | |
| Welded / Grouted Shear Connectors | E G F P <u>N/A</u> UR | STEEL BEAM BRIDGE 16130L | |
| | | LONG W/ 9.4L WIDE TIMBER DECK | |
