**Routine Condition Bridge Inspection Form**  
(except for log stringer or timber stringer bridges)**GENERAL INFORMATION**

| *Site #: <u>CL 2092</u> | *Crossing Name: <u>Rockwell Crk</u> | *Type/Class: <input type="checkbox"/> Temporary bridge<br><input checked="" type="checkbox"/> Permanent bridge | *Project File ID# <u>8648</u> |
| *FSR Name: <u>Florence</u> | *Forest District: <u>Chilliwack</u> | *Kilometres: <u>4.2km</u> | User km: |

| GENERAL INFORMATION | | | |
|---|---|---|---|
| *Date of Inspection (yyyy/mm/dd)<br>2011/11/15 | *Inspection Company Name<br>On Site Eng Ltd. | *Inspector's Name (print)<br>Greg Honeywell | Inspector's Signature<br>Greg Honeywell |

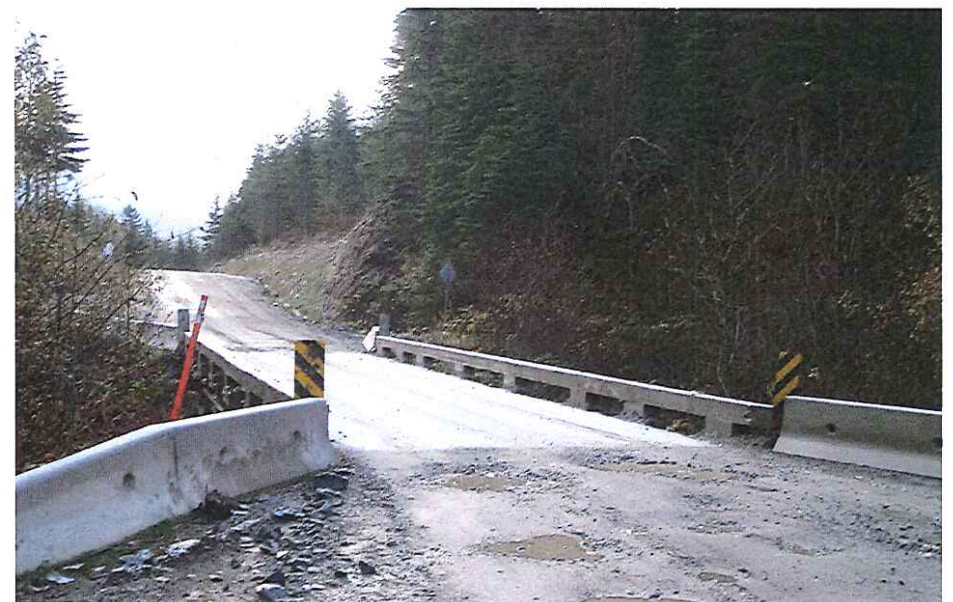
CK-2092 Approach Left Bank

| Item | Present Condition<br>(circle or fill-in) | Comments<br>(a comment is mandatory if condition "Poor" is selected) |
|---|---|---|
| Road Surface | E G F (P) UR | Needs grading/patching behind ballast wall |

| GENERAL INFORMATION | | | |
|---|---|---|---|
| 1 | H <u>M</u> L | | Grade patch approaches<br>Brush out approaches |
