**Routine Condition Bridge Inspection Form**  
(except for log stringer or timber stringer bridges)**GENERAL INFORMATION**

| *Site #: <u>CK 2093</u> | *Crossing Name: <u>79 crk</u> | *Type/Class: <input type="checkbox"/> Temporary bridge<br><input checked="" type="checkbox"/> Permanent bridge | *Project File ID# <u>56048</u> |
| *FSR Name: <u>Florence</u> | *Forest District: | *Kilometres: <u>7.0km</u> | User km: |

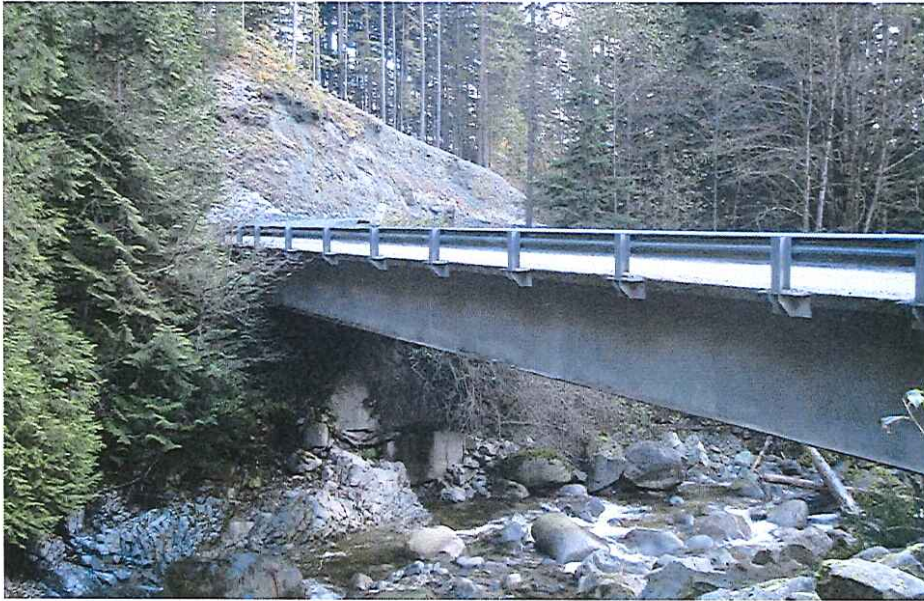
CK-2093 Crossing Upstream

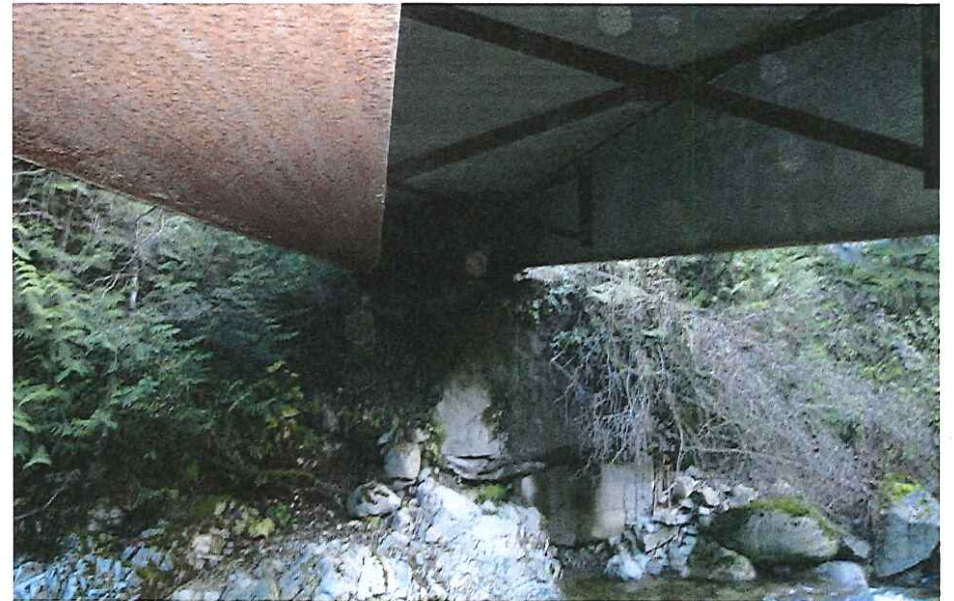
CK-2093 Abutment Left Bank

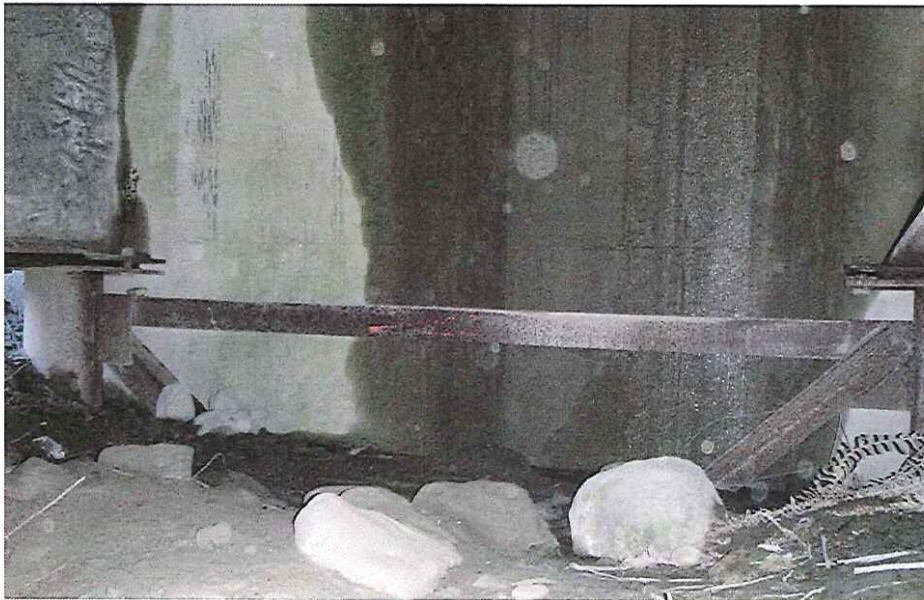
CK-2093 Abutment Right Bank

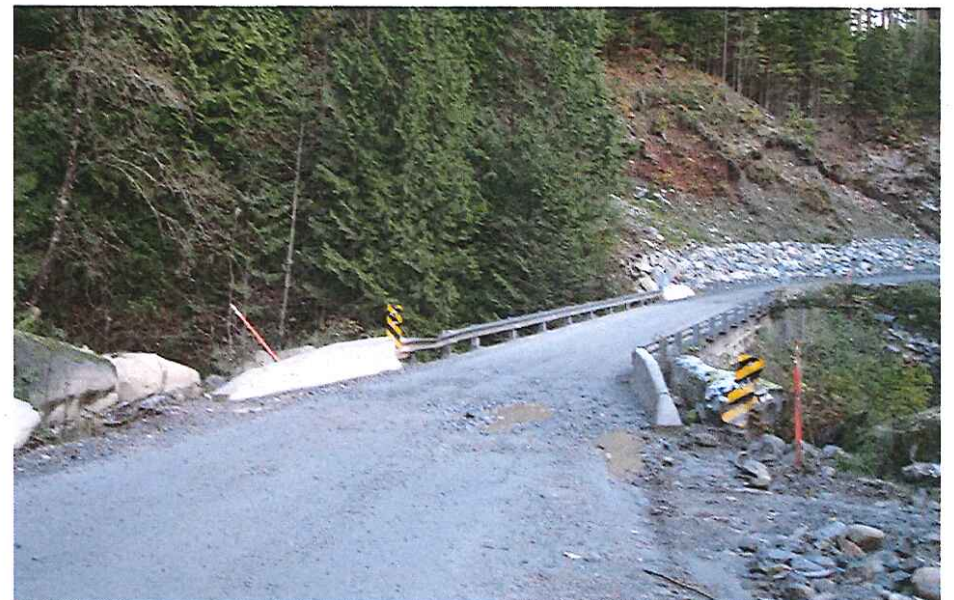
CK-2093 Approach Right Bank

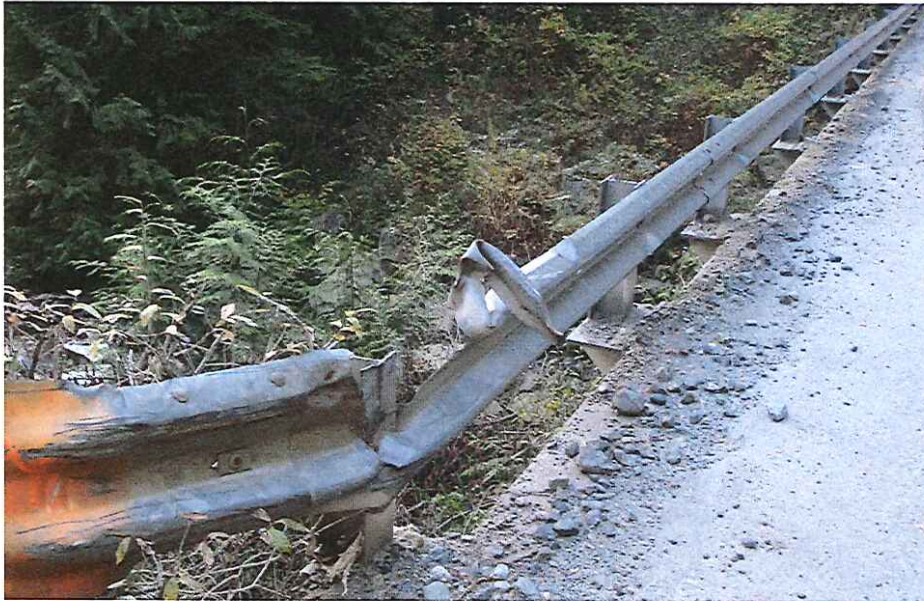
| Item | Present Condition (circle) | Comments (a comment is mandatory if condition "Poor" is selected) |
|---|---|---|
| Curb Rail/Blocks/Posts | E G (F) P UR | <i>Some mechanical damage still functional</i> |

CK-2093 Downstream Left Bank Guardrail

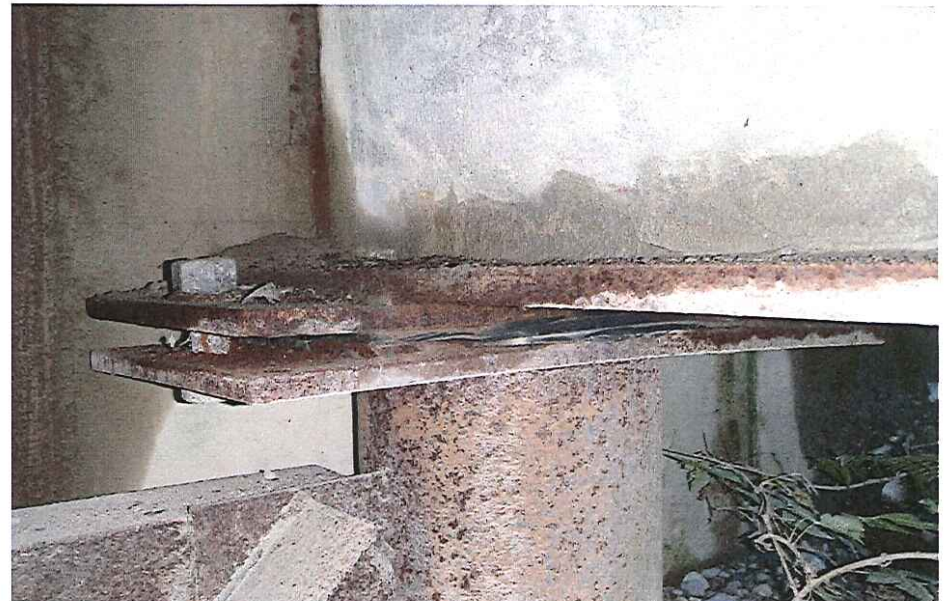
| Item | Present Condition (circle) | Comments (a comment is mandatory if condition "Poor" is selected) |
|---|---|---|
| Bearings | E (G) (F) P N/A UR | |

CK-2093 Condition of Bearing Pads

| GENERAL INFORMATION | | | |
|---|---|---|---|
| 2 | monitor bearing pads | | |

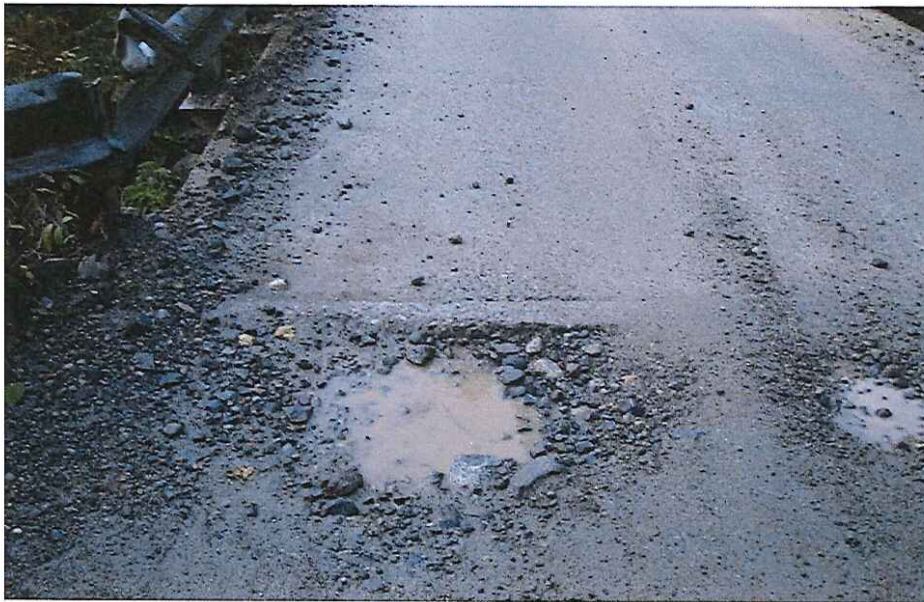
| Item | Present Condition (circle or fill-in) | Comments (a comment is mandatory if condition "Poor" is selected) |
|---|---|---|
| Road Surface | E G F (P) UR | <i>Needs grading patching</i> |

CK-2093 Condition of Approaches

| GENERAL INFORMATION | | | |
|---|---|---|---|
| 1 | H <u>M</u> L | | Clean deck<br>grade approaches |

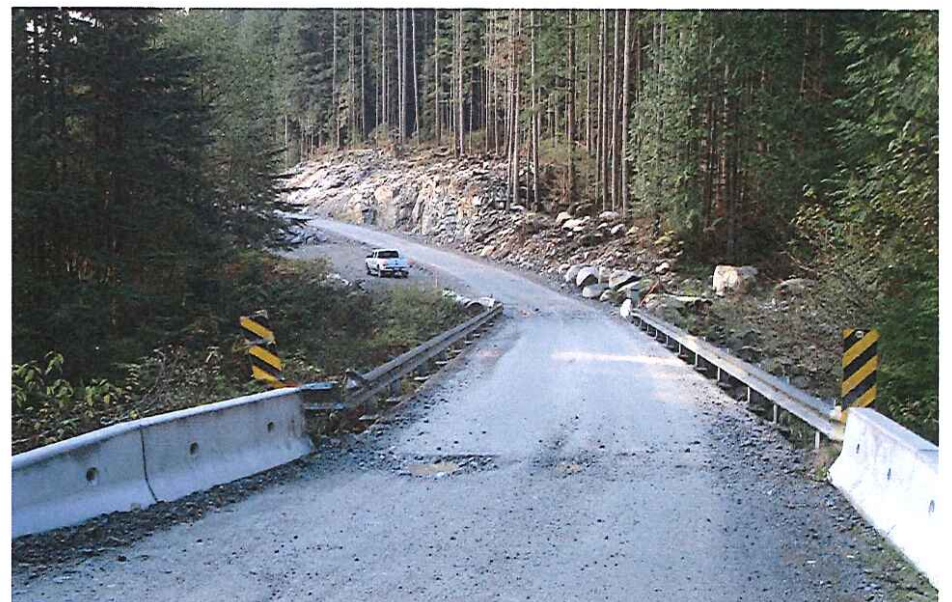
CK-2093 Approach Left Bank
