**Routine Condition Bridge Inspection Form**  
(except for log stringer or timber stringer bridges)**GENERAL INFORMATION** (enter either longlat or UTM below – not both)

| *Site #: <u>CV 2094</u> | *Crossing Name: <u>Unknown</u> | *Type/Class: <input type="checkbox"/> Temporary bridge<br><input checked="" type="checkbox"/> Permanent bridge | *Project File ID# <u>8648</u> |
| *FSR Name: <u>Florence</u> | *Forest District: <u>Chilliwack</u> | *Kilometres: <u>7.8 km</u> | User km: |

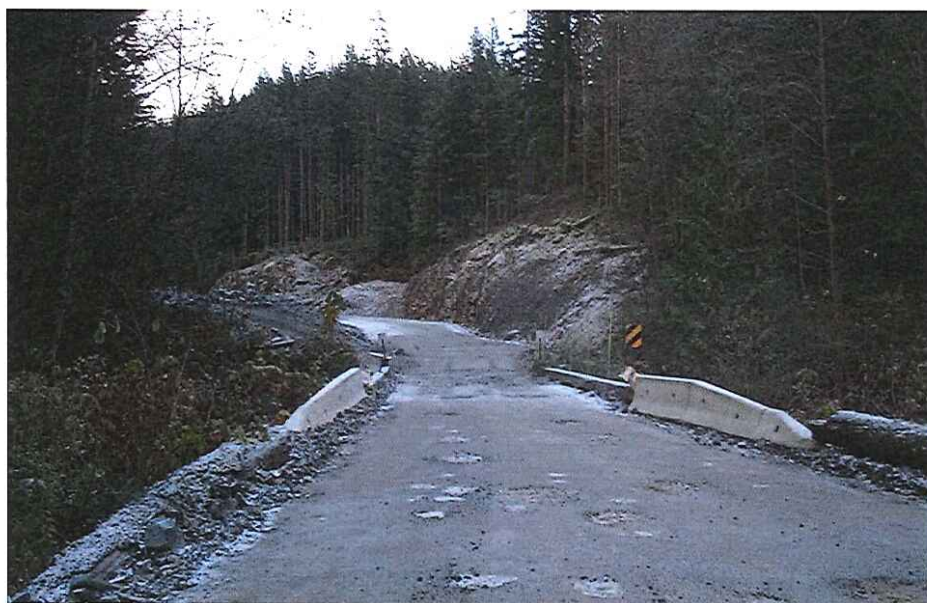
CK2094 Approach Right Bank

| Item | Present Condition<br>(circle or fill-in) | Comments<br>(a comment is mandatory if condition "Poor" is selected) |
|---|---|---|
| Road Surface | E G F (P) UR | Needs grading |

| GENERAL INFORMATION | | | |
|---|---|---|---|
| 1 | H <b>M</b> L | | Grade deck and approaches |
