**Routine Condition Bridge Inspection Form**  
(except for log stringer or timber stringer bridges)

| GENERAL INFORMATION | | | | (enter either long/lat or UTM below - not both) | | |
|---|---|---|---|---|--|--|
| *Site #: <u>CK-2096</u> | *Crossing Name: | *Type/Class: <input type="checkbox"/> Temporary bridge<br><input checked="" type="checkbox"/> Permanent bridge | *Project File ID# <u>8648</u> | | | |
| *FSR Name:<br><u>Furrow Lake FSR</u> | *Forest District:<br><u>OK</u> | *Kilometres:<br><u>13.1</u> | User km: | | | |

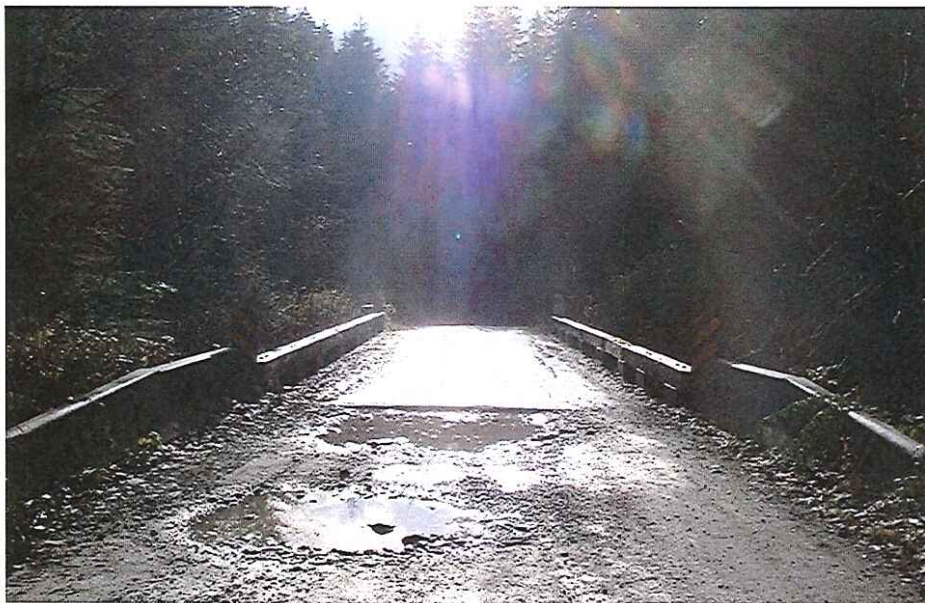
CK2096 Approach Left Bank

| GENERAL INFORMATION | | | | (enter either long/lat or UTM below - not both) | | |
|---|---|---|---|---|--|--|
| Road Surface | E G F <u>P</u> UR | large potholes on approaches. | | | | |

| GENERAL INFORMATION | | | |
|---|---|---|---|
| 2 | H <u>M</u> L | | grade approaches |

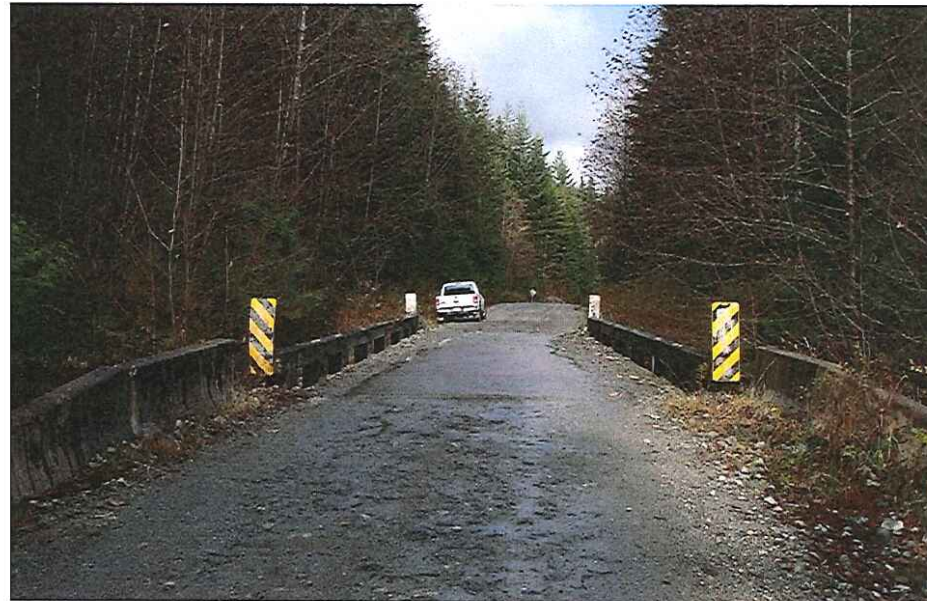
CK2096 Approach Right Bank

| GENERAL INFORMATION | | | | (enter either long/lat or UTM below - not both) | | |
|---|---|---|---|---|--|--|
| Alignment | E G <u>F</u> P UR | RIGHT VER alignment on right approach. | | | | |
