**Routine Condition Bridge Inspection Form**  
(except for log stringer or timber stringer bridges)**GENERAL INFORMATION**

| *Site #: <u>SK-2097</u> | *Crossing Name: | *Type/Class: <input type="checkbox"/> Temporary bridge<br><input checked="" type="checkbox"/> Permanent bridge | *Project File ID# <u>2648</u> |
| *FSR Name: <u>Florence Lake FSR</u> | *Forest District: <u>CK</u> | *Kilometres: <u>13.6</u> | User km: |

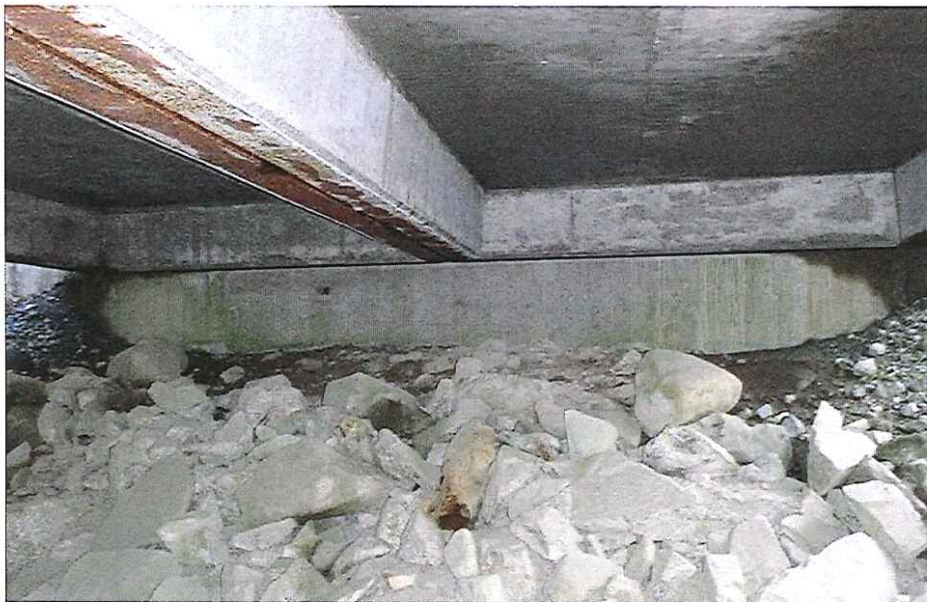
CK2097 Abutment Right Bank

| Item | Present Condition<br>(circle) | Comments<br>(a comment is mandatory if condition "Poor" is selected) |
|---|---|---|
| Concrete (cast in place; lock blocks, precast) | E <u>(G)</u> F P N/A UR | <u>Precast concrete cap + ballast wall amb.</u> |
| Caps or Sills | E <u>(G)</u> F P N/A UR | <u>precast concrete</u> |

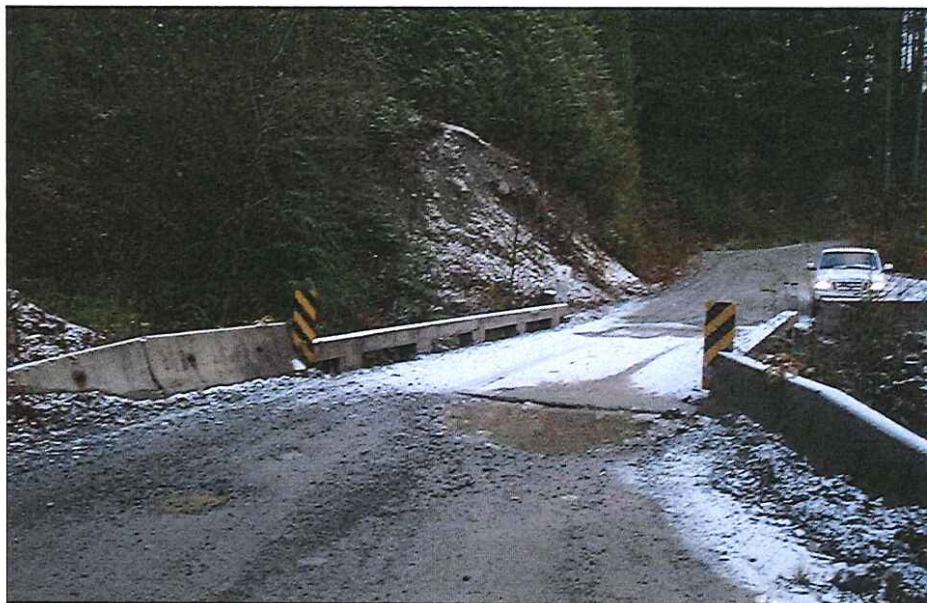
CK2097 Approach Right Bank

| Item | Present Condition<br>(circle or fill-in) | Comments<br>(a comment is mandatory if condition "Poor" is selected) |
|---|---|---|
| Road Surface | E G F <u>(D)</u> UR | <u>large potholes on approaches.</u> |

| GENERAL INFORMATION | | | | | |
|---|---|---|---|---|---|
| 1 | H M (L) | | grade/place material on approaches | | |
