**Routine Condition Bridge Inspection Form**  
(except for log stringer or timber stringer bridges)**GENERAL INFORMATION**

| *Site #: <u>CK-2098</u> | *Crossing Name: | *Type/Class: <input type="checkbox"/> Temporary bridge<br><input checked="" type="checkbox"/> Permanent bridge | *Project File ID# <u>2648</u> |
| *FSR Name: <u>Fluvine Lake FSR</u> | *Forest District: <u>CLC</u> | *Kilometres: <u>13.9</u> | User km: |

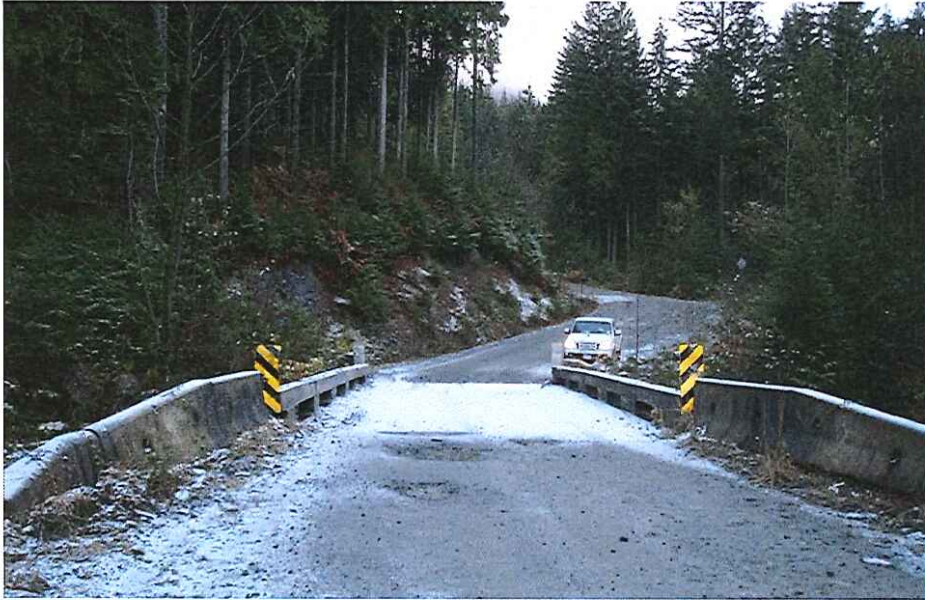
CK2098 Approach Right Bank

| Item | Present Condition (circle or fill-in) | Comments (a comment is mandatory if condition "Poor" is selected) |
|---|---|---|
| Road Surface | E G F <u>(P)</u> UR | large potholes on approaches - possible dam to deck. |

| GENERAL INFORMATION | | | |
|---|---|---|---|
| 1 | H <u>M</u> L | | grade/place material on approaches |
| P Eng Reviewer's Comments<br>Place material/grade approaches. | | | |

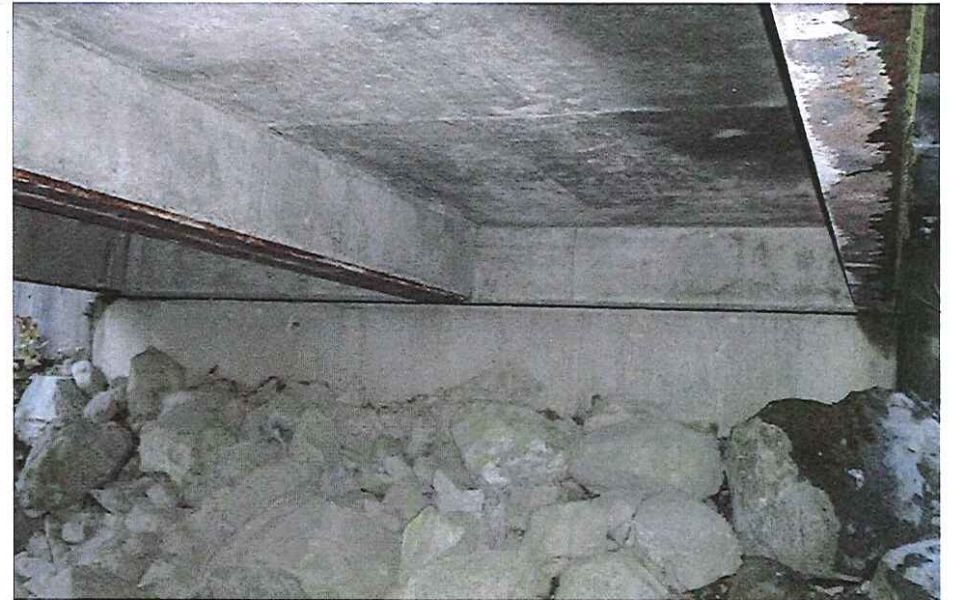
CK2098 Abutment Left Bank

| Item | Present Condition (circle) | Comments (a comment is mandatory if condition "Poor" is selected) |
|---|---|---|
| Concrete (cast in place; lock blocks, precast) | E <u>(G)</u> F P N/A UR | Precast concrete-ballast wall combo |
| Caps or Sills | E <u>(G)</u> F P N/A UR | Concrete cap |

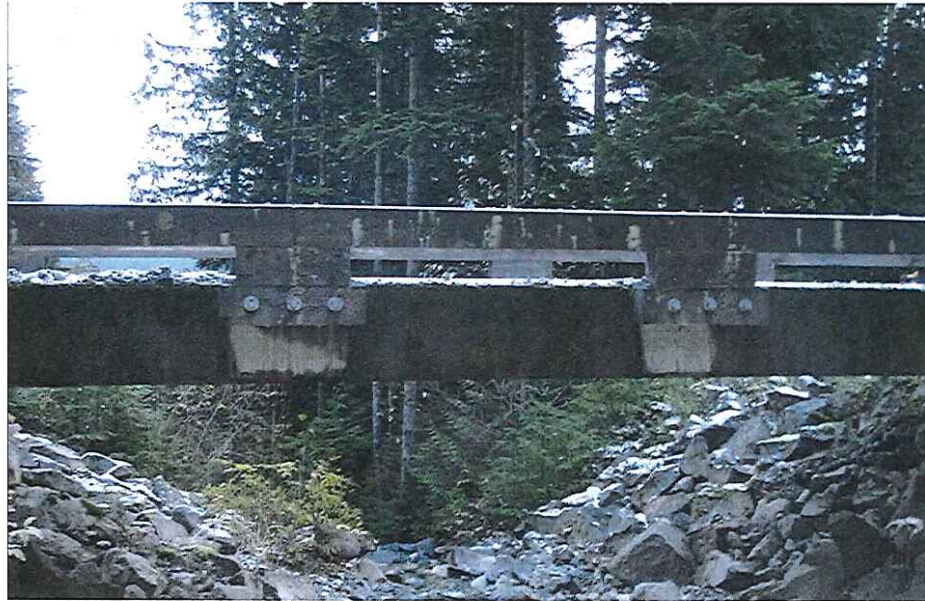
CK2098 Crossing Upstream

| GENERAL INFORMATION | | | |
|---|---|---|---|
| Comments <u>channel runs large amount of transient load bed.</u> | | | |
