**Routine Condition Bridge Inspection Form**  
(except for log stringer or timber stringer bridges)

| GENERAL INFORMATION | | (enter either longlat or UTM below - not both) | | | |
|---|---|---|---|---|---|
| *Site #: CK-2099 | *Crossing Name: | *Type/Class: <input type="checkbox"/> Temporary bridge<br><input checked="" type="checkbox"/> Permanent bridge | | *Project File ID# 8448 | |
| *FSR Name: Florence FSR | *Forest District: 14.1 | *Kilometres: | | User km: | |

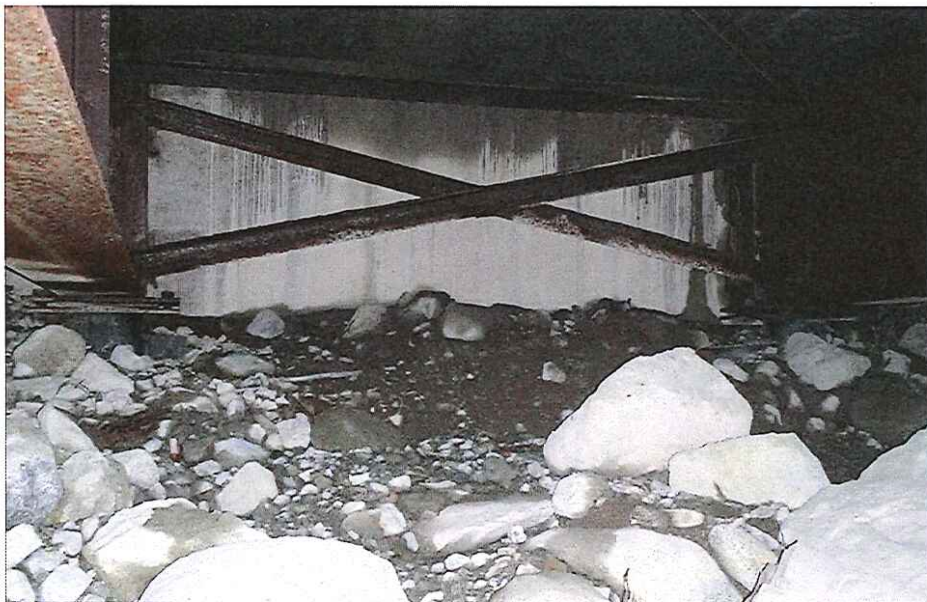
CK2099 Abutment Right Bank

| GENERAL INFORMATION | | (enter either longlat or UTM below - not both) | | | |
|---|---|---|---|---|---|
| Ballast Wall | E G (F) P N/A UR | DOWN STREAM, RIGHT ABUT. BALLAST WALL DAMAGED + REBAR EXPOSED. DUE TO LACK OF FILL AT THE APPROACH & IMPACT | | | |
| Riprap | E G (F) P N/A UR | SLOPE ON RIGHT ABUT RIP RAP | | | |

| GENERAL INFORMATION | | | |
|---|---|---|---|
| 1 | H (M) L | | patch downstream right ballast wall to |
| 2 | H M L | | cover exposed rebar |
| 1 | Monitor scour on the toe of rip rap @ right abutment | | |

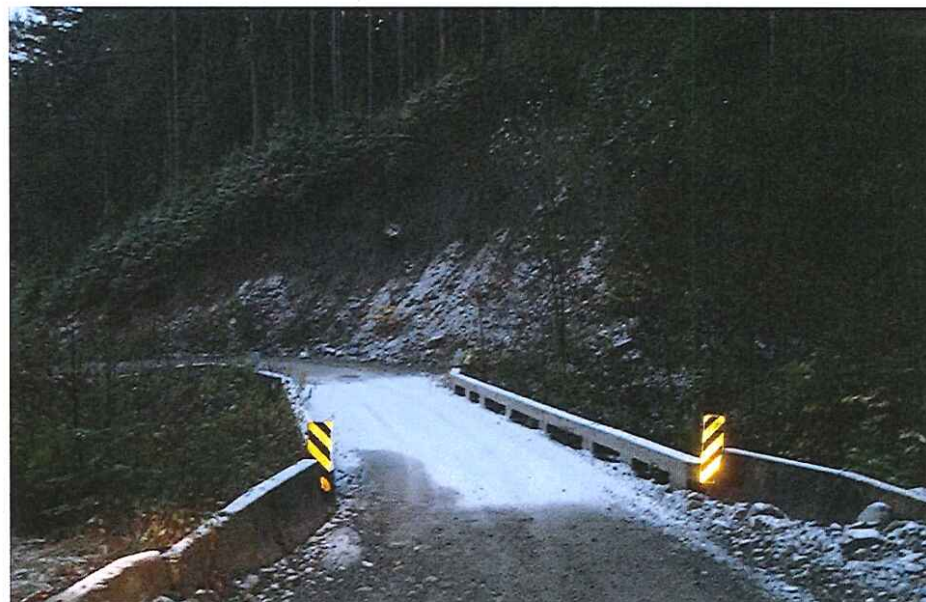
CK 2099 Approach Left Bank

| GENERAL INFORMATION | | (enter either longlat or UTM below - not both) | | | |
|---|---|---|---|---|---|
| Alignment | E G (F) P UR | steep VER + HOR CURVE w/ steep TIL cut banks | | | |
| Road Surface | E G F (P) UR | LARGE POTHOLE PAST JUNCTION w/ ROCK CRK FSR | | | |
