**Routine Condition Bridge Inspection Form**  
(except for log stringer or timber stringer bridges)**GENERAL INFORMATION**

| *Site ID: <u>6K-2109</u> | *Crossing Name: <u>Hornet Creek</u> | *Type/Class: <input checked="" type="checkbox"/> Temporary bridge<br><input type="checkbox"/> Permanent bridge | *Project File ID# <u>5748</u> |
| *FSR Name: <u>Harrison East</u> | *Forest District: <u>Chilliwack</u> | *Kilometres: _____ | User km: <u>03.43</u> |

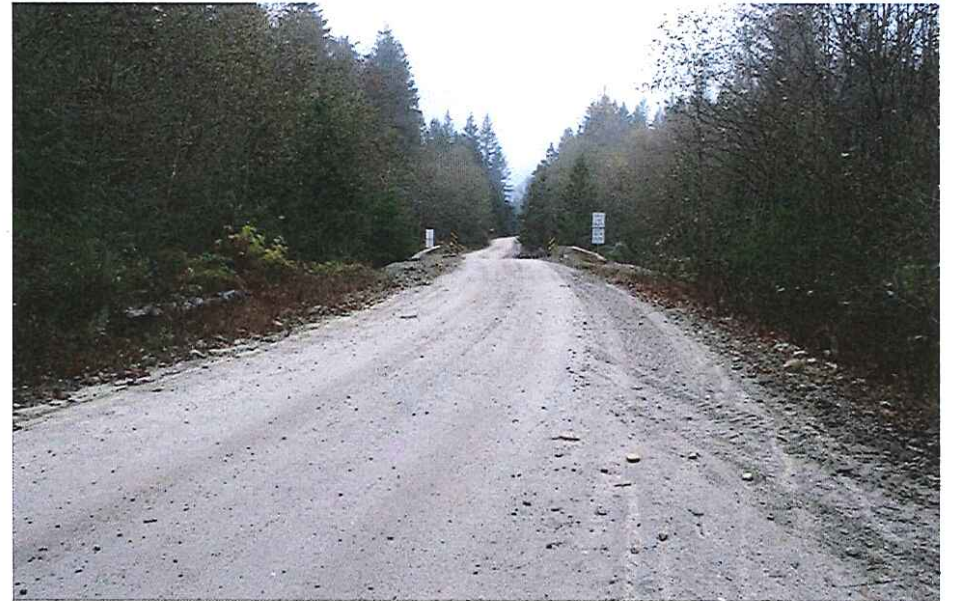
CK2109 Left to Right Approach

| Item | Present Condition<br>(circle or fill-in) | Comments<br>(a comment is mandatory if condition "Poor" is selected) |
|---|---|---|
| Alignment | E G <u>(P)</u> P UR | Poor vertical, ditches enter deck |

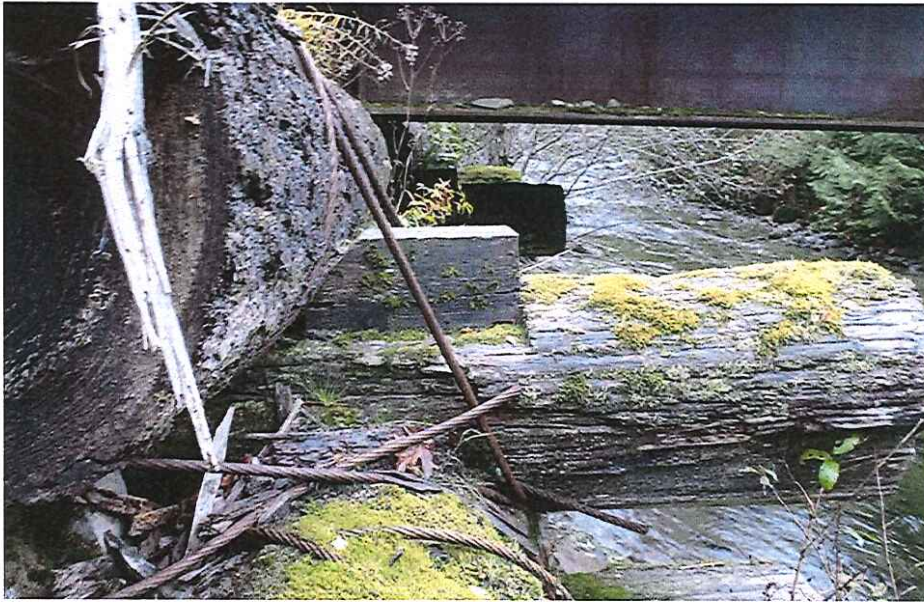
CK2109 Right Abutment

| Item | Present Condition<br>(circle) | Comments<br>(a comment is mandatory if condition "Poor" is selected) |
|---|---|---|
| Log/Timber Crib | E G <u>(F)</u> P N/A UR | Rotting but not critical |
| Tie-backs | E G <u>(F)</u> P N/A UR | " " " " |
| Hardware | E G <u>(F)</u> P N/A UR | Crib is lashed |

| GENERAL INFORMATION | | | |
|---|---|---|---|
| PEng Reviewer's Comments<br><u>Monitor cribs. Present load rating of L150 or 136 tonnes.</u> | | | |

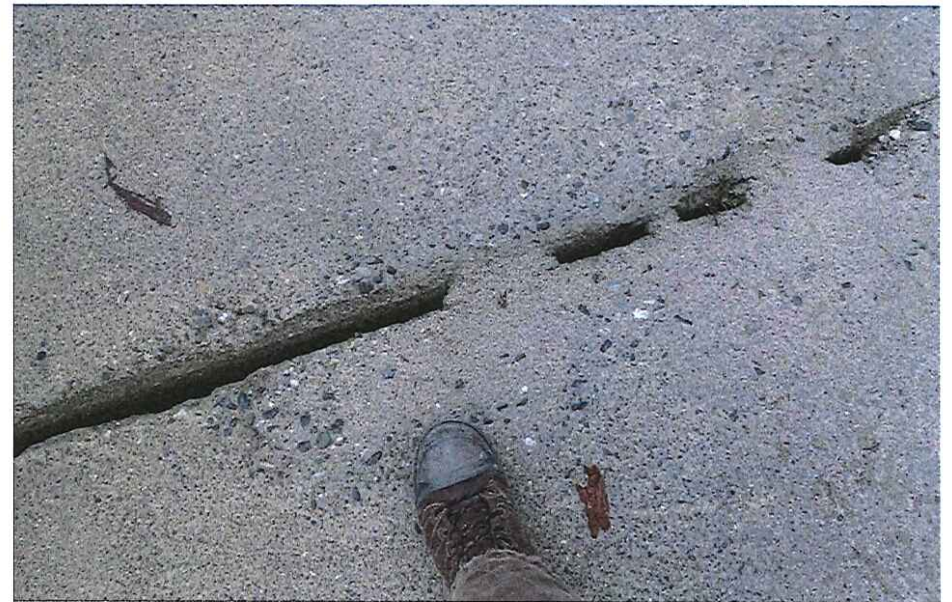
CK2109 Deck

| Item | Present Condition<br>(circle) | Comments<br>(a comment is mandatory if condition "Poor" is selected) |
|---|---|---|
| Running Surface (N/A if running surface is gravel or timber planks) | E G <u>(F)</u> P N/A UR | No foam in joints |
| Deck Joints | E G <u>(F)</u> P N/A UR | No sealant |

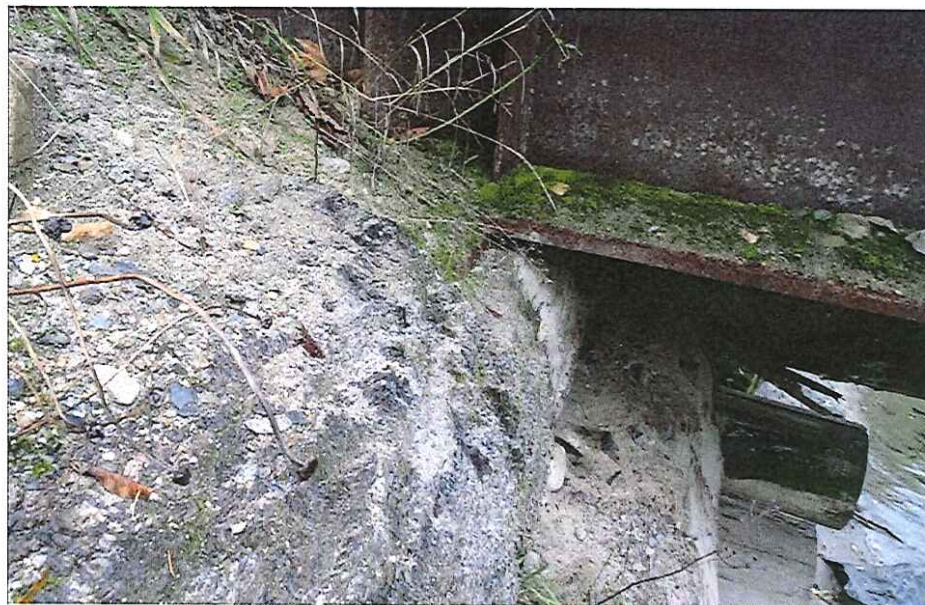
CK2109 Right Bearing

| Item | Present Condition<br>(circle) | Comments<br>(a comment is mandatory if condition "Poor" is selected) |
|---|---|---|
| Bearings | E G <u>(F)</u> P N/A UR | Top Ed sill cut flat |
