**Routine Condition Bridge Inspection Form**  
(except for log stringer or timber stringer bridges)

| GENERAL INFORMATION | | (enter either long/lat or UTM below - not both) | | | |
|---|---|---|---|---|--|
| *Site #: <u>CK-2110</u> | *Crossing Name: <u>Clear Crk</u> | *Type/Class: <input checked="" type="checkbox"/> Temporary bridge<br><input type="checkbox"/> Permanent bridge | *Project File ID# <u>5748</u> | | |
| *FSR Name: <u>Harrison East</u> | *Forest District: <u>Chwilk</u> | *User km: <u>38.5</u> | | | |

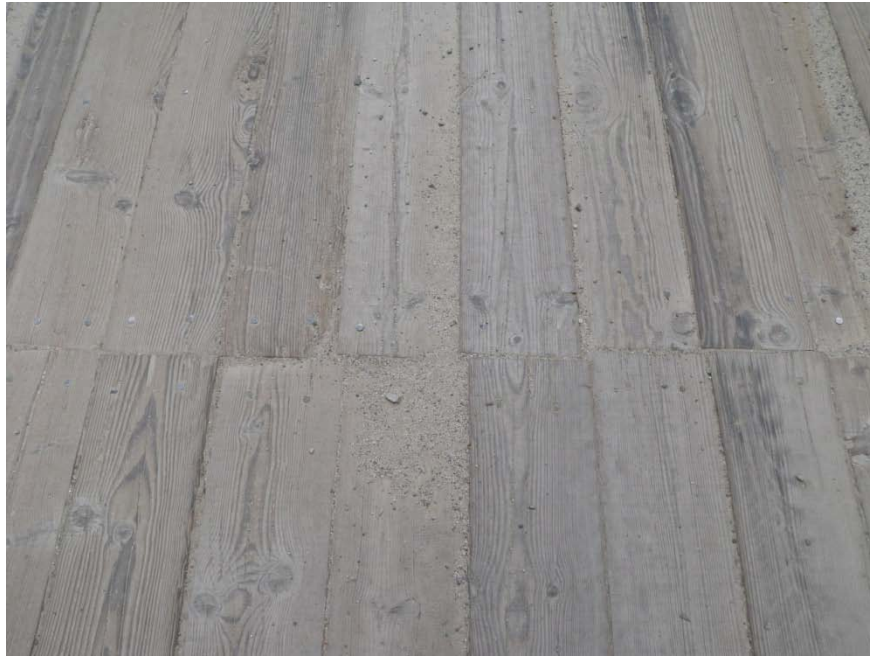
| GENERAL INFORMATION | | (enter either long/lat or UTM below - not both) | | | |
|---|---|---|---|---|--|
| Running Planks | E G <u>F</u> P N/A UR | <u>replaced in 2008 BUT NOT staggered (4x10) full width</u> | | | |

Running planks were not staggered when replaced in 2008.

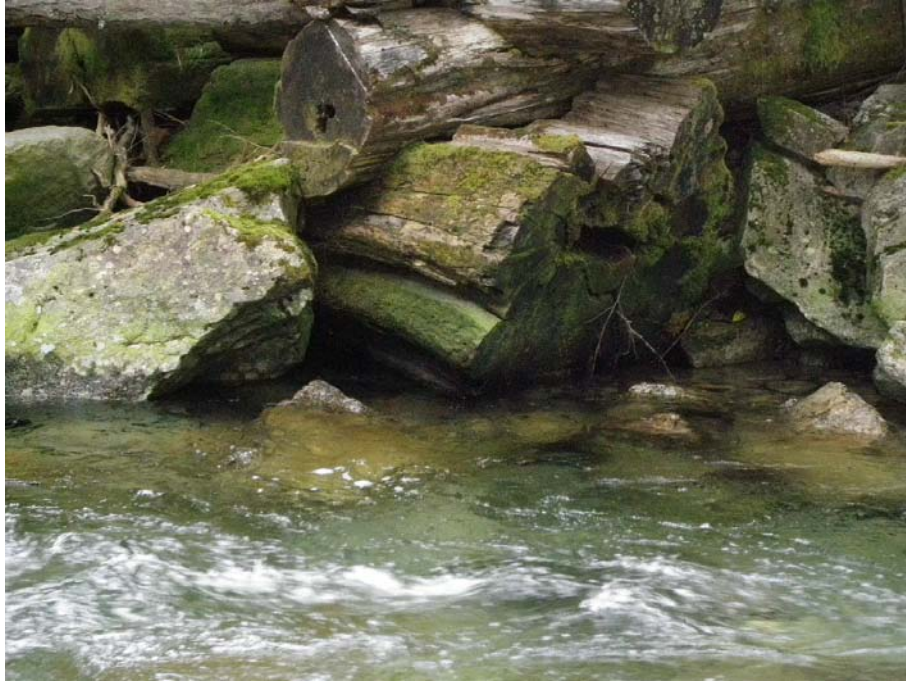
| GENERAL INFORMATION | | (enter either long/lat or UTM below - not both) | | | |
|---|---|---|---|---|--|
| Log/Timber Crib | E G F <u>P</u> N/A UR | <u>4 high - left d/s undermined</u> | | | |

Camp downstream crib is undermined due to large **flare** in Cw log

| Repair Item # | *Priority (circle) | *Estimate (\$) | *Repair Description |
|---|---|---|---|
| 1 | <u>H</u> M L | | both abutments nearing end of industrial life, replace |

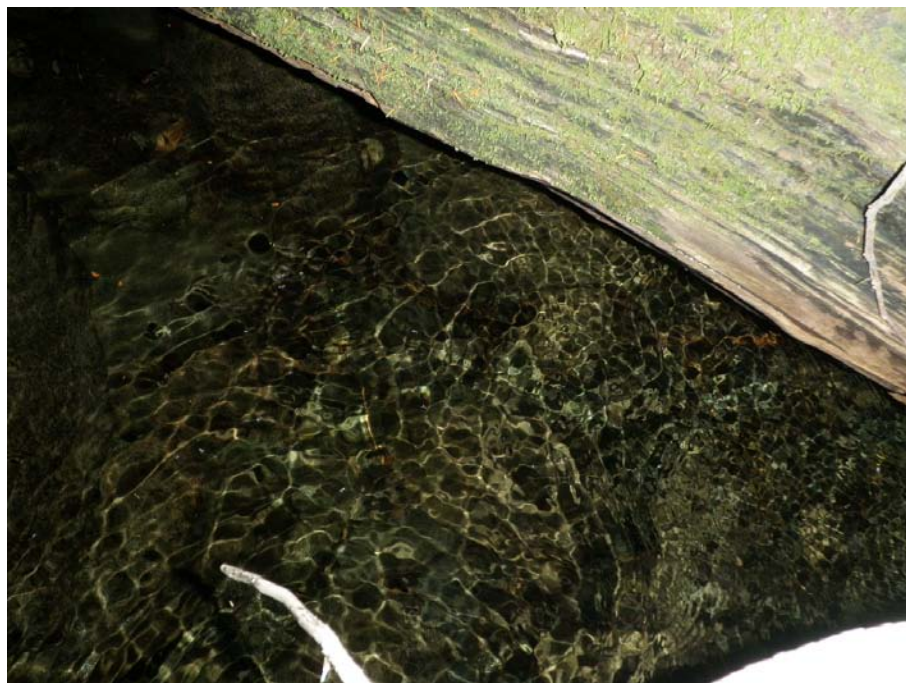
Camp downstream crib undermined.

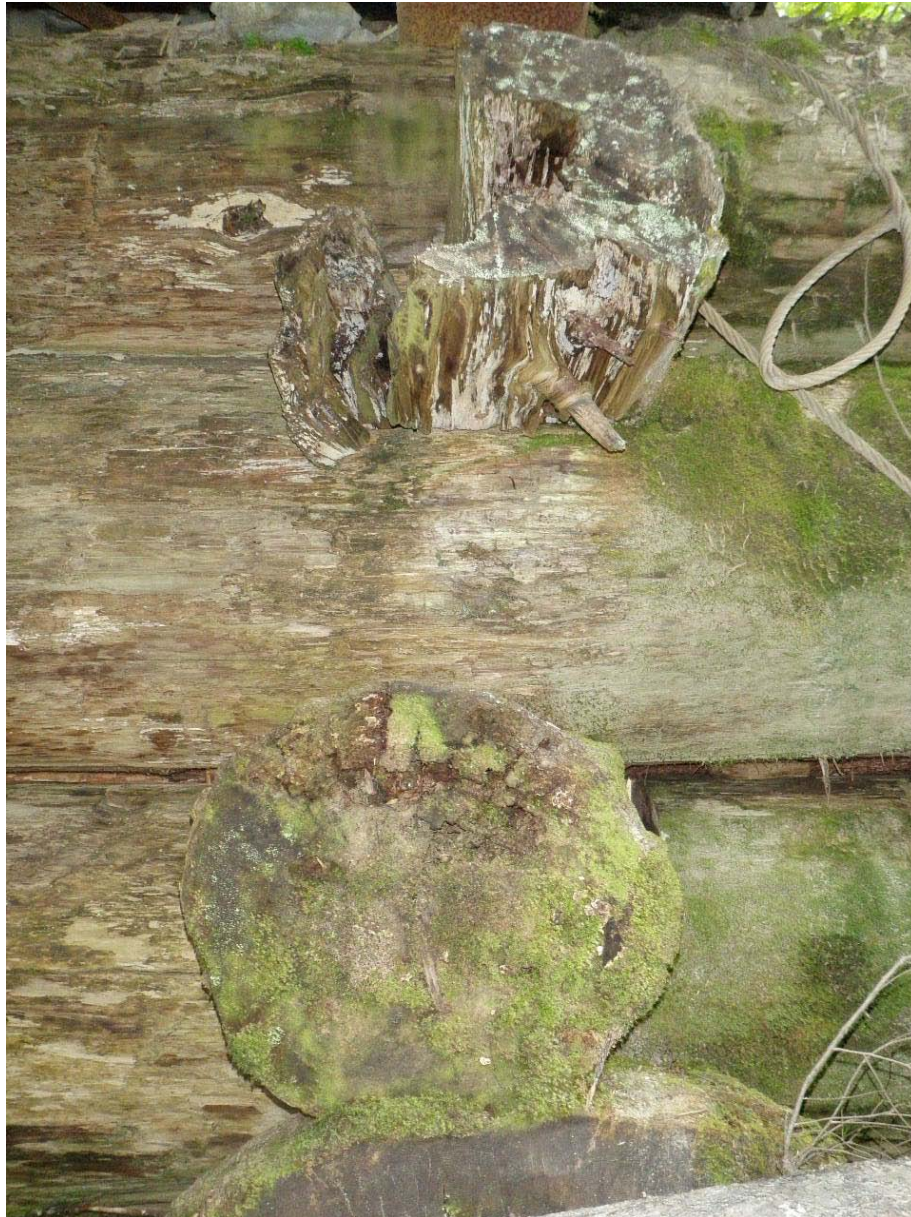
| GENERAL INFORMATION | | (enter either long/lat or UTM below - not both) | | | |
|---|---|---|---|---|--|
| Tie-backs | E G F <u>P</u> N/A UR | <u>4 tie backs, significant rot deterioration</u> | | | |

Both cribs are nearing the end of their industrial life. Significant rot in trebacks noted. Consider replacement soon. Update load rating sign ASAP.

Rotten tiebacks

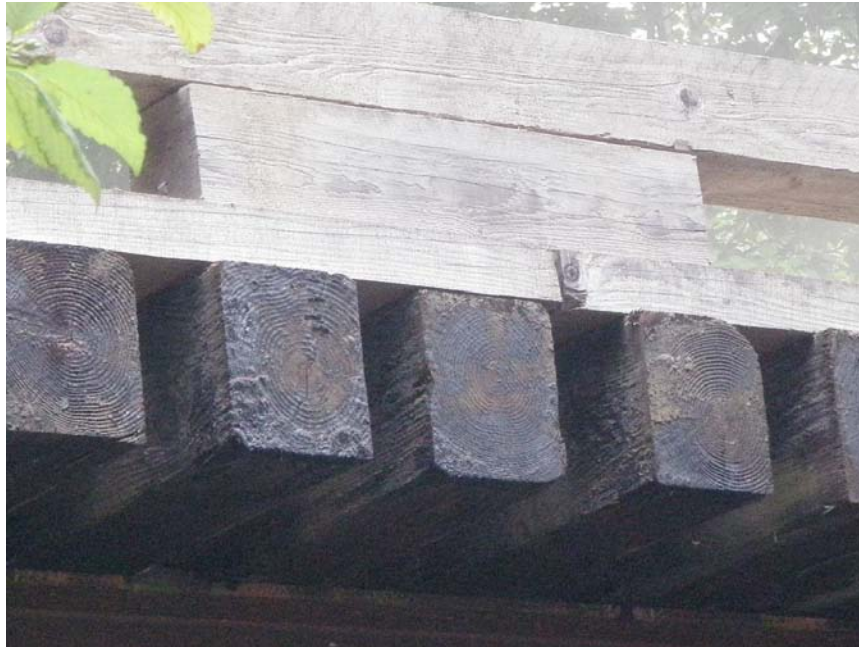
| GENERAL INFORMATION | | (enter either long/lat or UTM below - not both) | | | |
|---|---|---|---|---|--|
| Curb Rail/Blocks/Posts | E G <u>F</u> P UR | <u>undersized @ 200 x 200 - some bolts loose/missing</u> | | | |

Curb and riser with missing bolts. Nut was seen on top end but bolt does not extend through tie

| Repair Item # | *Priority (circle) | *Estimate (\$) | *Repair Description |
|---|---|---|---|
| 2 | <u>H</u> M L | | add guardrail bolts, 2 per rib |

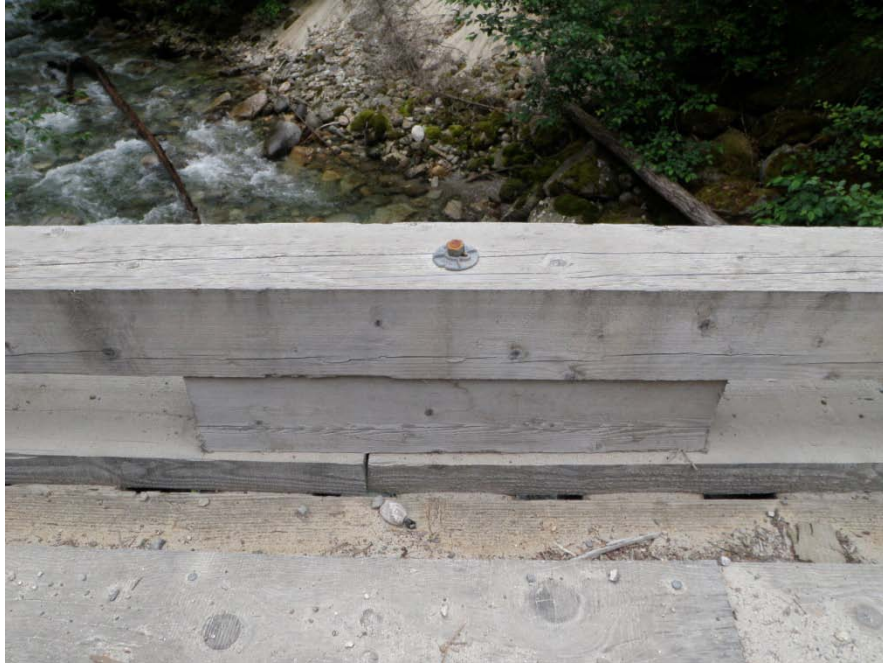
Riser and curb with only 1 bolt
