**Routine Condition Bridge Inspection Form**  
(except for log stringer or timber stringer bridges)**GENERAL INFORMATION**

| *Site #: <u>CK-2122</u> | *Crossing Name: <u>Big Silver Creek</u> | *Type/Class: <input type="checkbox"/> Temporary bridge<br><input checked="" type="checkbox"/> Permanent bridge | *Project File ID# <u>5713</u> |
| *FSR Name: <u>Harrison East Shore Creek</u> | | User km: <u>0.1</u> | |

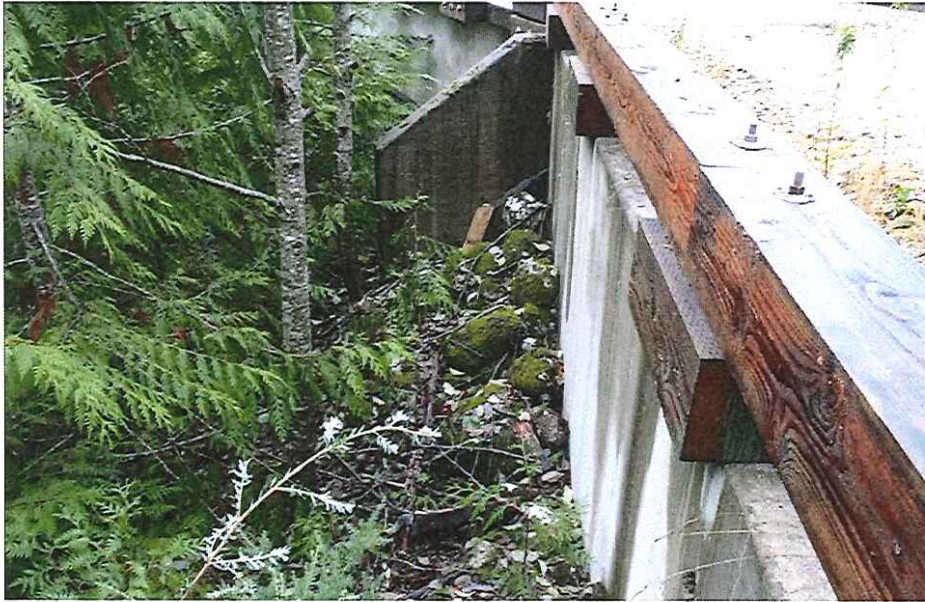
CK2122 Right Wingwall Upstream

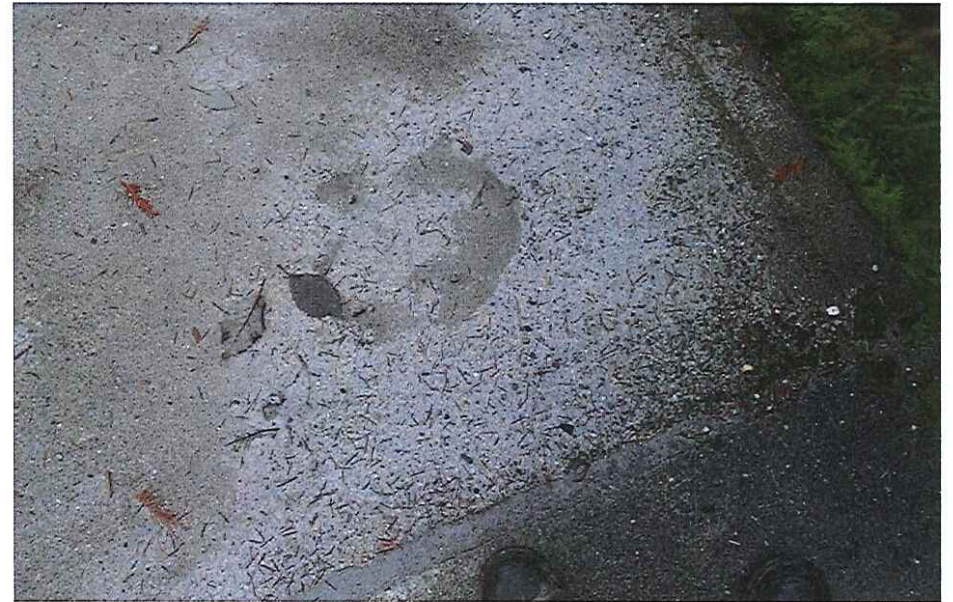
| Item | Present Condition<br>(circle) | Comments<br>(a comment is mandatory if condition "Poor" is selected) |
|---|---|---|
| Deck Joints | E <u>(G)</u> F P <u>(N/A)</u> UR | |

CK2122 Deck Joint

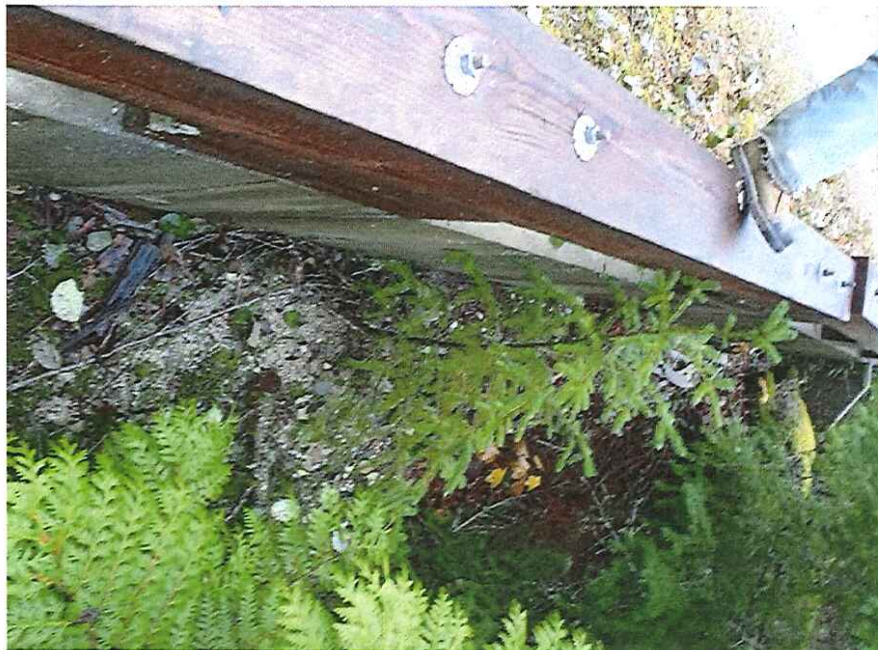
| Item | Present Condition<br>(circle) | Comments<br>(a comment is mandatory if condition "Poor" is selected) |
|---|---|---|
| Wing Wall | E <u>(G)</u> F P <u>(N/A)</u> UR | <u>Right side only</u> |

CK2122 Right Wingwall...

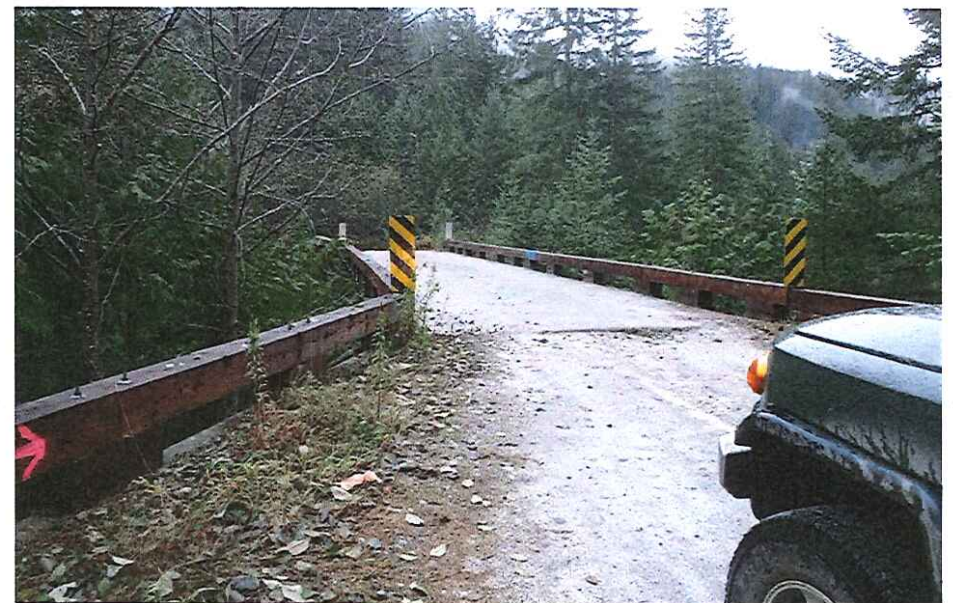
CK2122 Right to Left Approach

| GENERAL INFORMATION | | | |
|---|---|---|---|
| PEng Reviewer's Comments<br><u>Post bridge ahead signs.</u> | | | |

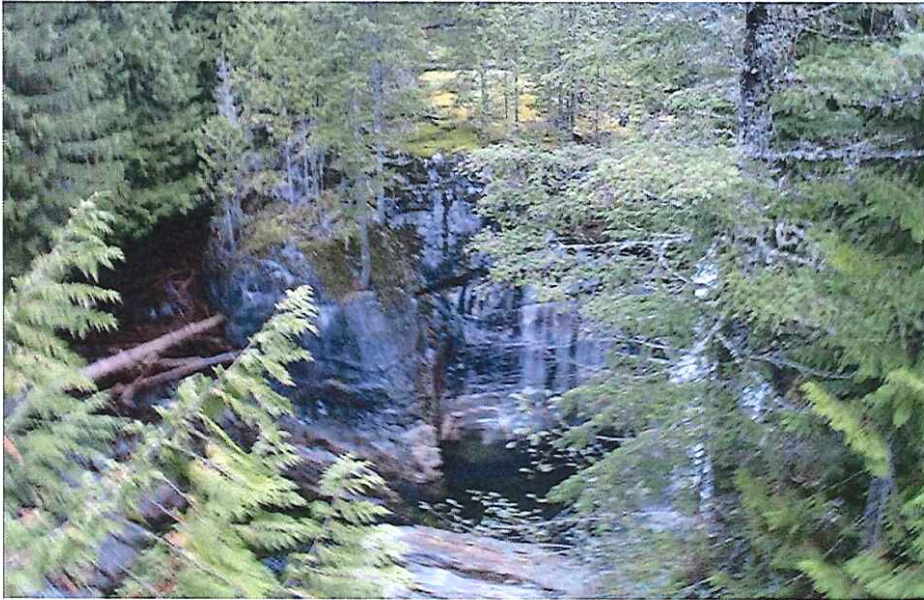
CK2122 Upstream

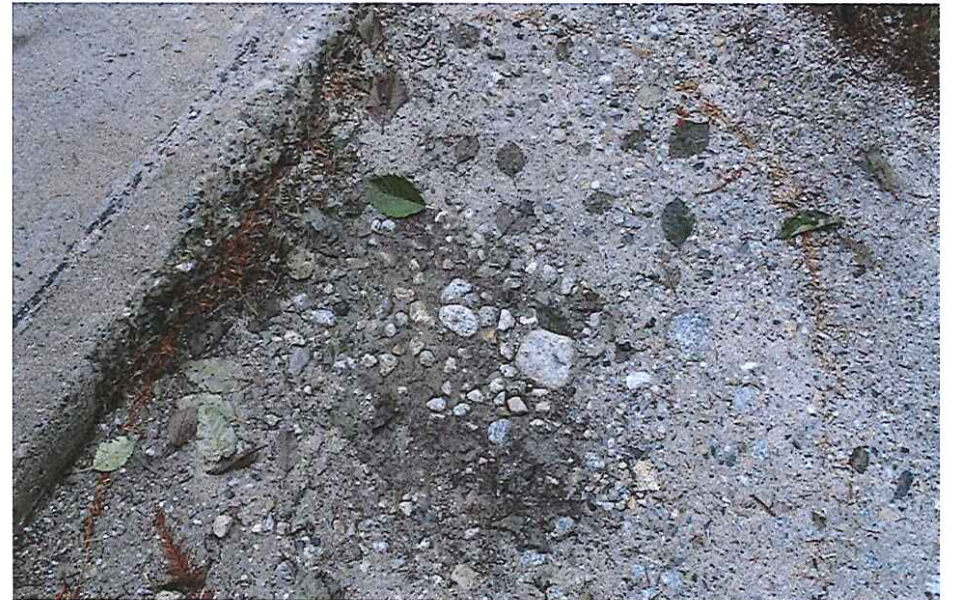
| Item | Present Condition<br>(circle or fill-in) | Comments<br>(a comment is mandatory if condition "Poor" is selected) |
|---|---|---|
| Road Surface | E G <u>(P)</u> P UR | <u>Pothole on right side</u> |

CK2122 Right approach pothole

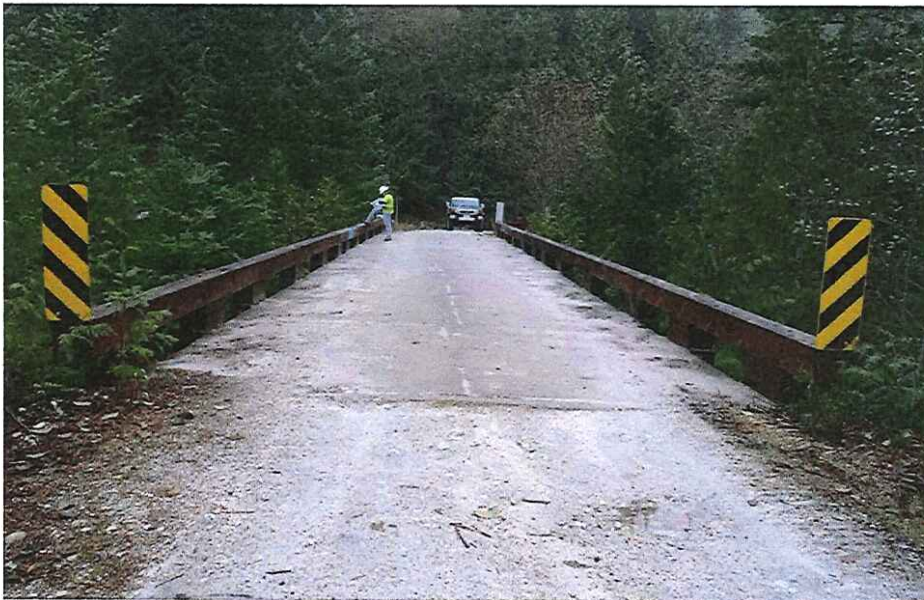
CK2122 Left to Right Approach

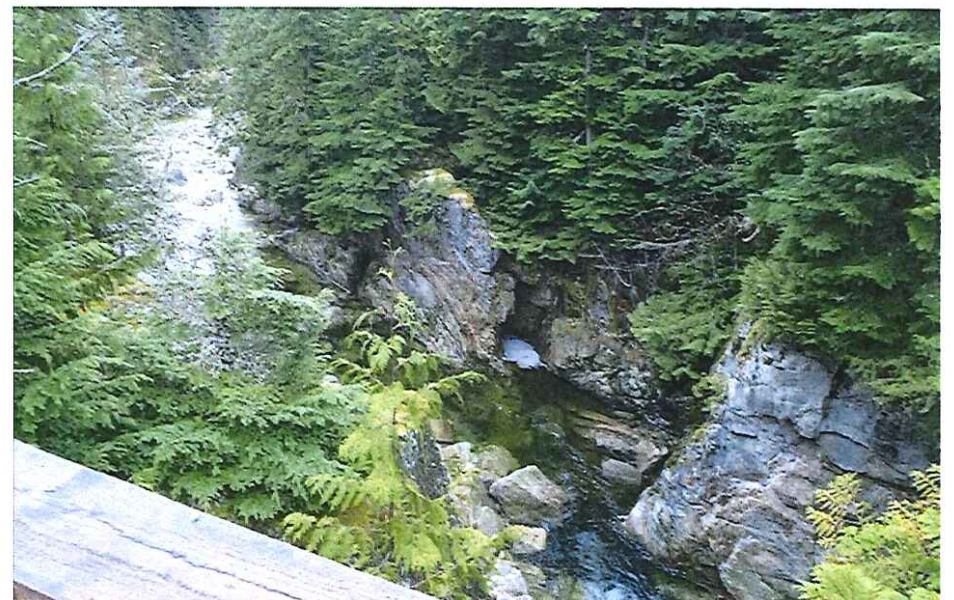
CK2122 Downstream

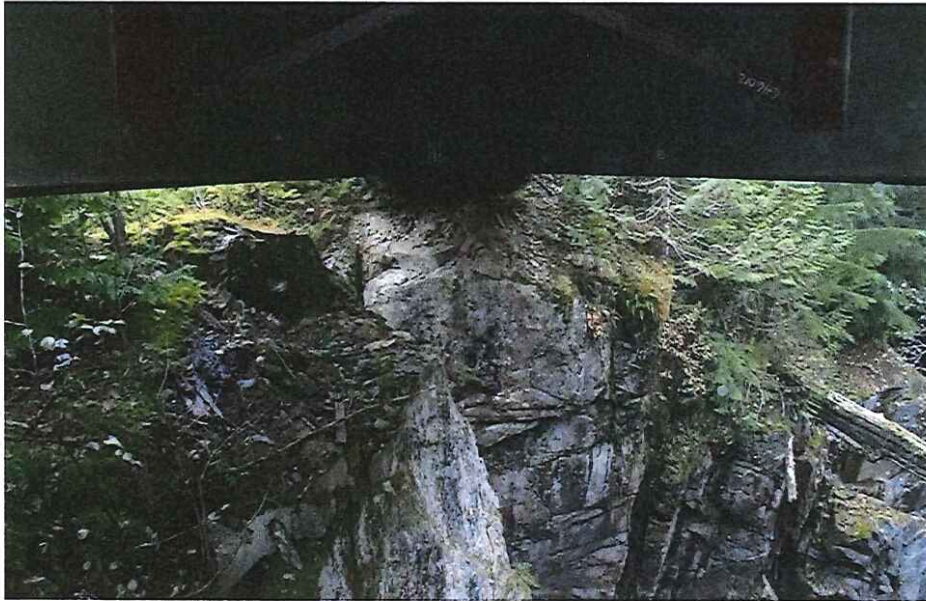
CK2122 Right Abutment

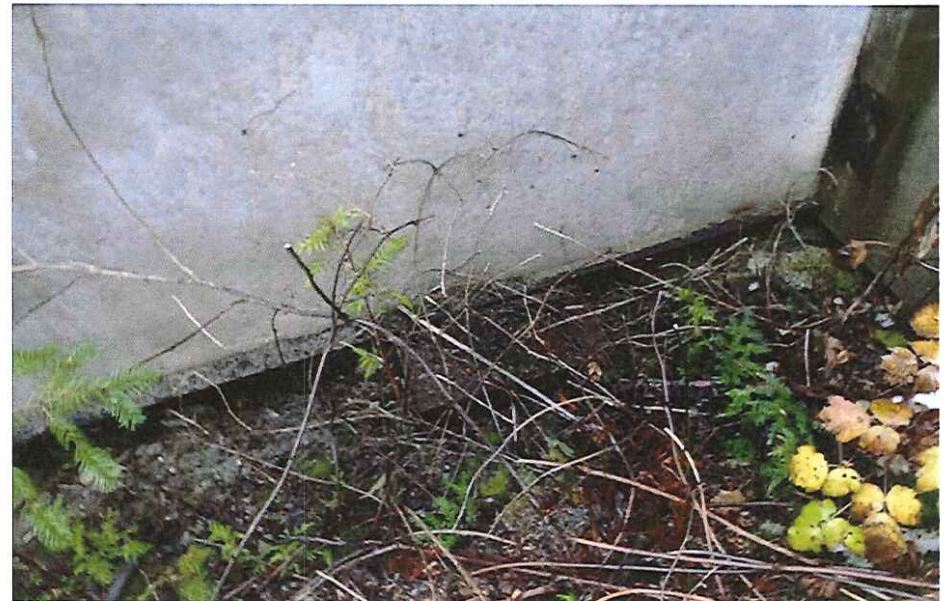
| Item | Present Condition<br>(circle) | Comments<br>(a comment is mandatory if condition "Poor" is selected) |
|---|---|---|
| Bearings | E <u>(G)</u> F P <u>(N/A)</u> UR | |

CK2122 Left Abutment Bearing

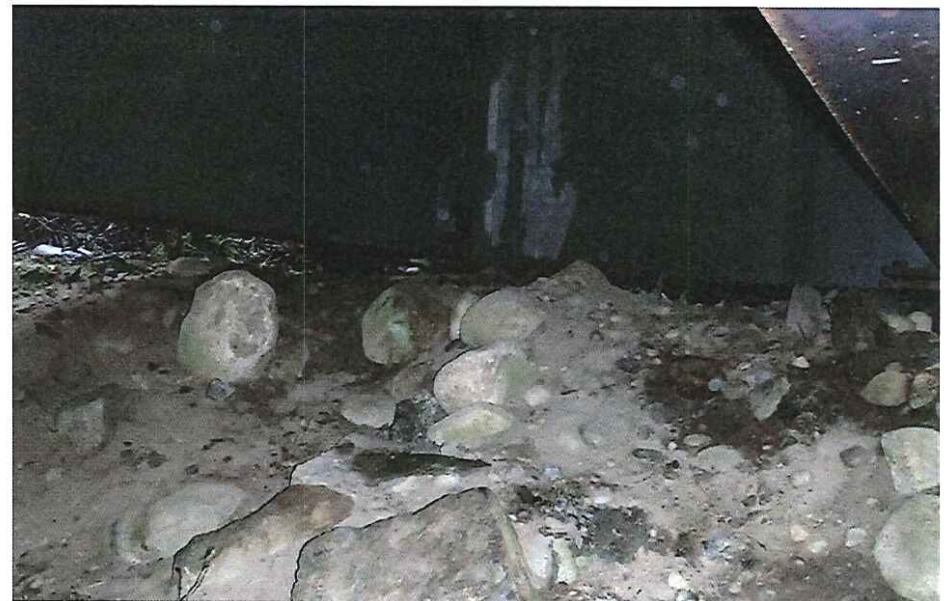
CK2122 Left Abutment
