**Routine Condition Bridge Inspection Form**  
(except for log stringer or timber stringer bridges)

| GENERAL INFORMATION | | (enter either long/lat or UTM below – not both) | | | |
|---|---|---|---|---|--|
| *Site #: <u>CK-2157</u> | *Crossing Name: <u>Hunter Crk</u> | *Type/Class: <input checked="" type="checkbox"/> Temporary bridge<br><input type="checkbox"/> Permanent bridge | | *Project File ID# <u>6086</u> | |
| *Structure #: <u>CK-2157</u> | *Forest District: <u>Lorenzetta-Hunter Crk</u> | *Kilometres: <u>2.2 km</u> | | *Br. <u>01</u> | |

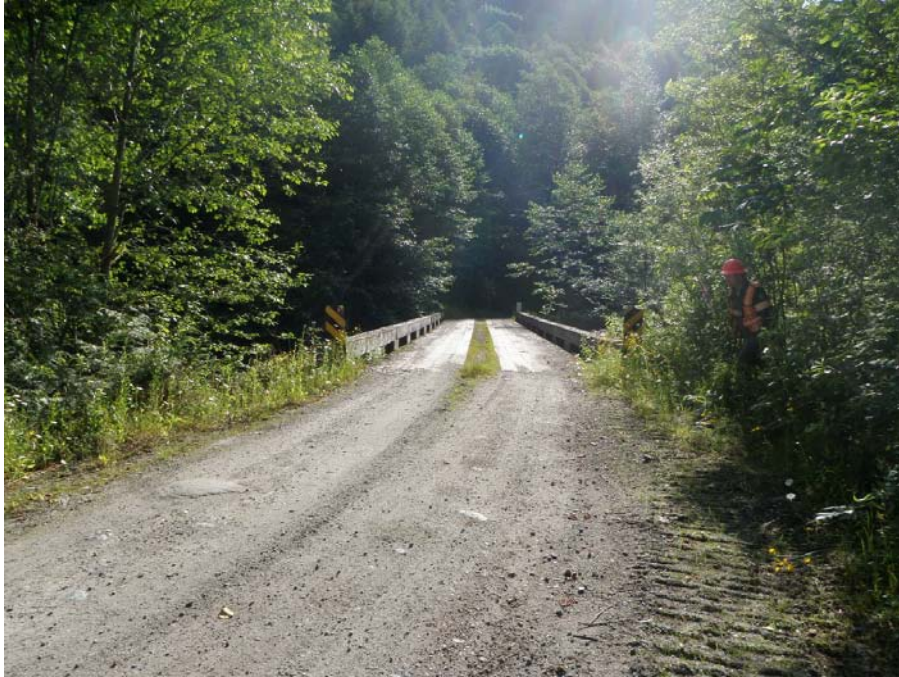
1. Camp approach.

| GENERAL INFORMATION | | (enter either long/lat or UTM below – not both) | | | |
|---|---|---|---|---|--|
| Alignment | E G <u>F</u> P UR | <u>S' curve</u> | | | |
| Brushing Required | <u>Yes</u> No | | | | |

| GENERAL INFORMATION | | | |
|---|---|---|---|
| 6 | H M L | | - brush approaches |

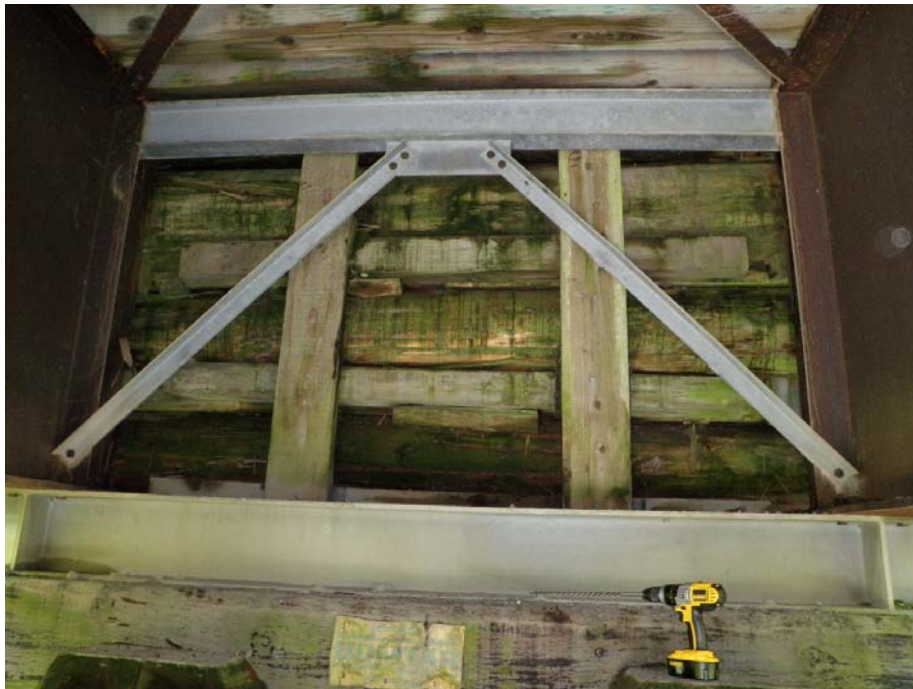
2. Camp ballast wall.

| GENERAL INFORMATION | | (enter either long/lat or UTM below – not both) | | | |
|---|---|---|---|---|--|
| Ballast Wall | E G <u>F</u> P N/A UR | <u>log</u> | | | |

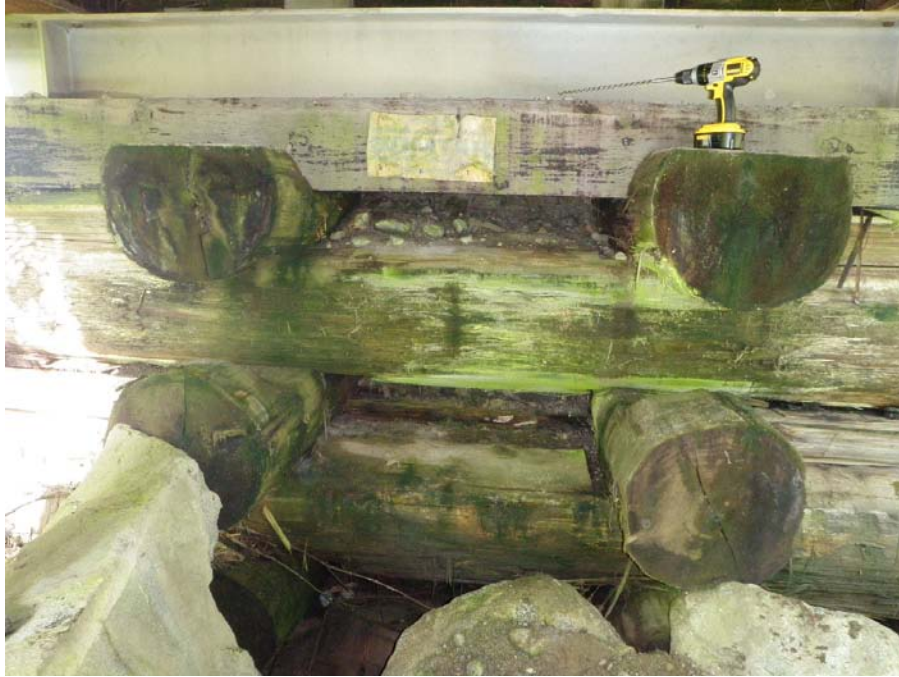
3. Camp abutment.

| GENERAL INFORMATION | | (enter either long/lat or UTM below – not both) | | | |
|---|---|---|---|---|--|
| Log/Timber Cribs | E G <u>F</u> P N/A UR | <u>3 High (visible) CW</u> | | | |
| Tie-backs | E G <u>F</u> P N/A UR | <u>4 tie backs CW</u> | | | |

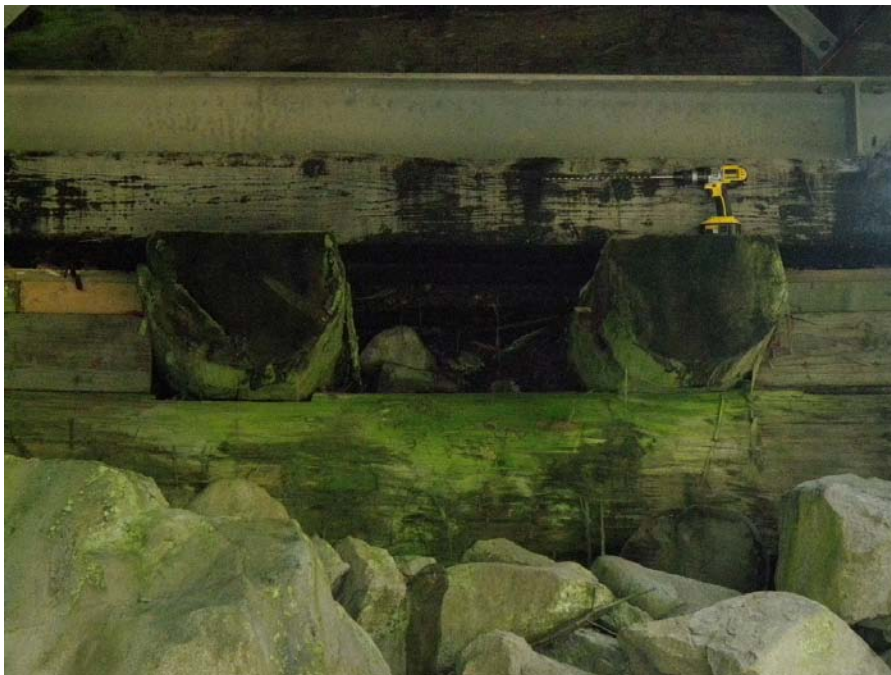
| GENERAL INFORMATION | | (enter either long/lat or UTM below – not both) | | | |
|---|---|---|---|---|--|
| Corrosion Protection | E G F P <u>N/A</u> UR | <u>filly' timber missing between tieback &amp; crib log</u> | | | |

6. Gap between tiebacks and crib logs – consider placing filler timbers to properly distribute load downwards.

| GENERAL INFORMATION | | | |
|---|---|---|---|
| 3 | H M L | | - fill gaps between crib logs - toebacks |

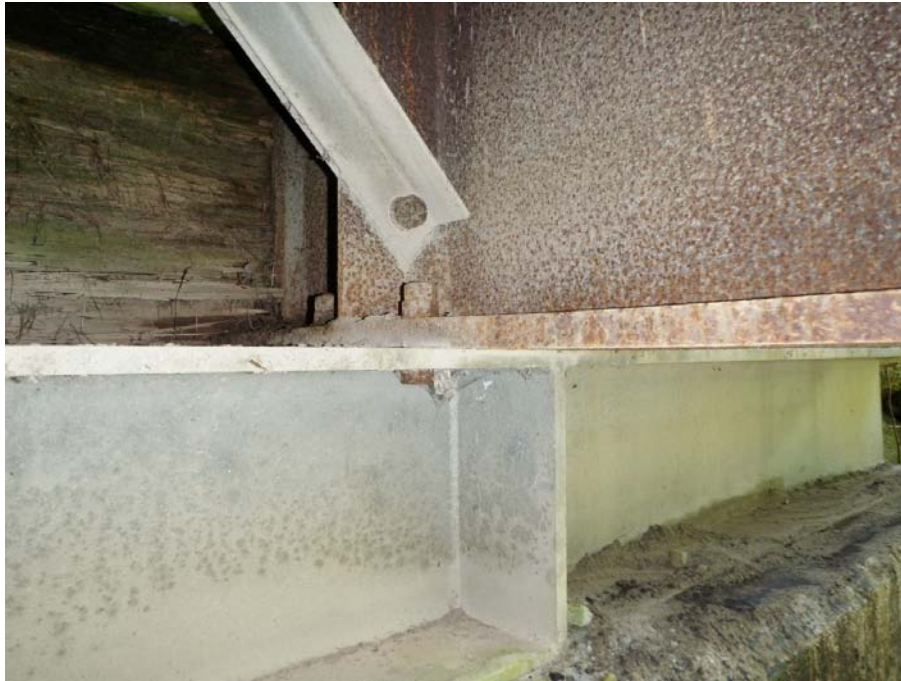
| GENERAL INFORMATION | | (enter either long/lat or UTM below – not both) | | | |
|---|---|---|---|---|--|
| Bearings | E G <u>F</u> P N/A UR | <u>1-ben sits directly on steel cap &amp; -</u> | | | |

7. Steel girder bearing directly on steel cap.
