**Routine Condition Bridge Inspection Form**  
(except for log stringer or timber stringer bridges)**GENERAL INFORMATION** (enter either long/lat or UTM below - not both)

| *Structure #: CL2175 | | | *Br. 02 |
| *FSR Name: Lost-Murdo | *Forest District: Chalk | *Kilometres: | User km: 1.2 km |

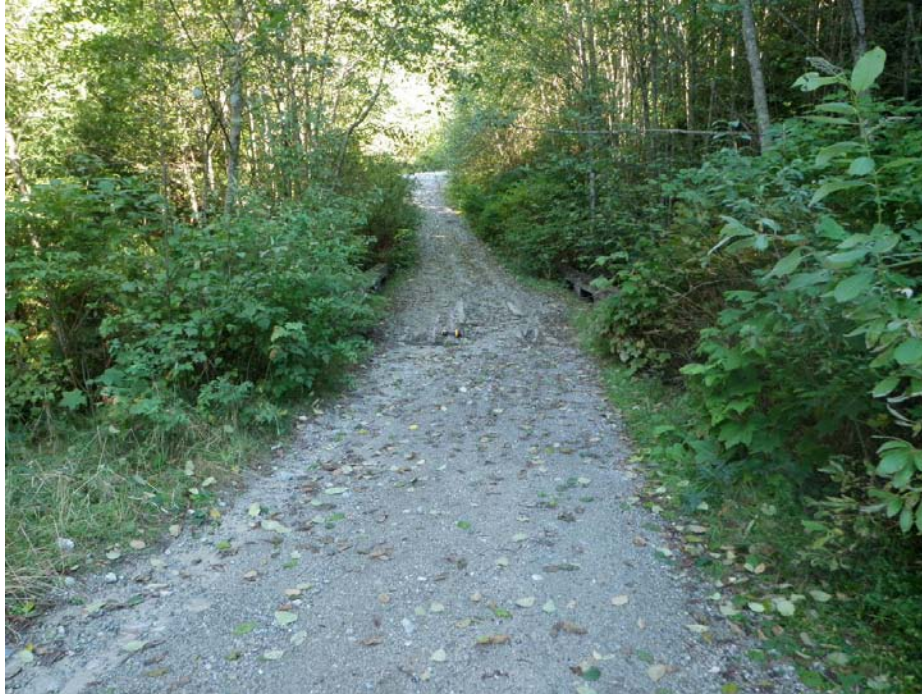
Town approach

| Item | Present Condition (circle or fill-in) | Comments (a comment is mandatory if condition "Poor" is selected) |
|---|---|---|
| Fender Condition | E G <u>F</u> <u>P</u> None UR | logs on town end, rock on woods end |
| Road Surface | E G <u>F</u> <u>P</u> UR | gravel accumulating on deck, road badly rutted |

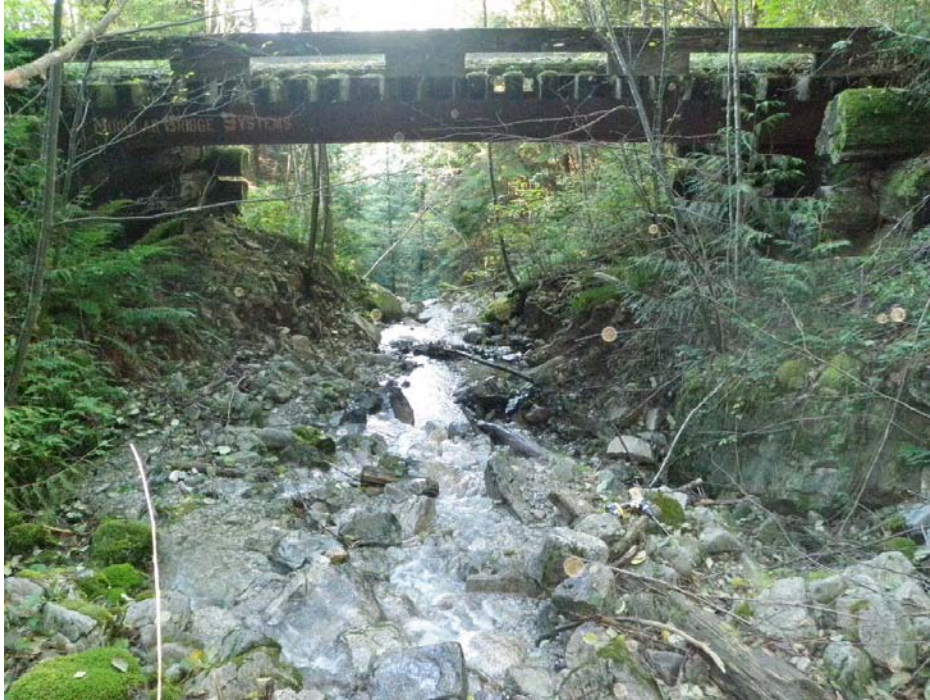
View from upstream

| GENERAL INFORMATION | | | | | |
|---|---|---|---|---|---|
| Girders | E | G <u>F</u> P UR | 2 steel beams to surface rust | | |
| Diaphragms | E | G <u>F</u> P N/A UR | 3- surface rust | | |
| Bracing | E | G <u>F</u> P N/A UR | surface rust | | |

| GENERAL INFORMATION | | | | | |
|---|---|---|---|---|---|
| <u>1</u> | <u>H</u> M L | | replace structure prior to industrial activity | | |

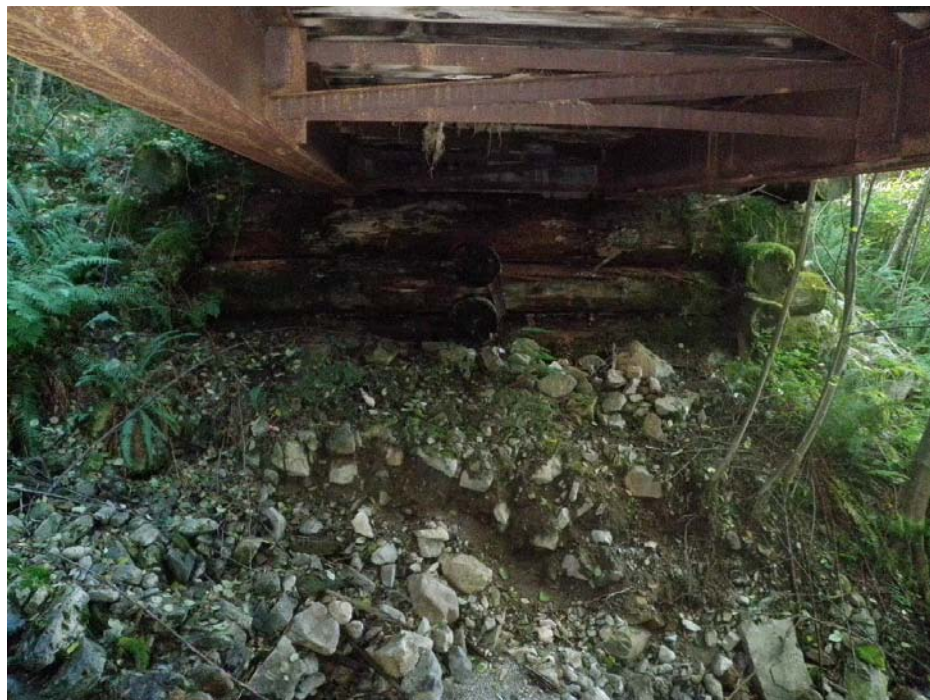
Town abutment

| Item | Present Condition (circle) | Comments (a comment is mandatory if condition "Poor" is selected) |
|---|---|---|
| Log/Timber Crib | E G <u>F</u> <u>P</u> N/A UR | 3X |
| Tie-backs | E G <u>F</u> <u>P</u> N/A UR | significant rot noted |

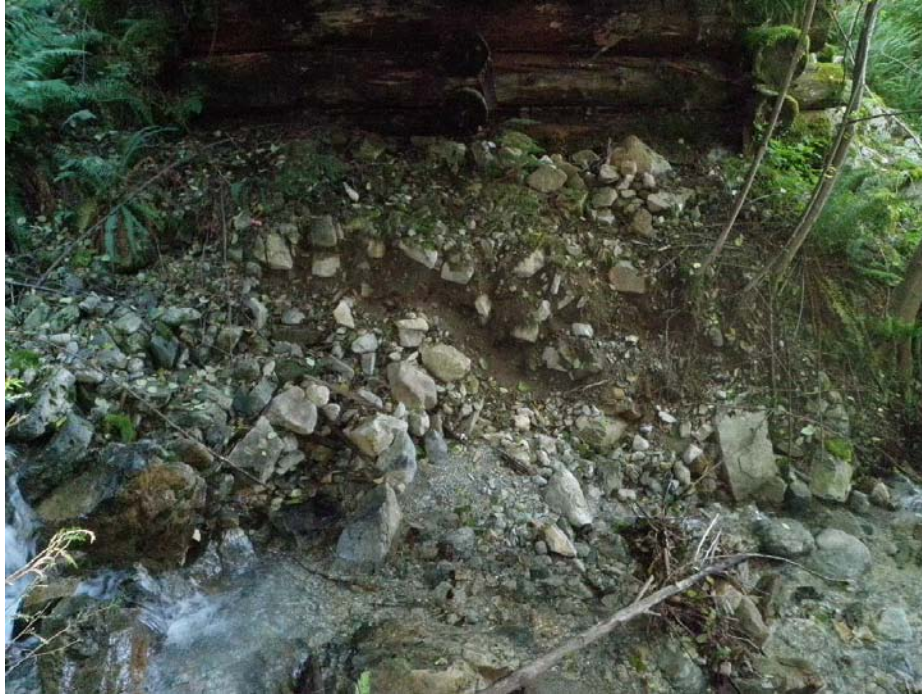
| Item | Present Condition (circle) | Comments (a comment is mandatory if condition "Poor" is selected) |
|---|---|---|
| Riprap | E G <u>F</u> <u>P</u> N/A UR | heavily scoured |

Town abutment scour

| GENERAL INFORMATION | | | | | |
|---|---|---|---|---|---|
| <u>1</u> | monitor crib scour | | | | |

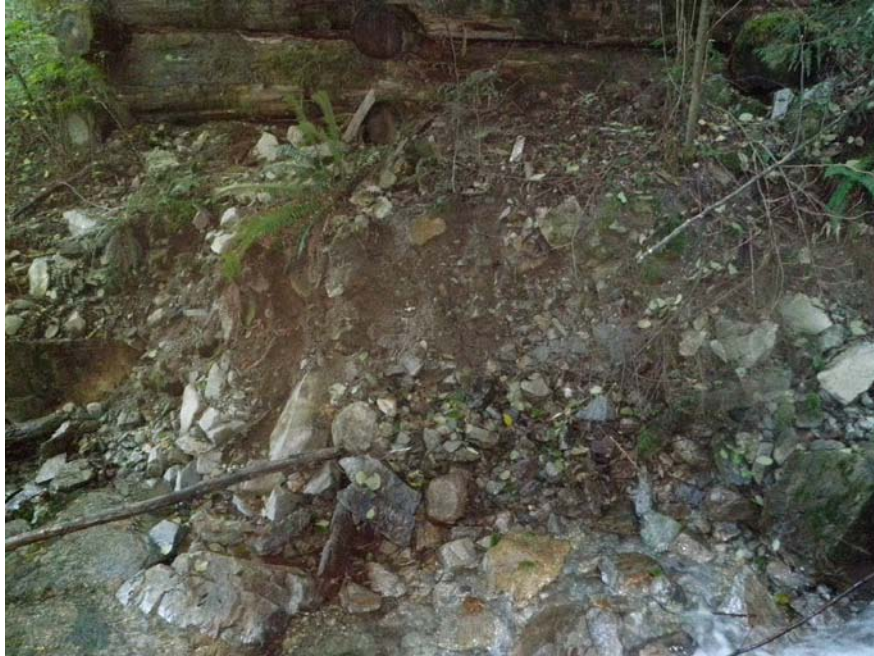
Woods abutment scour

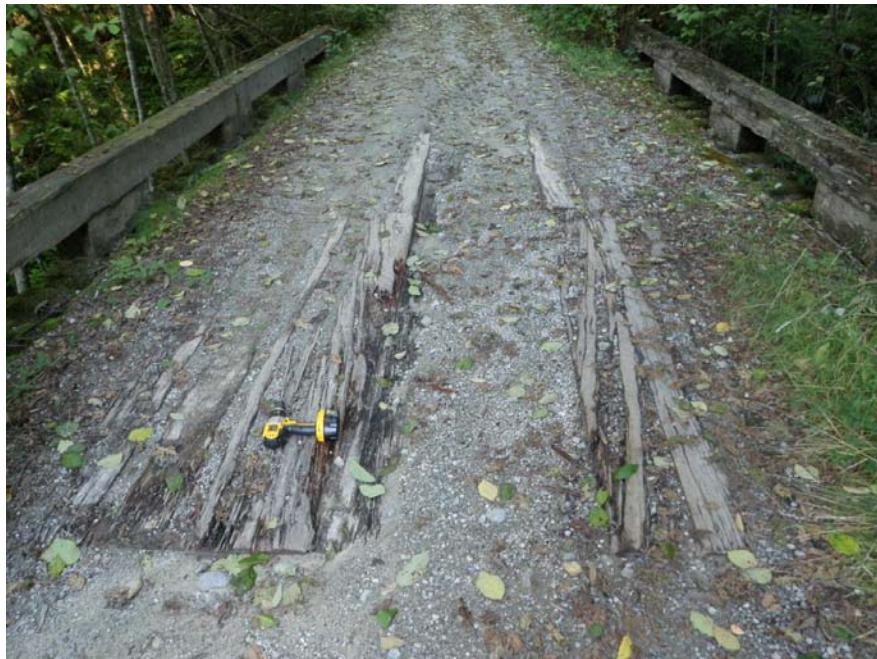
| Item | Present Condition (circle) | Comments (a comment is mandatory if condition "Poor" is selected) |
|---|---|---|
| Running Planks | E G <u>F</u> <u>P</u> N/A UR | rotten |
| Sub-deck | E G <u>F</u> <u>P</u> N/A UR | rotten |
| Ties | E G <u>F</u> <u>P</u> N/A UR | rotten |
| Nails | E G <u>F</u> <u>P</u> N/A UR | protruding |
| Curb Rail/Blocks/Posts | E G <u>F</u> <u>P</u> UR | rotten |
| Overall Deck Condition | E G <u>F</u> <u>P</u> UR | replace |

| GENERAL INFORMATION | | | | | |
|---|---|---|---|---|---|
| PEng Reviewer's Comments<br><u>- replace entire structure prior to industrial activity.</u> | | Date Reviewed (yyyy/mm/dd)<br><u>2011/09/30</u> | | | |
