**Routine Condition Bridge Inspection Form**  
(except for log stringer or timber stringer bridges)

| GENERAL INFORMATION | | (enter either long/lat or UTM below - not both) | | | |
|---|---|---|---|--|--|
| *Site #: <u>CK 2176</u> | *Crossing Name: <u>Darlene Crk</u> | *Type/Class: <input checked="" type="checkbox"/> Temporary bridge<br><input type="checkbox"/> Permanent bridge | *Project File ID# <u>8466</u> | | |
| *Structure #: <u>CK 2176</u> | *Forest District: <u>Chwkw</u> | *Kilometres: <u>2.0km</u> | *Br. <u>Set</u> | | |
| *FSR Name: <u>Lost South</u> | *User km: | | | | |

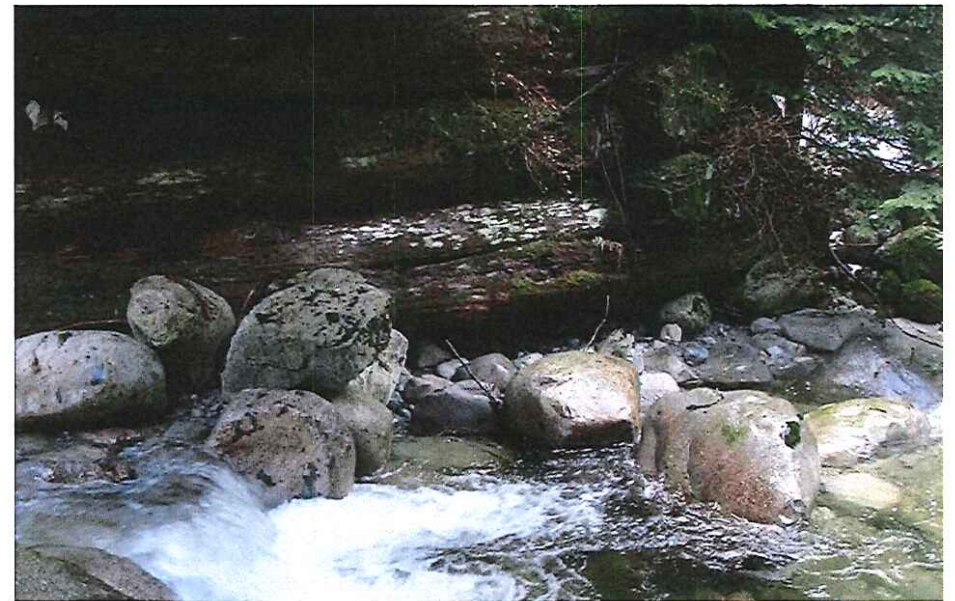
CK2176 Abutment Left Bank

| GENERAL INFORMATION | | | |
|---|---|---|---|
| PEng Reviewer's Comments: 5 tonnes load restriction due to crib condition. | | | |

Post load rating and monitor annually.

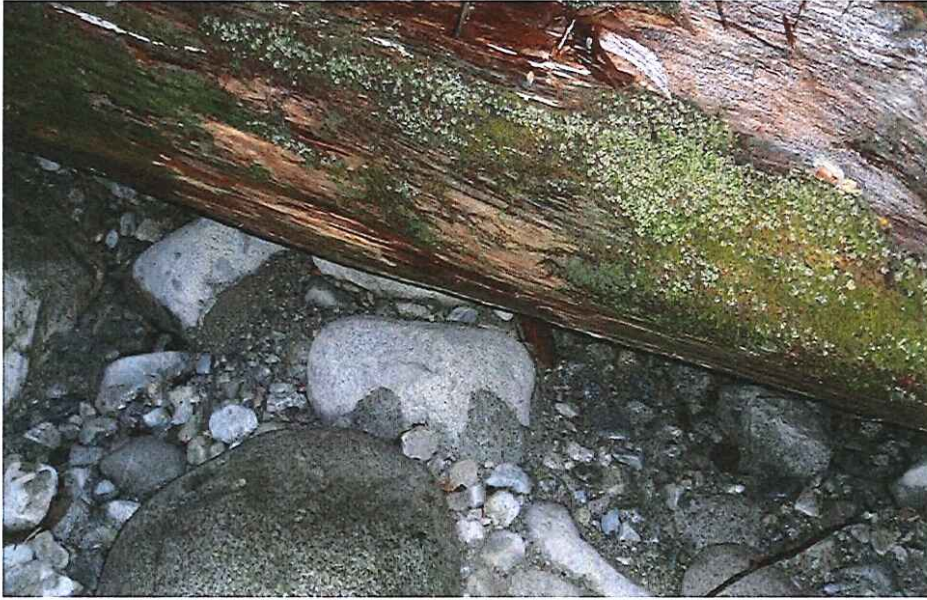
| GENERAL INFORMATION | | | |
|---|---|---|---|
| 1 | Scour at Downstream LIB cribbing does not look like it has progressed since last | | |

CK2176 Undermining scour left ban...
